**ADDENDUM TO PROPERTY INSPECTION REPORT
PROPERTY INSPECTION AGREEMENT
SAMPLE REPORT**

ALLIED HOME INSPECTION SERVICES

**JOHN O. FRANZEN
LICENSED BUILDING INSPECTOR
T.R.E.C. # 1553**

TYPE OF STRUCTURE: CONDO

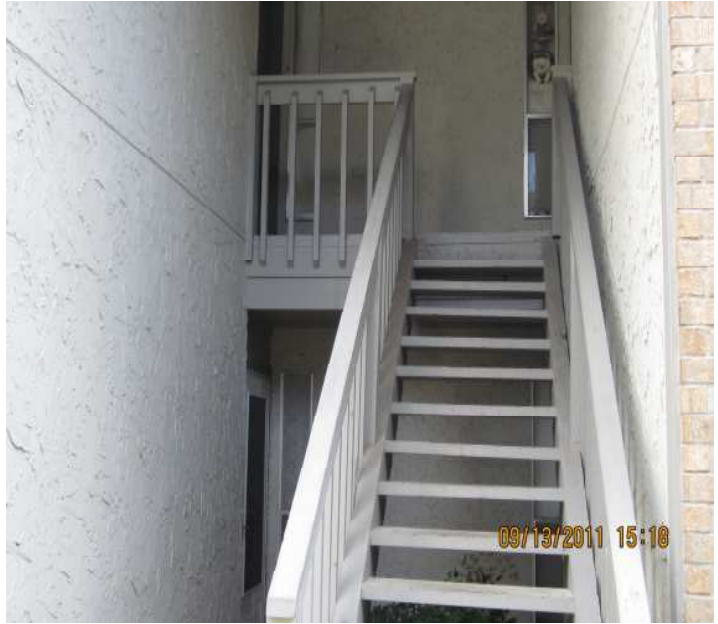
**NO. 7 EXTERIOR STAIRWAY DOES NOT MEET THE "4-INCH" RULE.
THE PRESENT SETUP POSES A SAFETY HAZARD. REPAIRS
ARE NEEDED. SEE APPENDIX G.**

PHOTO NO. 2 STAIRWAY DOES NOT MEET "4-INCH" RULE

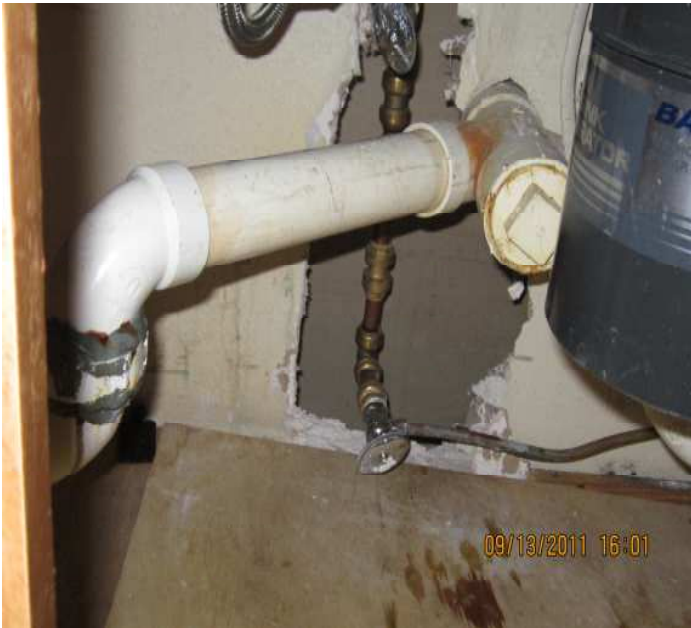
- NO. 3 BACK WALL, UNDER THE KITCHEN SINK, IS DAMAGED. REPAIRS
ARE NEEDED.**

PHOTO NO. 3 DAMAGED WALL UNDER KITCHEN SINK

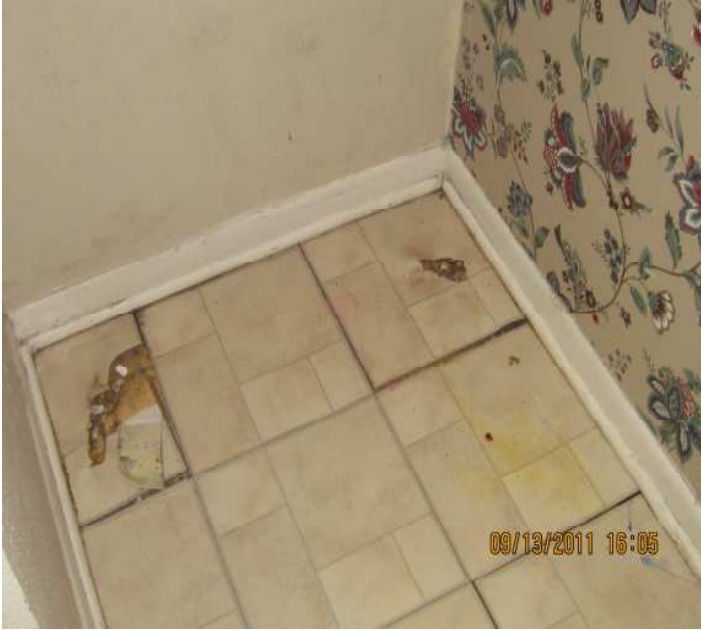
**NO. 4 VINYL FLOORING, IN THE UTILITY ROOM AREA, IS DAMAGED.
REPAIRS ARE NEEDED.**

PHOTO NO. 5 DAMAGED FLOORING IN
UTILITY ROOM

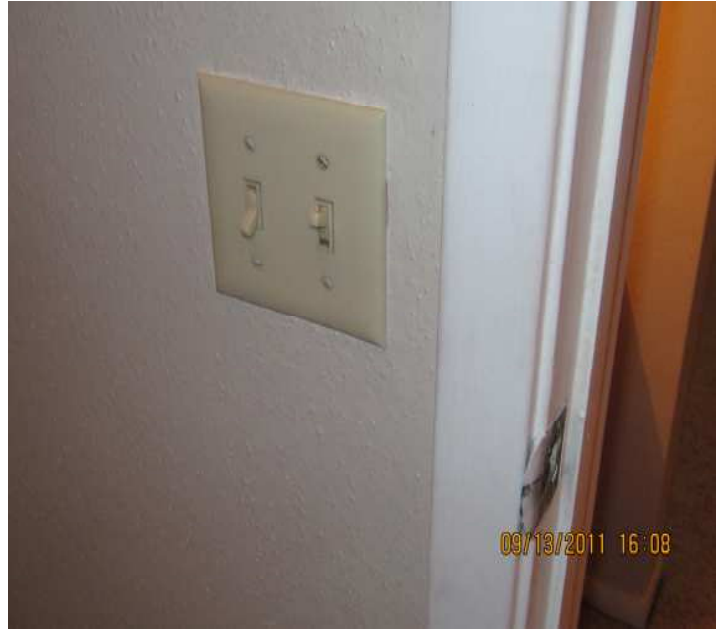
PHOTO NO. 6 WALL SWITCHES, IN M. BATH,
TOO CLOSE TO TUB

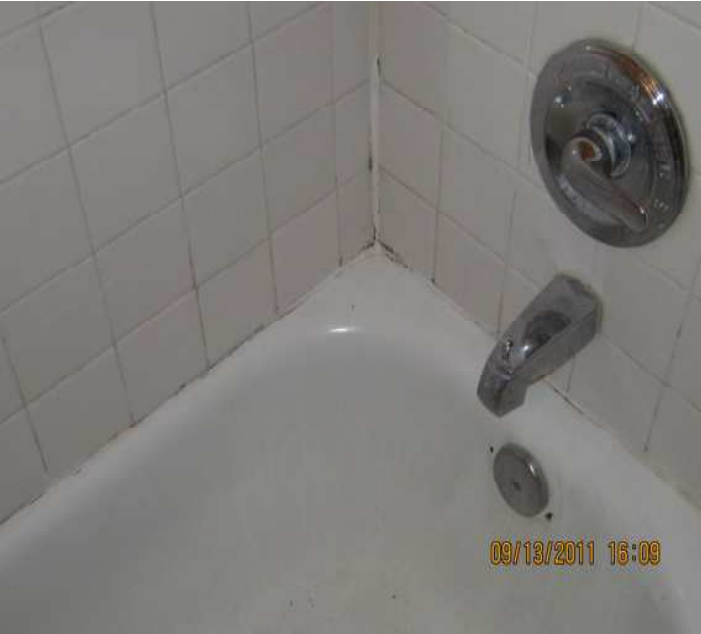
PHOTO NO. 7 DAMAGED CERAMIC TILE
OVER M. BATH TUB

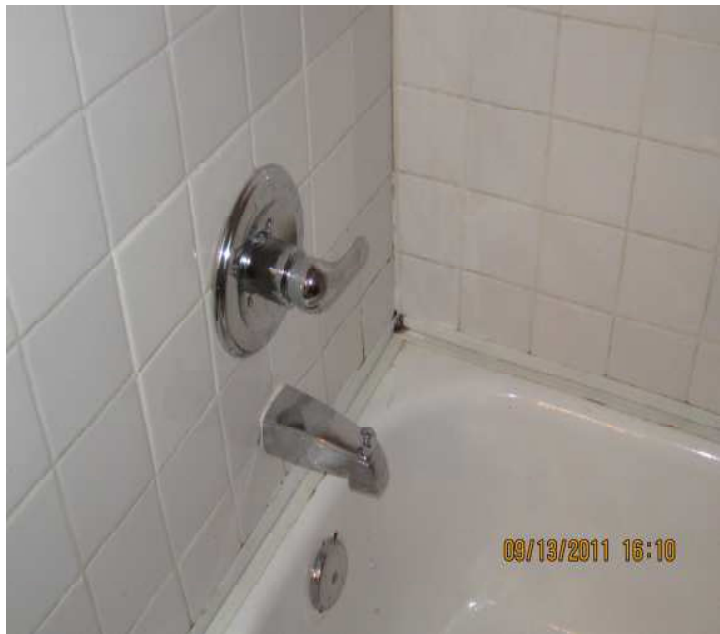
PHOTO NO. 8 DAMAGED CERAMIC TILE
IN NO. 2 BATH

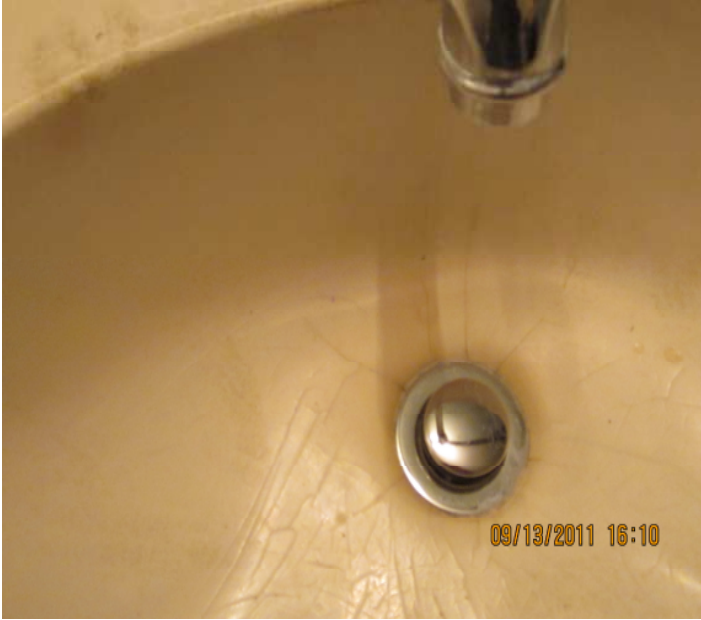
PHOTO NO. 9

DAMAGED SINK, IN M. BATH,
BY DRAIN

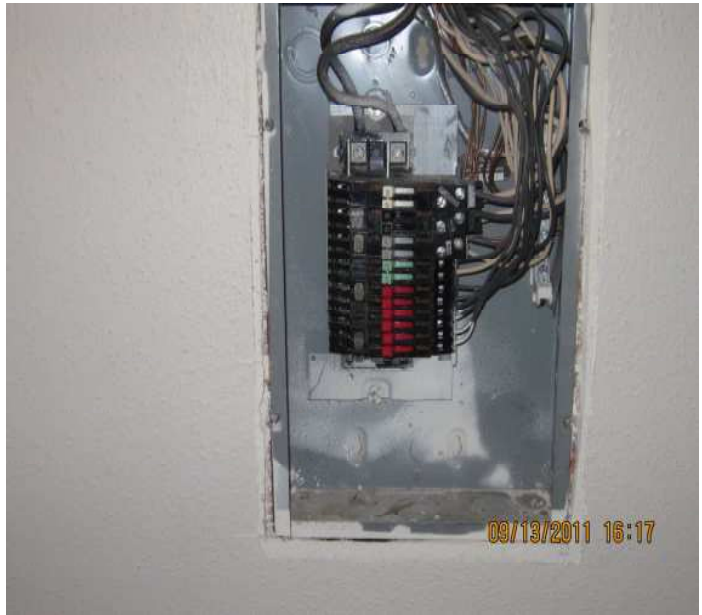
PHOTO NO. 10

AS DISCUSSED DURING THE INSPECTION, THE SUB-PANEL BREAKER BOX, INSIDE THE CLOSET, POSES A FIRE HAZARD. IT IS STRONGLY RECOMMENDED THAT BOTH SYLVANIA BREAKER BOXES BE REPLACED AND UPGRADED TO MEET ALL CURRENT NEC AND CITY OF WEBSTER ELECTRICAL CODES. ESTIMATED COST IS \$2,000 - \$2,500.

BREAKER BOX IN FRONT
BEDROOM CLOSET

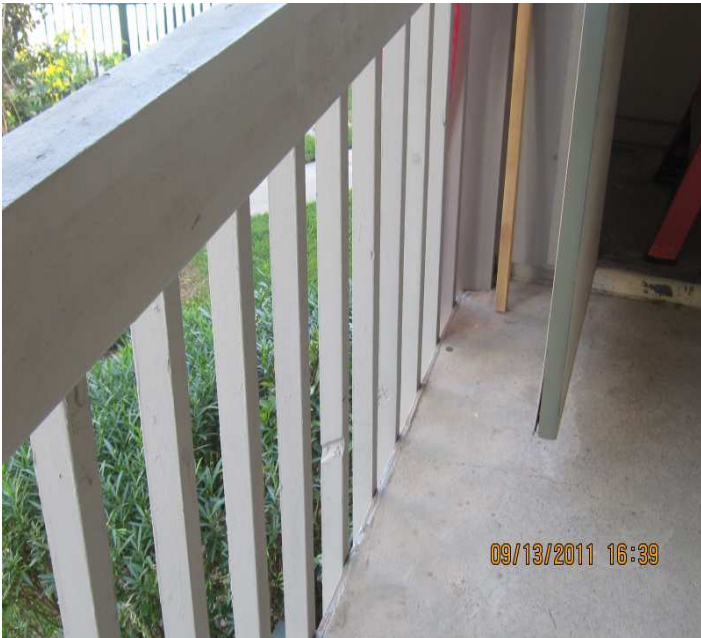
PHOTO NO. 11

**NO. 5 STORAGE ROOM DOOR, ON THE OUTSIDE DECK, IS DAMAGED AT
THE BOTTOM. THIS DOOR NEEDS TO BE REPLACED. MISSING OR
DAMAGED DOOR STOPS IN SEVERAL AREAS. MISSING ONE SLIDING
PATIO SCREEN DOOR. REPAIRS ARE NEEDED.**

STORAGE ROOM DOOR
DAMAGED AT BOTTOM

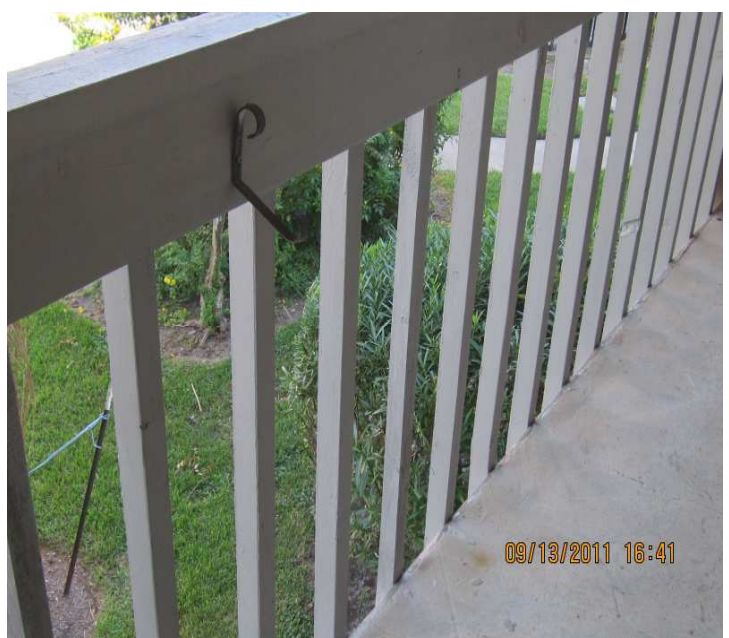
PHOTO NO. 12

**NO. 8 GUARD RAIL SEPARATION, AT THE FRONT PORCH AND BACK
DECK, DOES NOT MEET THE "4-INCH" RULE. SEE APPENDIX G.
REPAIRS ARE NEEDED.**

GUARD RAIL, ON DECK, DOES
NOT MEET "4-INCH" RULE

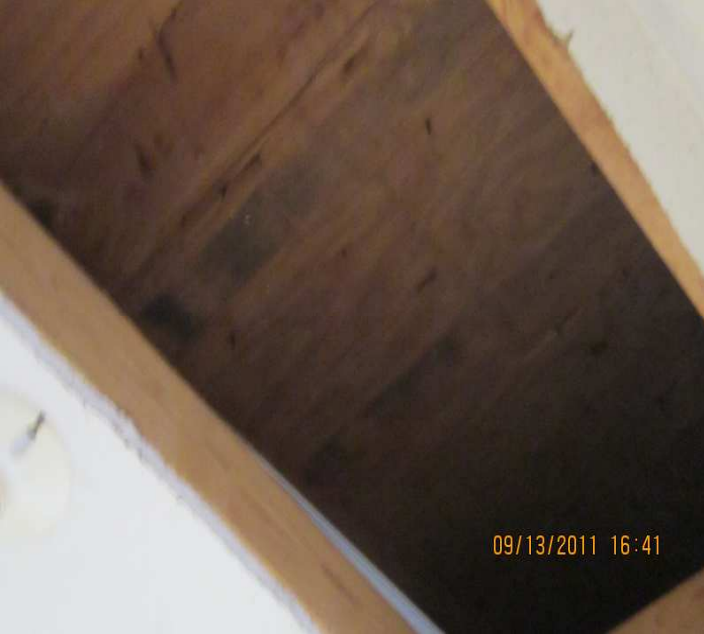
- NO. 1 INSULATION IS LAYING IN THE ATTIC ON LIGHT FIXTURES
OR VENT FAN ASSEMBLIES. THE PRESENT SETUP POSES A FIRE
HAZARD. THE INSULATION NEEDS TO BE PULLED BACK FROM THESE
AREAS. SEE APPENDIX JJ-4 & S-3.
SCUTTLE HOLE, TO ATTIC IN THE OUTSIDE STORAGE ROOM, IS
MISSING A COVER. ATTIC**
- NO. 2 ATTIC IS MISSING FIRE-BLOCKING BETWEEN THE UNITS. SEE
APPENDIX FF-1-A. REPAIRS ARE NEEDED.**

**PHOTO NO. 13 SCUTTLE HOLE OPENING
 TO ATTIC ON BACK DECK**

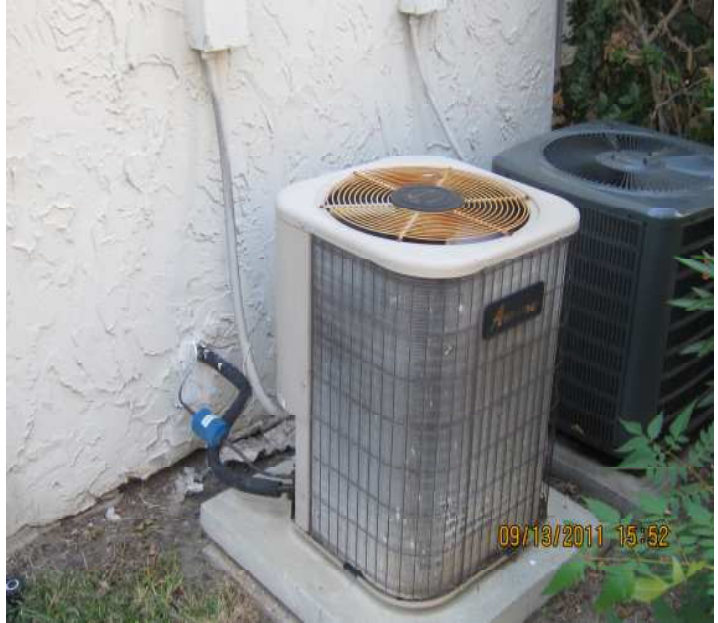
**NO. 13 A/C CONDENSER, IN BACK, HAS HEAVY FIN DAMAGE. ELECTRICAL
DISCONNECT, AT THE CONDENSER UNIT, NEEDS TO BE
RELOCATED A MINIMUM OF 15 INCHES TO THE SIDE OF THE
CONDENSER. SEE APPENDIX E3305.2 SUCTION LINE, AT THE
CONDENSER UNIT, NEEDS TO BE REINSULATED**

**AS DISCUSSED DURING THE INSPECTION, A/C SYSTEM IS OLD AND
HAS A VERY LIMITED REMAINING USEFUL LIFE. ESTIMATED COST,
TO REPLACE THE A/C SYSTEM, IS \$4000 - \$4,500.**

PHOTO NO. 14 A/C UNIT IN BACK
