**ADDENDUM TO PROPERTY INSPECTION REPORT
PROPERTY INSPECTION AGREEMENT
SAMPLE REPORT**

ALLIED HOME INSPECTION SERVICES

**JOHN O. FRANZEN
LICENSED BUILDING INSPECTOR
T.R.E.C. # 1553**

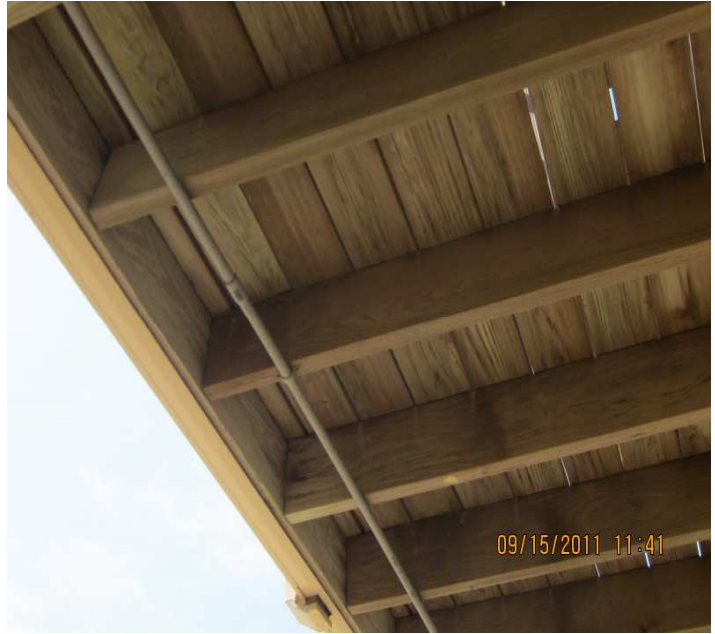
PHOTO NO. 2

- NO. 12 FLOOR JOISTS, ON THE DECKS, ARE MISSING JOIST HANGERS. SEE APPENDIX U-1. DECK FLOORING, ON THE MAIN SECOND LEVEL DECK, IS WATER DAMAGED AND NEEDS TO BE REPLACED. GUARD RAIL SPACING, ON ALL OF THE DECKS, DOES NOT MEET THE "4-INCH" RULE. SEE APPENDIX G.**

FLOOR JOISTS MISSING
JOIST HANGERS

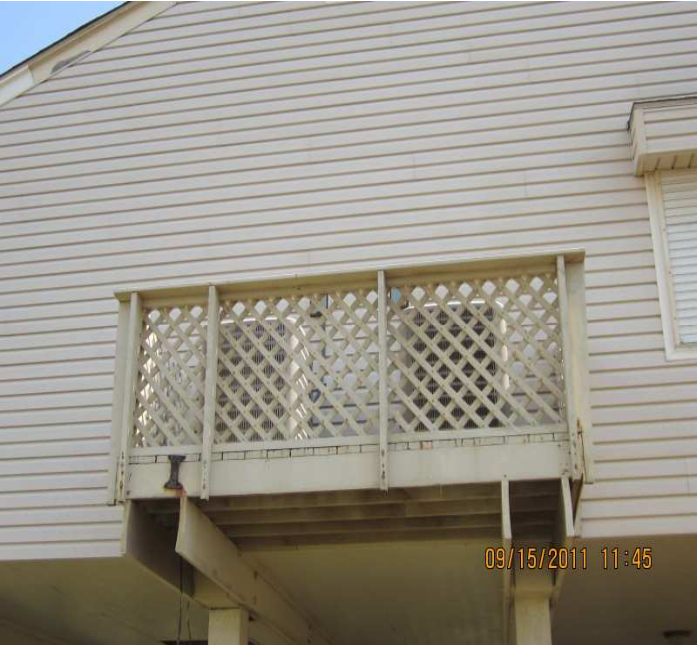
PHOTO NO. 3

TWO A/C UNITS ON WEST
SIDE PLATFORM

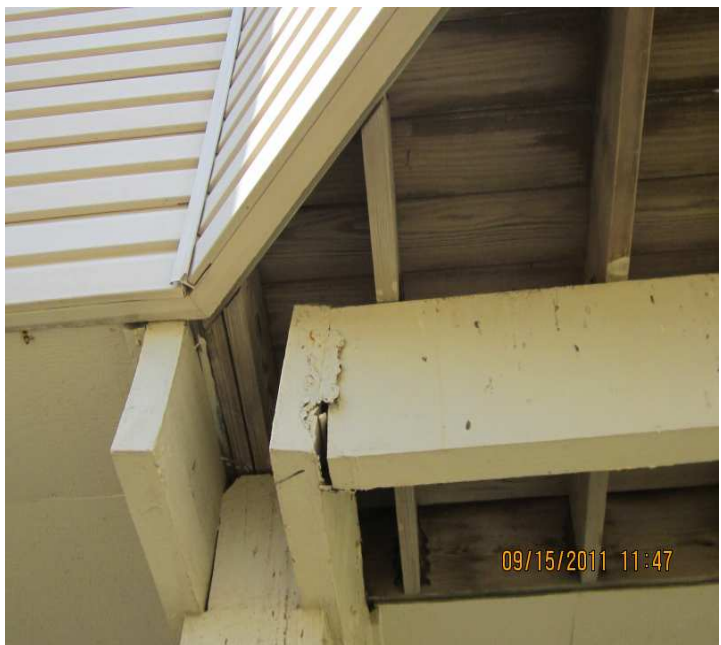
PHOTO NO. 4

BACK NORTHEAST CORNER OF THE HOUSE IS PULLING AWAY AND DROPPING. MAJOR REPAIRS ARE NEEDED. IT IS RECOMMENDED, THAT THE SERVICES OF A QUALIFIED AND LICENSED STRUCTURAL ENGINEER BE OBTAINED (WHO IS FAMILIAR WITH RESIDENTIAL PIER & BEAM FOUNDATIONS), TO DETERMINE THE SCOPE OF NEEDED REPAIRS AND A MORE ACCURATE COST OF THE NEEDED REPAIRS THE STEEL SUPPORTS, ON THE PIERS, ARE BADLY RUSTING OUT. THEY MAY NEED TO BE REPLACED. JOIST HANGERS, IN THIS AREA, HAVE BROKEN INDICATING THE DEGREE OF MOVEMENT

BACK CORNER OF HOUSE
PULLING APART

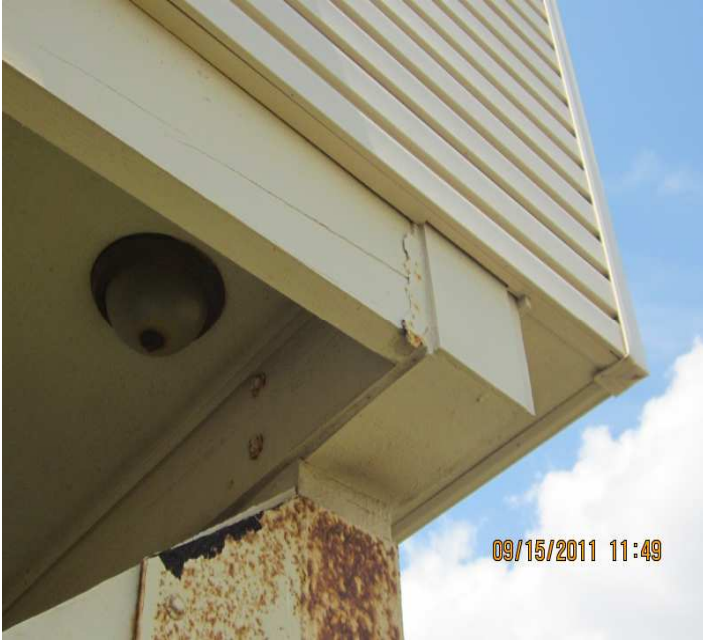
PHOTO NO. 5 JOIST HANGERS RUSTING
OUT AND BROKEN

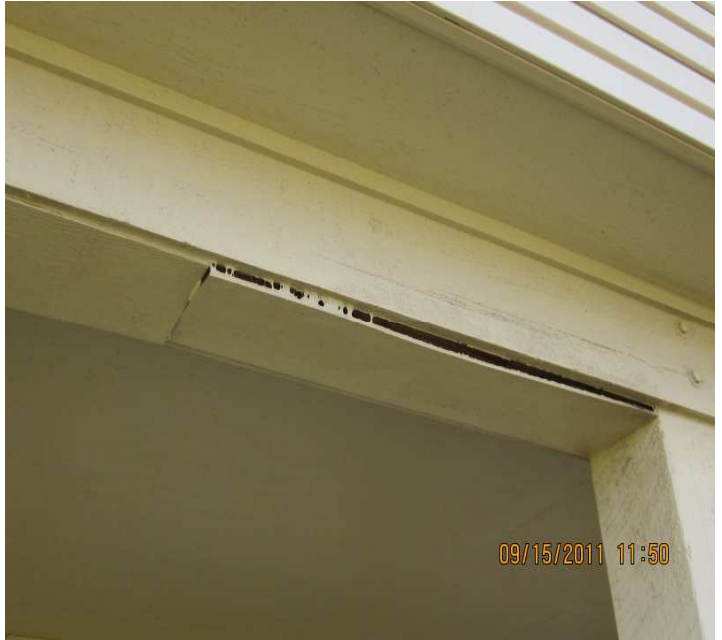
PHOTO NO. 6 SOFFIT BOARDS PULLING AWAY
AT BACK SIDE

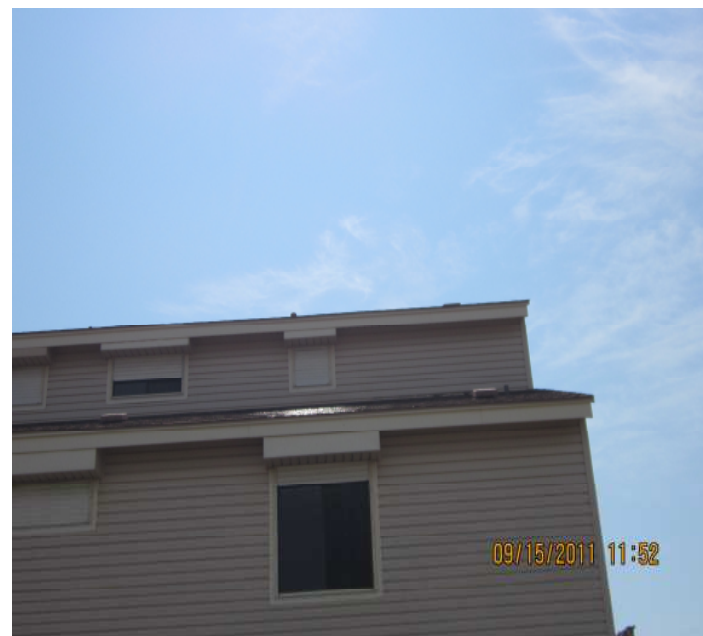
PHOTO NO. 7 FRONT SIDE ROOF SHINGLES
HAVE LIFTED DURING IKE

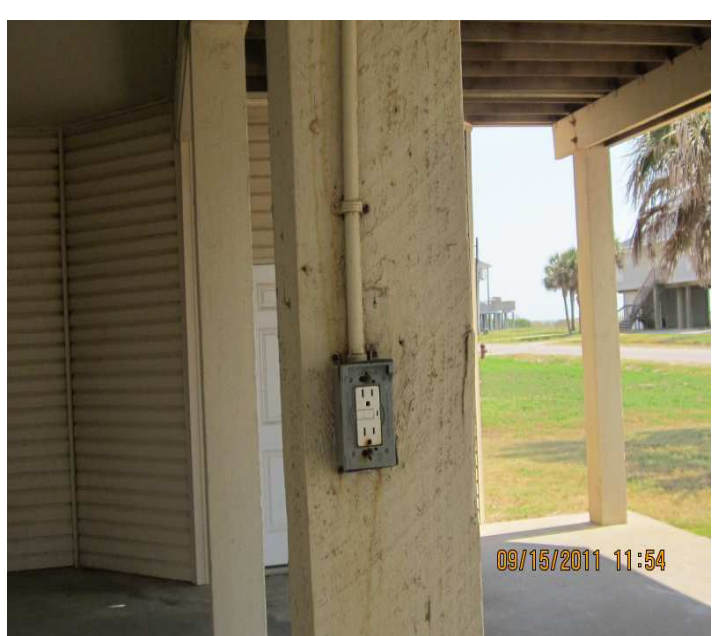
PHOTO NO. 8 EXTERIOR WALL OUTLET
MISSING COVER

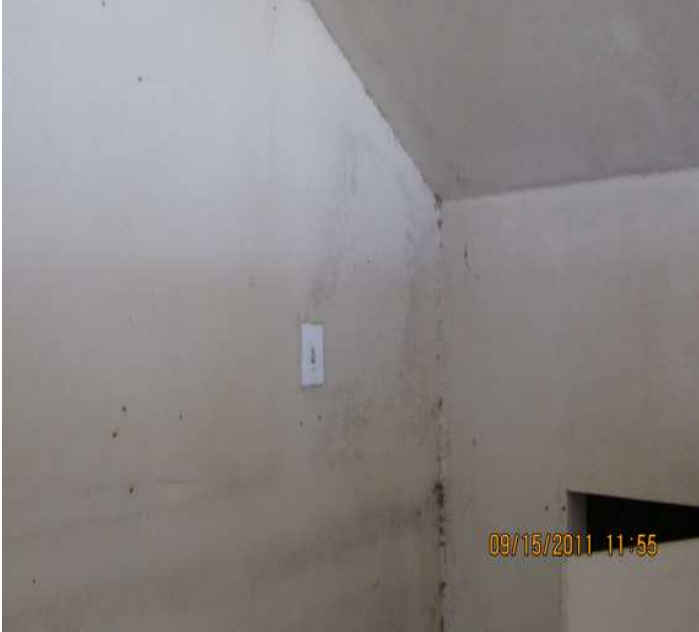
PHOTO NO. 9 WATER DAMAGED WALL
IN ENTRYWAY

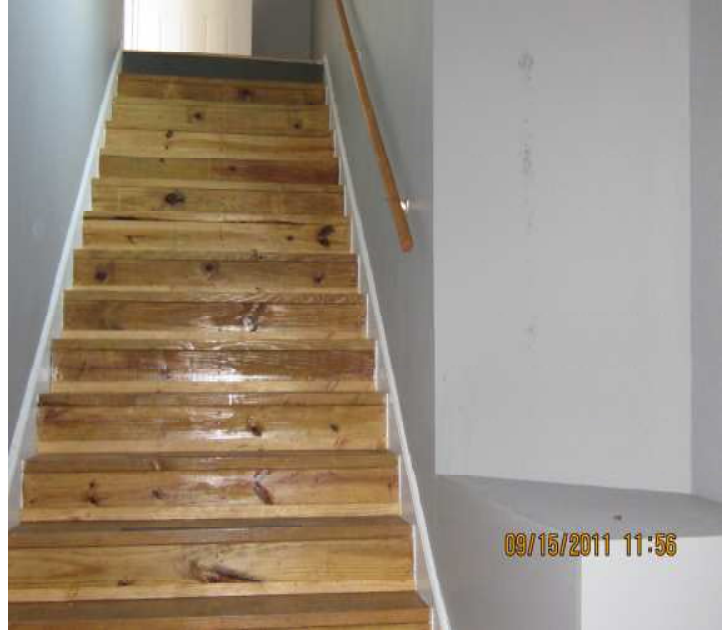
- NO. 9 STAIRWAY, IN THE ENTRYWAY, IS MISSING A CONTINUOUS HAND RAIL. SEE APPENDIX F & F-2. HAND RAIL, AT THE TOP OF THE STAIRS, IS NOT TURNED IN. BOTTOM SECTION, OF THIS STAIRWAY, IS MISSING A HAND RAIL. LIGHT, FOR THIS STAIRWAY CANNOT BE ACTIVATED AT BOTH THE TOP AND BOTTOM. REPAIRS ARE NEEDED.

PHOTO NO. 10 STAIRWAY IN ENTRYWAY

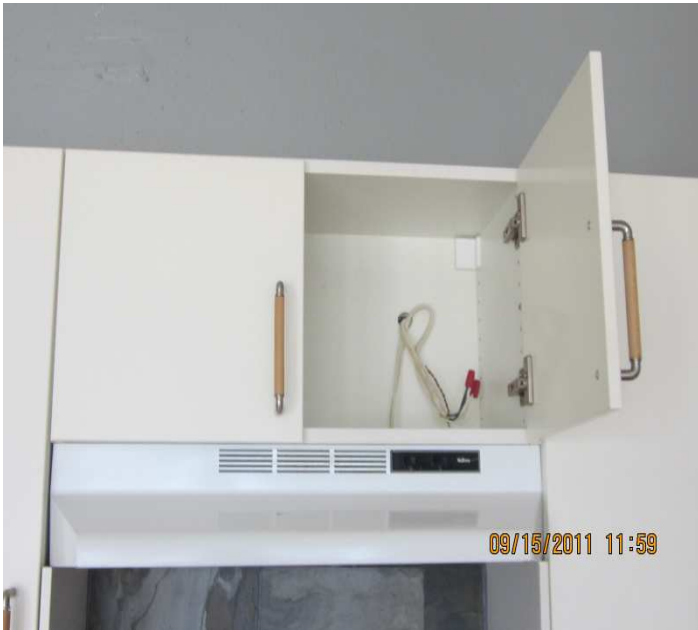
PHOTO NO. 11 LOOSE WIRING IN UPPER
KITCHEN CABINET

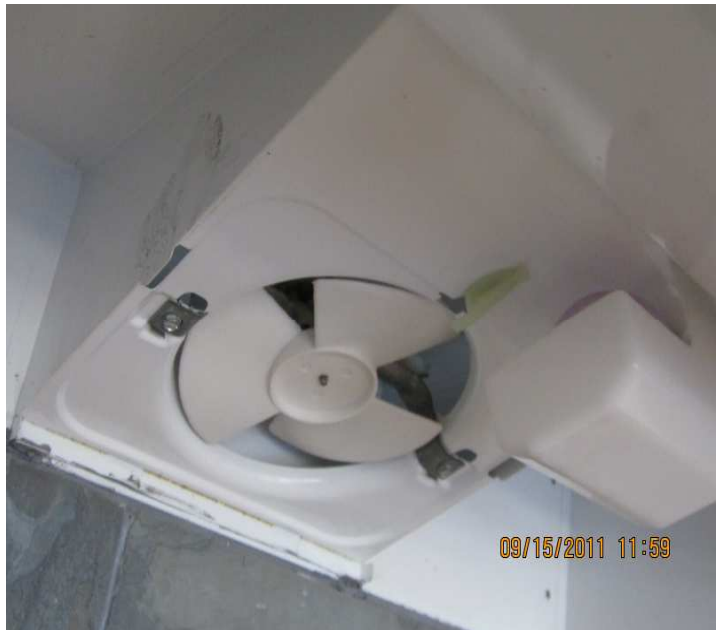
NO. 26 KITCHEN VENT FAN ASSEMBLY IS MISSING A COVER. THE PRESENT SETUP POSES A SAFETY HAZARD.

PHOTO NO. 12 KITCHEN VENT FAN MISSING
A COVER

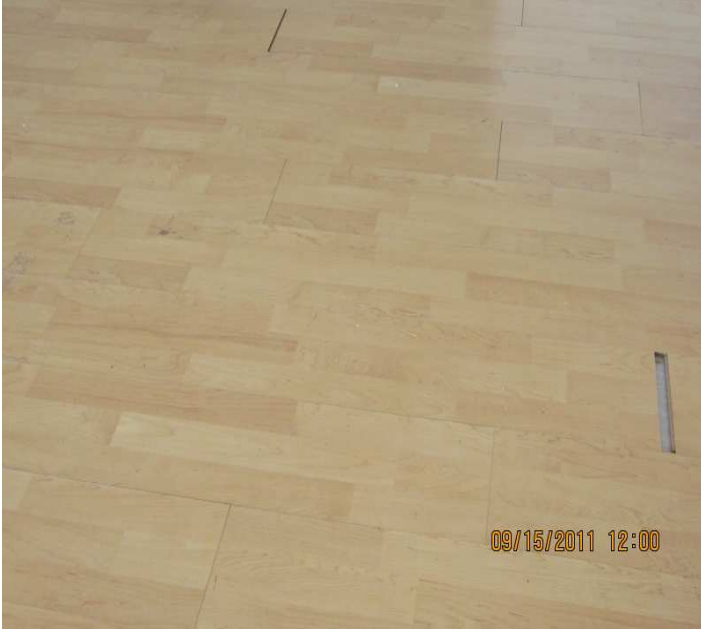
- NO. 6 CEILING, IN THE LIVING ROOM, HAS COLLAPSED. MAJOR REPAIRS ARE NEEDED. WOOD FLOORING, ON THE SECOND LEVEL, IS PULLING LOOSE AND IS MISSING IN SEVERAL AREAS. ALL, OF THIS FLOORING, NEEDS TO BE REMOVED AND REPLACED. THE SUB-FLOORING, IN THIS AREA, IS ALSO WATER DAMAGED AND WILL NEED TO BE REPLACED

PHOTO NO. 13 DAMAGED & MISSING
WOOD FLOOR SECOND LEVEL

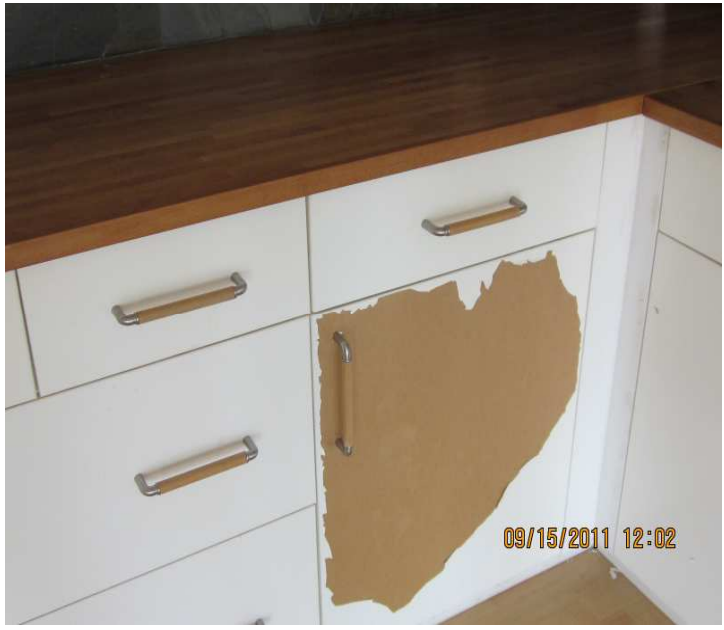
- NO. 13 KITCHEN CABINETS ARE DAMAGED IN A NUMBER OF AREAS. REPAIR OR REPLACEMENT IS NEEDED**

PHOTO NO. 14 DAMAGED KITCHEN CABINETS

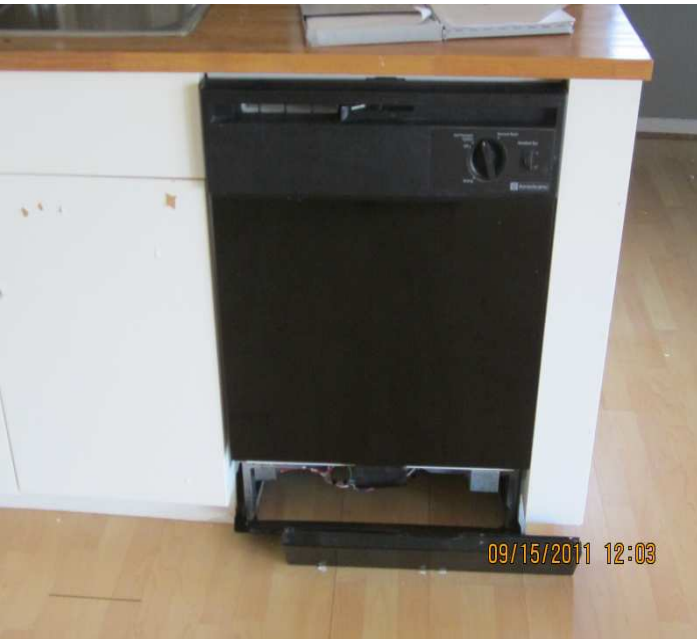
NO. 24 DISHWASHER IS DAMAGED AND MAKES GRINDING NOISE. THE DISHWASHER NEEDS TO BE REPLACED.

PHOTO NO. 15 DAMAGED DISHWASHER
IN KITCHEN

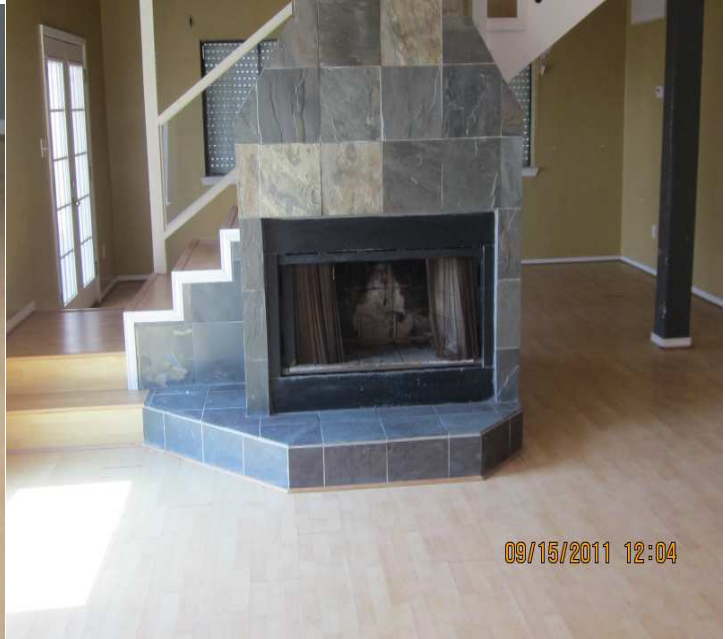
PHOTO NO. 16 LIVING ROOM STAIRWAY
MISSING GUARD RAIL

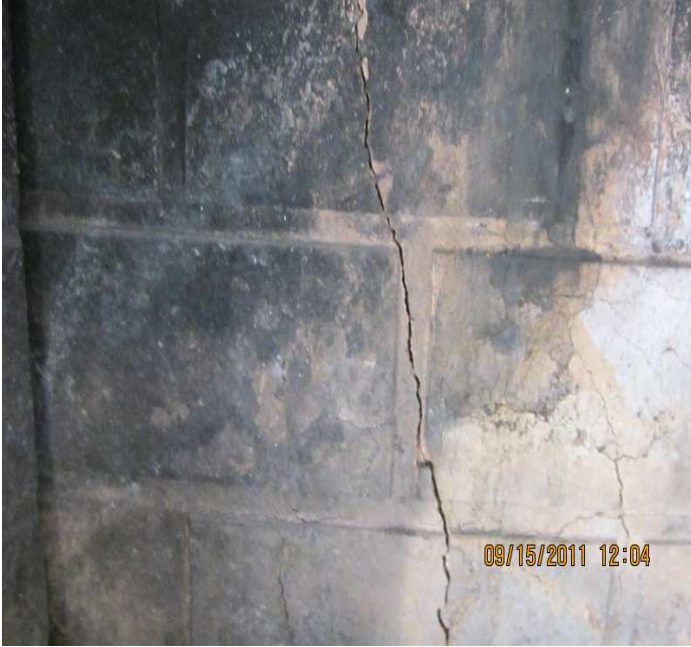
- NO. 11 FIREPLACE BACK WALL IS BADLY DAMAGED AND NEEDS TO BE REPLACED. DAMPER IS RUSTED SHUT. MAJOR REPAIRS ARE NEEDED**

PHOTO NO. 17 BACK WALL OF FIREPLACE
IS BADLY DAMAGED

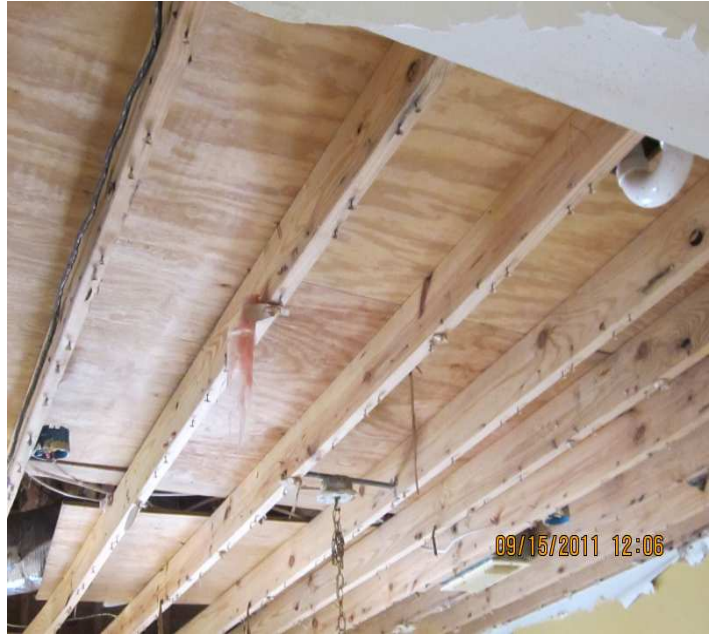
PHOTO NO. 18 OPEN ELECTRICAL JUNCTION
BOXES IN ATTIC AREA

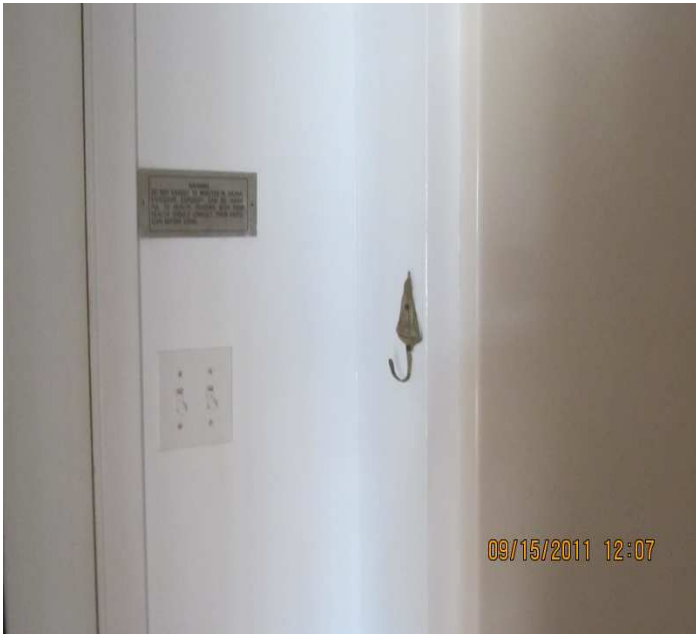
PHOTO NO. 19 WALL SWITCHES TOO CLOSE
TO SHOWER IN NO. 2 BATH

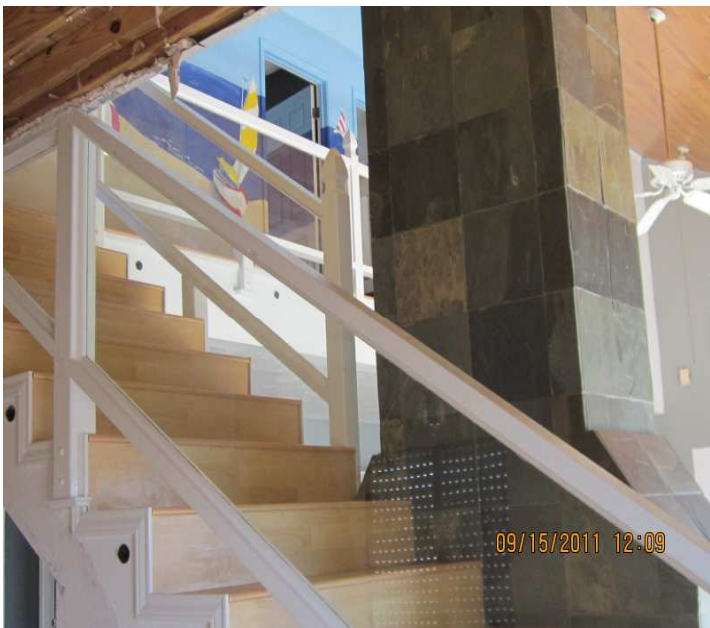
PHOTO NO. 20 GUARD RAIL ON STAIRWAY
TO 2nd FLOOR DOES NOT MEET "4INCH:RULE

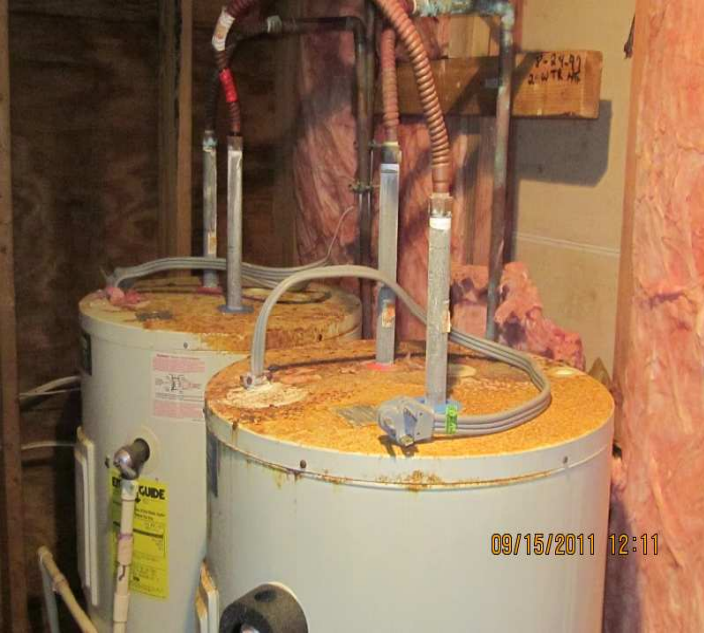
- NO. 23 BOTH ELECTRIC WATER HEATERS, IN THE ATTIC AREA, ARE RUSTING
OUT AND NEED TO BE REPLACED. GALVANIZED - COPPER PIPING
CONNECTIONS, AT THE TOP OF THE WATER HEATERS, ARE MISSING
DIELECTRIC FITTINGS.**

PHOTO NO. 21 RUSTING OUT WATER HEATERS IN ATTIC

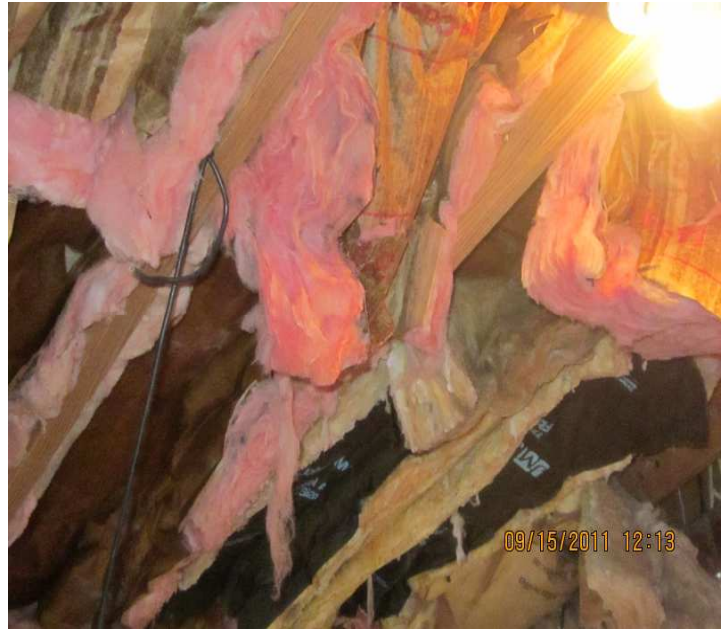
NO. 4 MISSING ATTIC ACCESS LADDER FOR THE A/C - FURNACE UNIT THAT IS LOCATED AT THE WEST END OF THE UPSTAIRS HALLWAY INSULATION IS LAYING IN THE ATTIC ON LIGHT FIXTURES OR VENT FAN ASSEMBLIES. THE PRESENT SETUP POSES A FIRE HAZARD. THE INSULATION NEEDS TO BE PULLED BACK FROM THESE AREAS. SEE APPENDIX JJ-4 & S-3. SPRINGS, ON THE ATTIC ACCESS LADDER, ARE MISSING SAFETY WIRE. INSULATION NEEDS TO BE REPLACED IN ALL ATTIC AND EXTERIOR WALL AREAS. THE INSULATION IS WATER DAMAGED

PHOTO NO. 22 DAMAGED & MISSING INSULATION IN ATTIC AREA

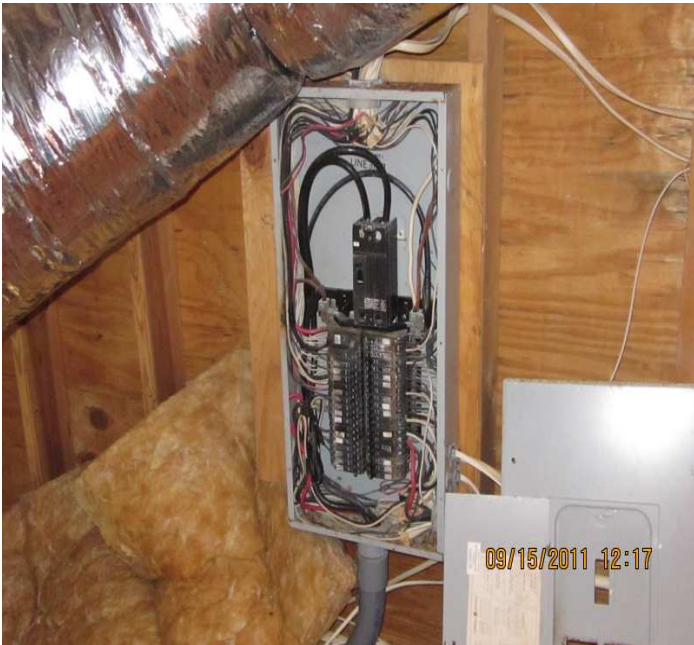
- NO. 15 BREAKER BOX IS MAXXED OUT. THERE IS NO ROOM FOR EXPANSION. ALL, OF THE BREAKERS, NEED TO BE LABELED PROPERLY. THERE ARE LOOSE WIRES INSIDE THE BREAKER BOX. THE PRESENT SETUP POSES BOTH A FIRE AND SAFETY HAZARD. ALL 15 & 20 AMP CIRCUITS, THAT SERVE LIVING AREAS, ARE MISSING ARC-FAULT PROTECTION. SEE APPENDIX M-2 & NEC 210.12. LUGS, IN THE BREAKER BOX, ARE BADLY CORRODED. THE BREAKER BOX NEEDS TO BE REPLACED AND UPGRADED TO MEET ALL CURRENT NEC AND LOCAL GOVERNMENT ELECTRICAL CODES. WIRES, THAT ARE LEAVING THE BREAKER BOX, ARE BUNDLED TOGETHER. THIS IS AN OVER-HEATING ISSUE. THESE WIRES NEED TO BE SPREAD OUT. BARE GROUND WIRES AND WHITE NEUTRAL WIRES ARE CONNECTED TO THE SAME LUGS.**

PHOTO NO. 23 BREAKER BOX IN FRONT ATTIC AREA

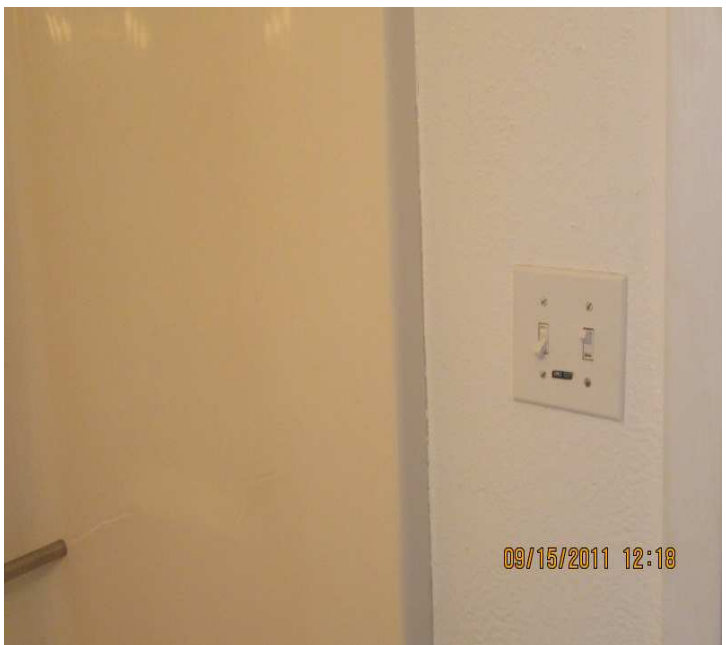
PHOTO NO. 24 WALL SWITCHES TOO CLOSE TO THIRD LEVEL BATH TUB

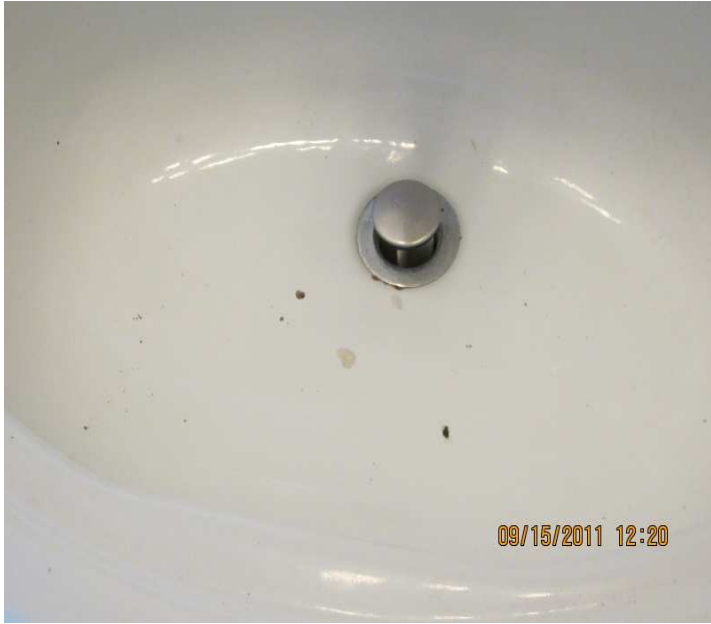
PHOTO NO. 25

- NO. 21 BATH TUBS ARE MISSING PLUMBING ACCESS PANELS.
SEE APPENDIX K-2 & K-3. THIRD LEVEL BATH SINK IS DAMAGED
BY THE DRAIN. THE SINK NEEDS TO BE REPAIRED OR REPLACED.
CERAMIC TILE, IN THE SECOND LEVEL BATH, IS DAMAGED. THE
SHOWER PAN WILL NEED TO BE REPLACED.**

SINK, IN THIRD LEVEL BATH,
DAMAGED BY DRAIN

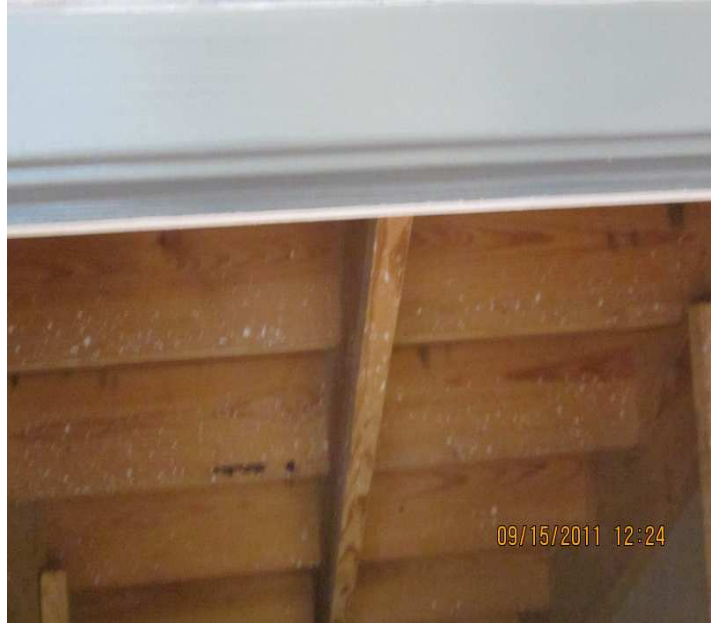
PHOTO NO. 26

BACK SIDE OF STAIRWAY
NOT FIRE-BLOCKED

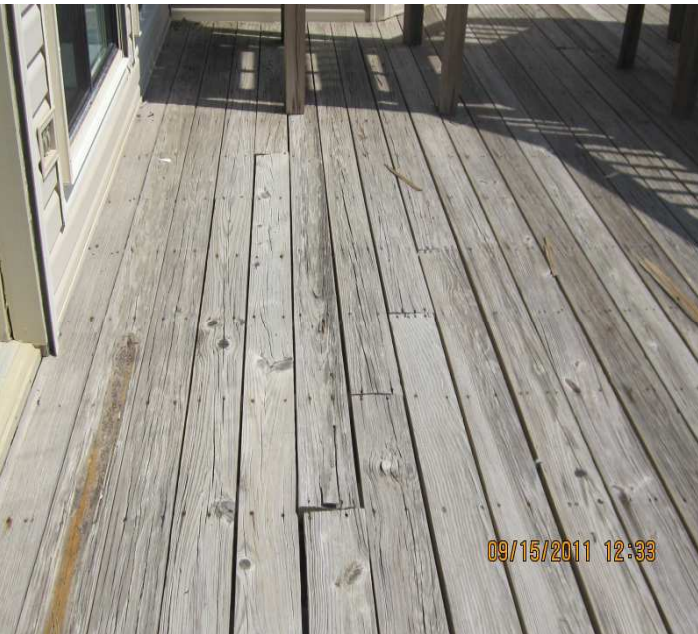
PHOTO NO. 27

FRONT DECK FLOORING IS
DAMAGED AND BOWING.

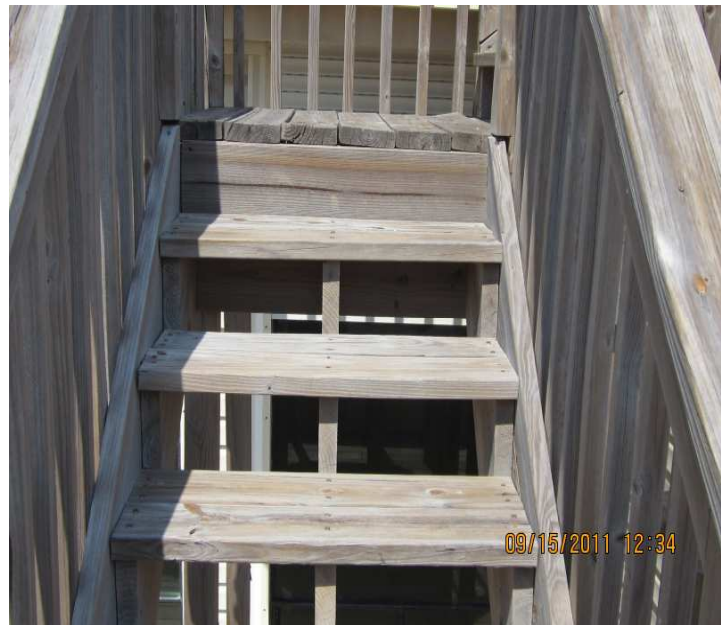
PHOTO NO. 28

- NO. 10 STAIRWAY STRUCTURE, TO THE CROW'S NEST, IS WOBBLY AND NOT SAFE. REPAIRS ARE NEEDED. EXTERIOR STAIRS DO NOT MEET THE "4-INCH" RULE. SEE APPENDIX G STAIRWAY, TO THE THIRD LEVEL, IS MISSING A CONTINUOUS HAND RAIL. BOTTOM OF THE STAIRWAY, IS MISSING A GUARD RAIL THIS STAIRWAY SPACING DO NOT MEET THE "4-INCH" RULE. SEE APPENDIX F & F-2**

DECK STAIRWAY TO
CROW'S NEST

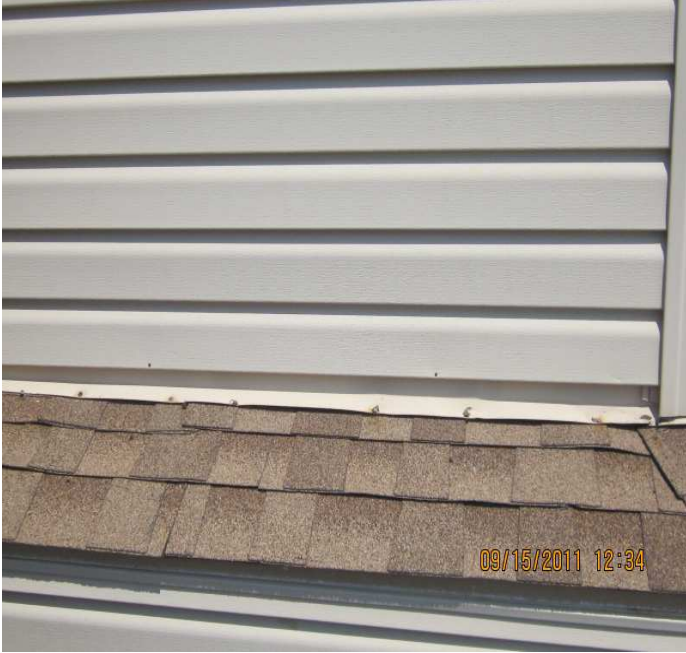
PHOTO NO. 29

NO. 3 METAL ROOF FLASHING IS DAMAGED BY UPPER CROW'S NEST AREA. ROOF WAS LIFTED BY THE HURRICANE IKE AND NEEDS TO BE REPLACED.

DAMAGED ROOF FLASHING
AT CROWS NEST

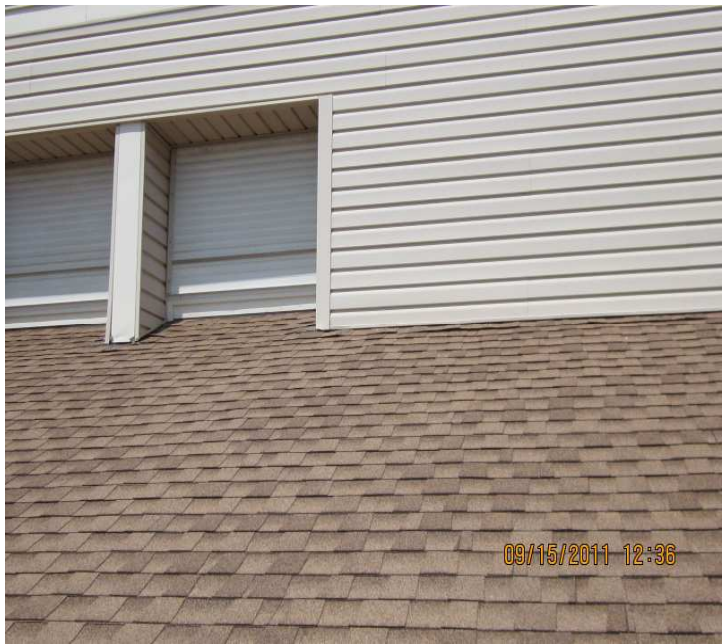
PHOTO NO. 30

ROOF SHINGLES LIFTING UP
AT FRONT LOWER ROOF

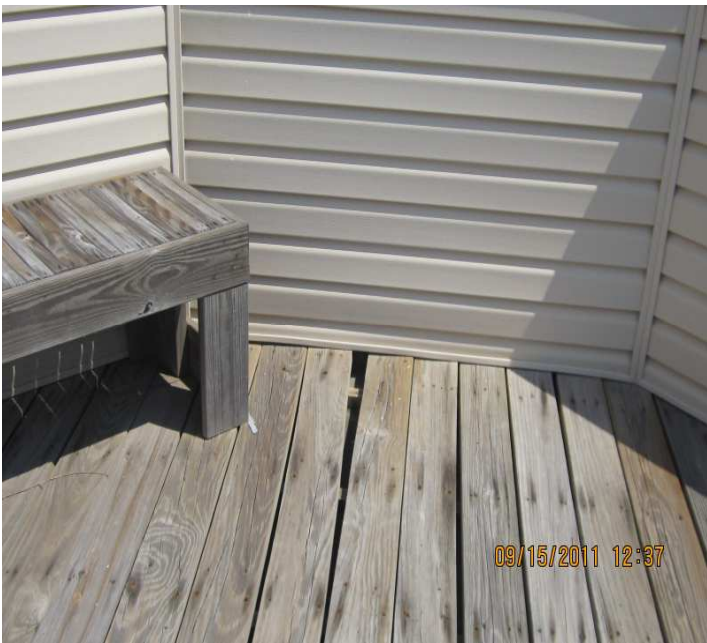
PHOTO NO. 31

DAMAGED WOOD FLOORING
AT CROWS NEST

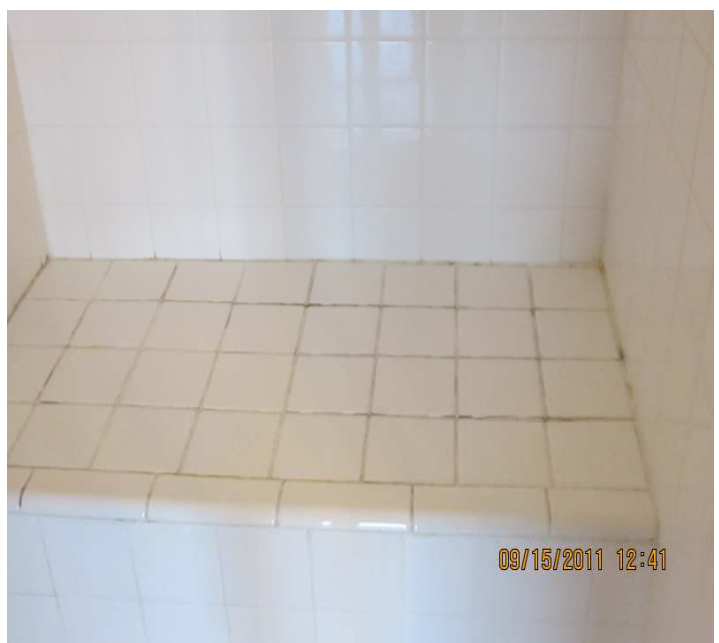
PHOTO NO. 32

DAMAGED CERAMIC TILE &
BENCH IN BATH SHOWER

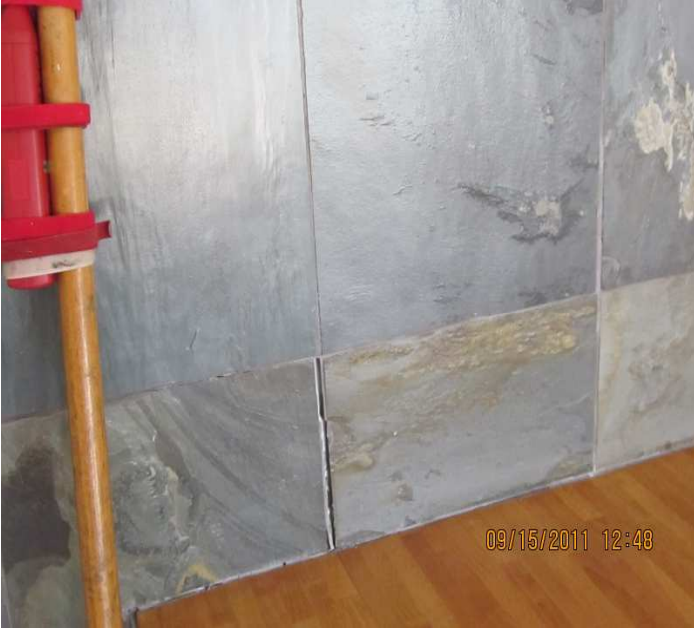
PHOTO NO. 33

DAMAGED TILE SPLASH
BLOCK IN KITCHEN

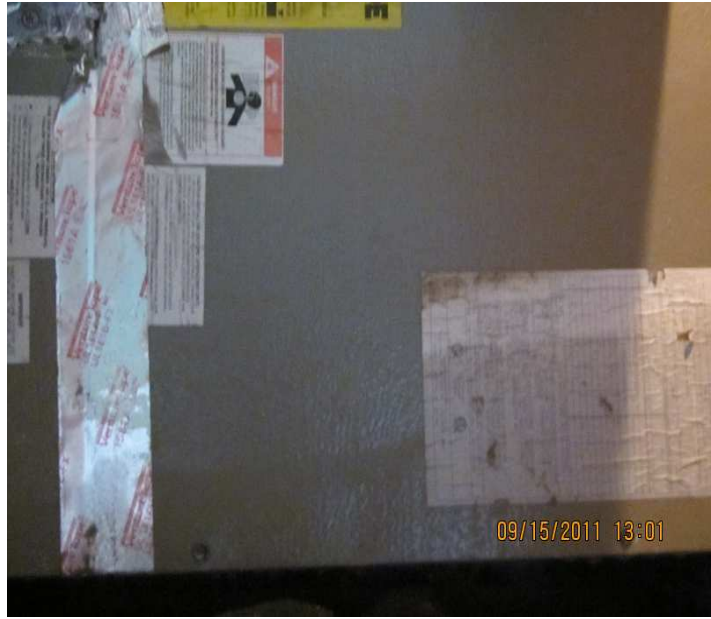
PHOTO NO. 34

ELECTRIC FURNACE MISSING
DISCONNECT

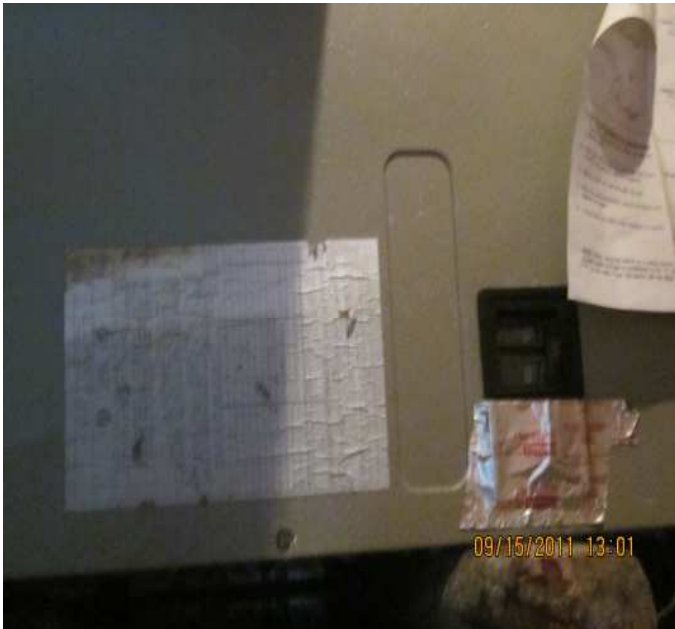
PHOTO NO. 35

A/C DRAIN PAN MISSING
FLOAT SWITCH

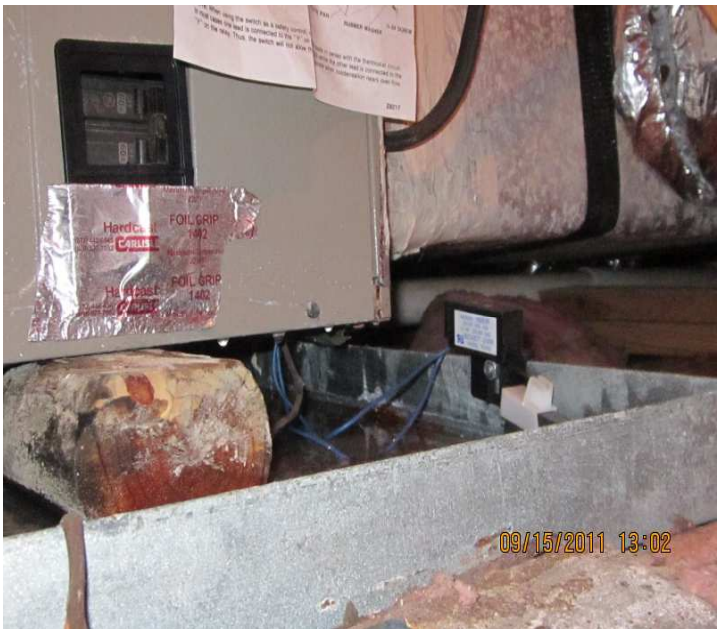
PHOTO NO. 36

BACK SIDE A/C- FURNACE
HAS DISCONNECT & FLOAT SWITCH

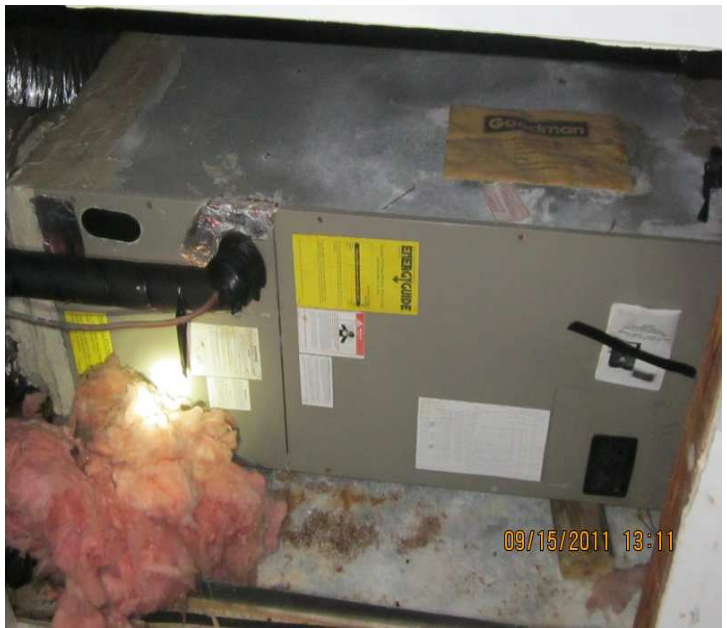
PHOTO NO. 38

FRONT SIDE A/C DRAIN PAN
MISSING FLOAT SWITCH
