**ADDENDUM TO PROPERTY INSPECTION REPORT  
PROPERTY INSPECTION AGREEMENT  
SAMPLE REPORT**

**ALLIED HOME INSPECTION SERVICES**

**JOHN O. FRANZEN  
LICENSED BUILDING INSPECTOR  
T.R.E.C. # 1553**

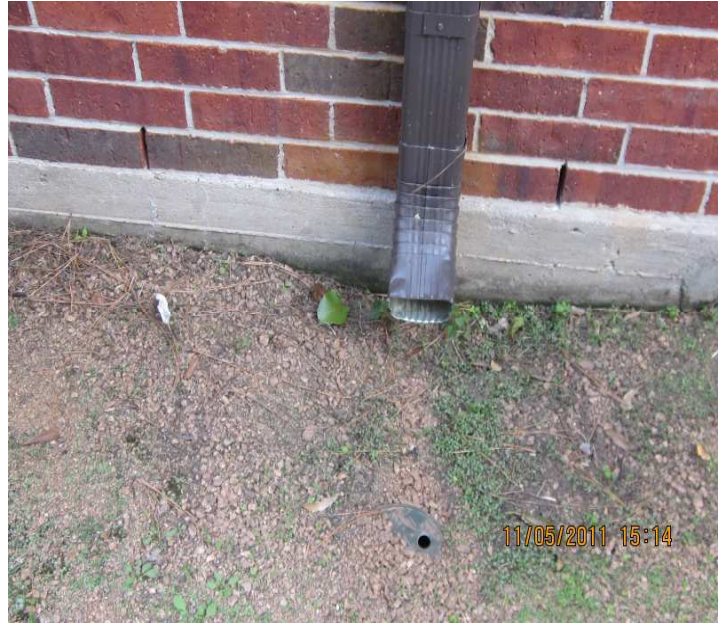
PHOTO NO. 2

<b>NO. 1</b>	<b>MISSING SPLASH BLOCKS UNDER DOWNSPOUTS. SEE APPENDIX B-1 &amp; U-3. REPAIRS ARE NEEDED</b>	<b>\$50.00 TO \$100.00</b>
--------------	---	------------------------------------

MISSING SPLASH BLOCKS  
UNDER DOWNSPOUTS

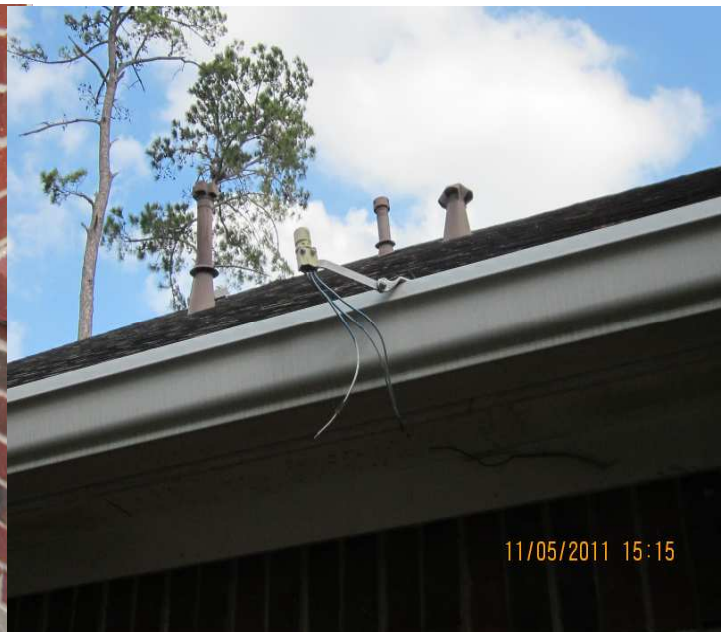
PHOTO NO. 4

<b>NO. 22</b>	<b>GARAGE IS MISSING AN ELECTRICAL OUTLET FOR THE SPRINKLER CONTROL BOX. THE SPRINKLER SYSTEM WAS NOT OPERATED. ZONES, AT THE CONTROL BOX, ARE NOT LABELED RAIN GAUGE, ON WEST SIDE EAVE, IS DAMAGED. THERE ARE LOOSE WIRES. REPAIRS ARE NEEDED</b>	<b>\$150.00 TO \$250.00</b>
---------------	---	-------------------------------------

DAMAGED RAIN GAUGE  
ON WEST EAVE

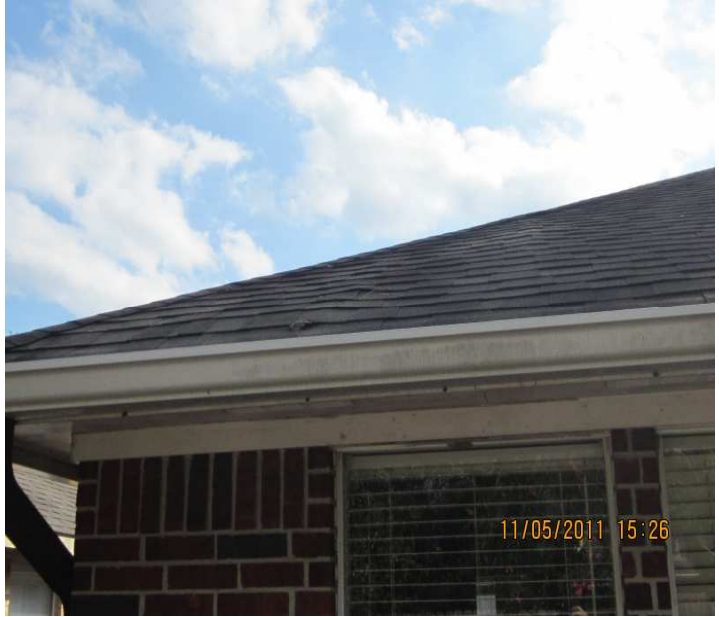
PHOTO NO. 6

<b>NO. 2</b>	<b>ROOF SHINGLES, AT THE BACK NORTHEAST CORNER, HAVE PULLED UP. REPAIRS ARE NEEDED.</b>	<b>\$200.00 TO \$300.00</b>
--------------	---	-------------------------------------

DAMAGED ROOF SHINGLES  
AT BACK NE CORNER OF ROOF

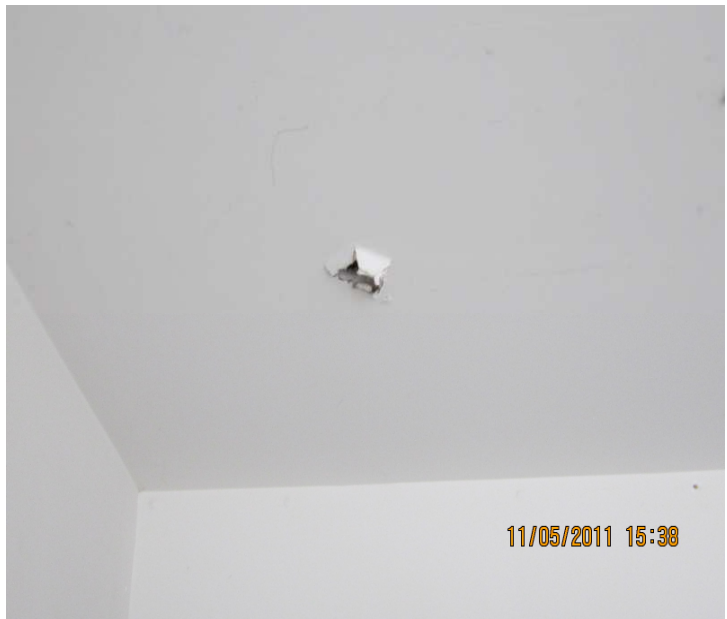
PHOTO NO. 8

DAMAGED CEILING INSIDE  
GARAGE

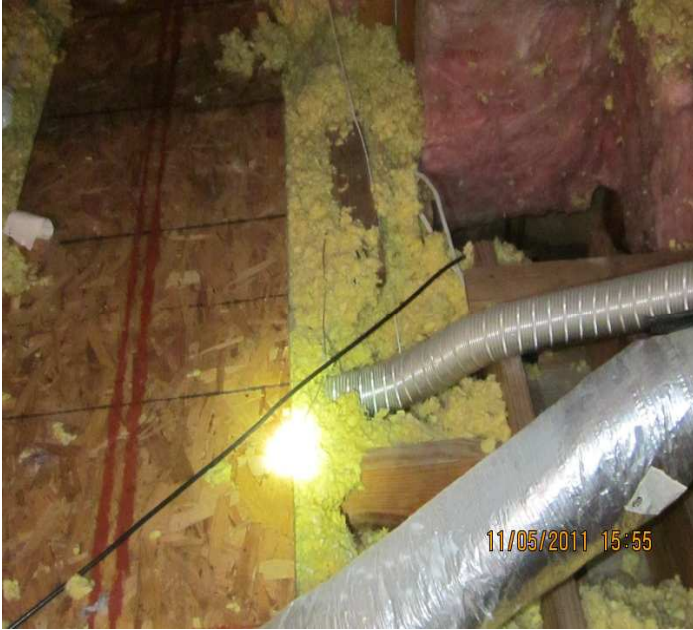
<b>NO. 3</b>	<b>INSULATION IS LAYING IN THE ATTIC ON VENT FAN ASSEMBLIES. THE PRESENT SETUP POSES A FIRE HAZARD. THE INSULATION NEEDS TO BE PULLED BACK FROM THESE AREAS. SEE APPENDIX JJ-4 &amp; S-3. SPRINGS, ON THE ATTIC ACCESS LADDER, ARE MISSING SAFETY WIRE. ATTIC ACCESS LADDER IS MISSING FIRE-GUARD PROTECTION. IT IS REQUIRED DUE TO THE PRESENCE OF THE GAS APPLIANCES IN THE ATTIC. ONE, OF THE MAIN RAFTERS, IN THE ATTIC, HAS EITHER PULLED OR WAS NOT NAILED PROPERLY WHEN THE HOUSE WAS BUILT. THIS RAFTER NEEDS TO BE REBRACED PROPERLY</b>	<b>\$500.00 TO \$800.00</b>
--------------	---	-------------------------------------

PHOTO NO. 9 INSULATION LAYING ON  
VENT FANS IN ATTIC

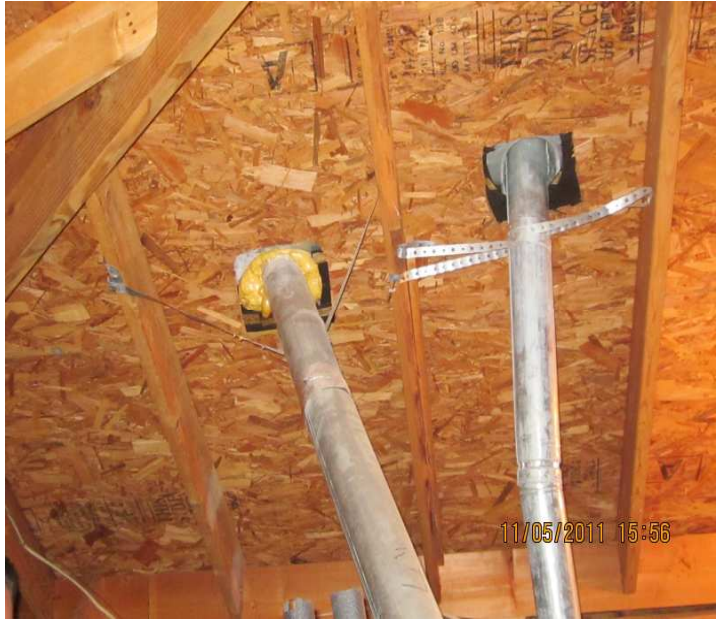
<b>NO. 21</b>	<b>THE LENGTH, OF THE METAL DRYER VENT, DOES NOT MEET THE "25-FOOT" RULE. SEE APPENDIX E &amp; EE-1-A. REPAIRS ARE NEEDED</b>	<b>\$200.00 TO \$300.00</b>
---------------	---	-------------------------------------

PHOTO NO. 10 DRYER VENT IN ATTIC  
DOES NOT MEET "25-FOOT" RULE

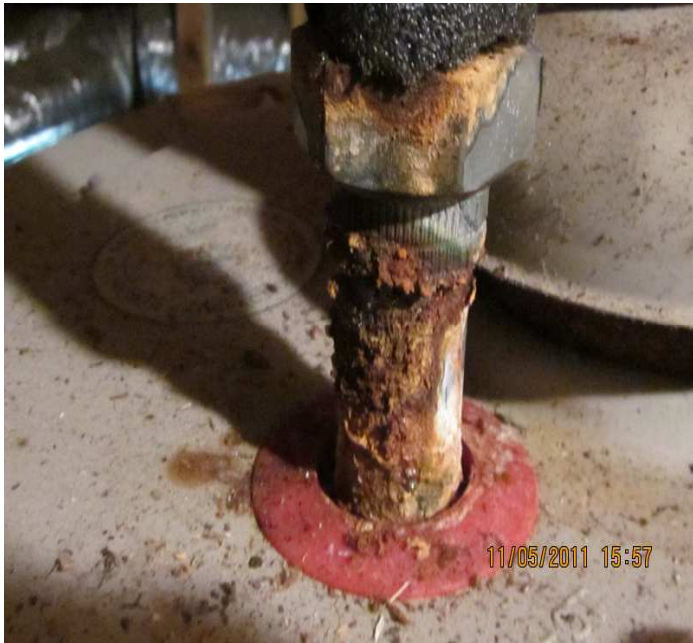
<b>NO. 16</b>	<b>PIPING CONNECTIONS, AT THE TOP OF THE WATER HEATER, ARE BADLY CORRODED. THE WATER HEATER NEEDS TO BE REPLACED. THE OLD WATER HEATER NEEDS TO BE REMOVED FROM THE ATTIC AND HAULED AWAY. GAS LINE, TO THE WATER HEATER, IS MISSING A SEDIMENT TRAP. SEE APPENDIX R-4 &amp; R-5. REPAIRS ARE NEEDED</b>	<b>\$500.00 TO \$800.00</b>
---------------	--	-------------------------------------

PHOTO NO. 11 BADLY CORRODED PIPING  
AT WATER HEATER IN ATTIC

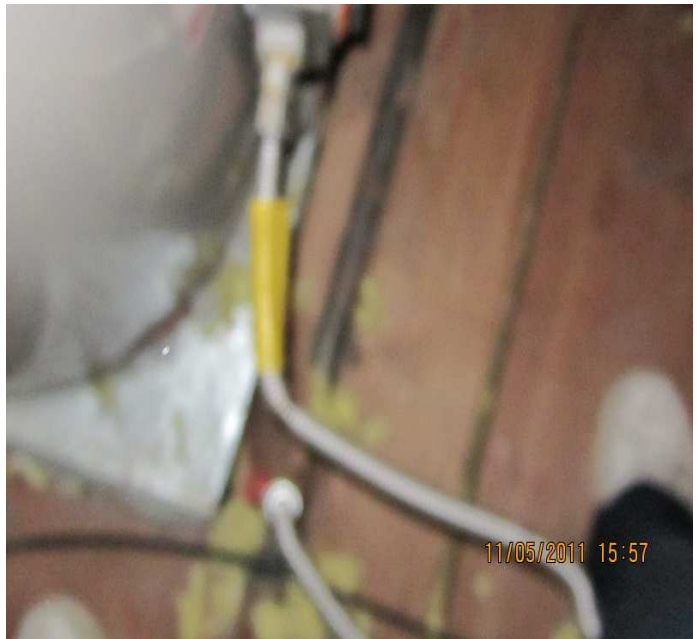
PHOTO NO. 12 GAS LINE, TO WATER HEATER,  
MISSING SEDIMENT TRAP

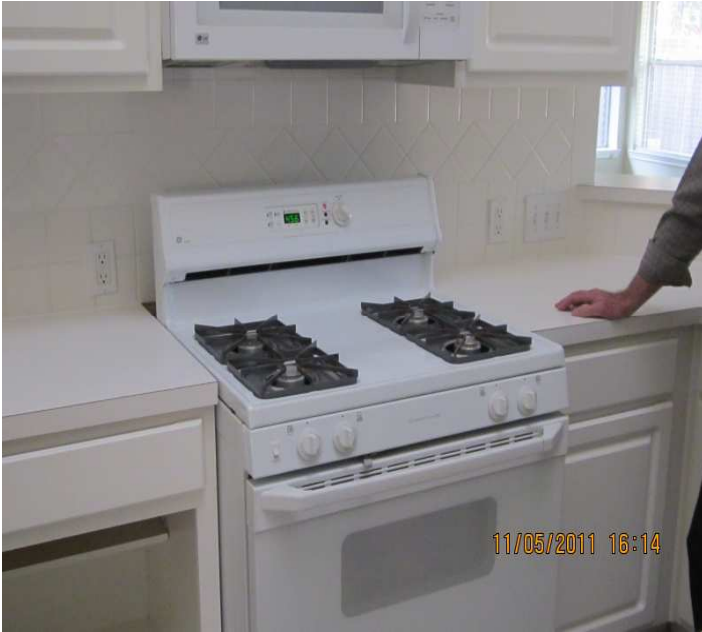
<b>NO. 19</b>	<b>FREE-STANDING GAS RANGE / OVEN IS MISSING AN ANTI-TIPPING DEVICE. GAS LINE SHUTOFF VALVE, TO THE RANGE / OVEN IS NOT EASILY ACCESSIBLE. THIS SHUTOFF VALVE NEEDS TO BE RELOCATED TO THE SIDE OF THE APPLIANCE UNDER THE ADJACENT CABINET. SEE APPENDIX H, R-4, R-5 &amp; Z.</b>	<b>\$200.00 TO \$300.00</b>
---------------	--	-------------------------------------

PHOTO NO. 17 FREE-STANDING RANGE /  
OVEN MISSING ANTI-TIPPING DEVICE

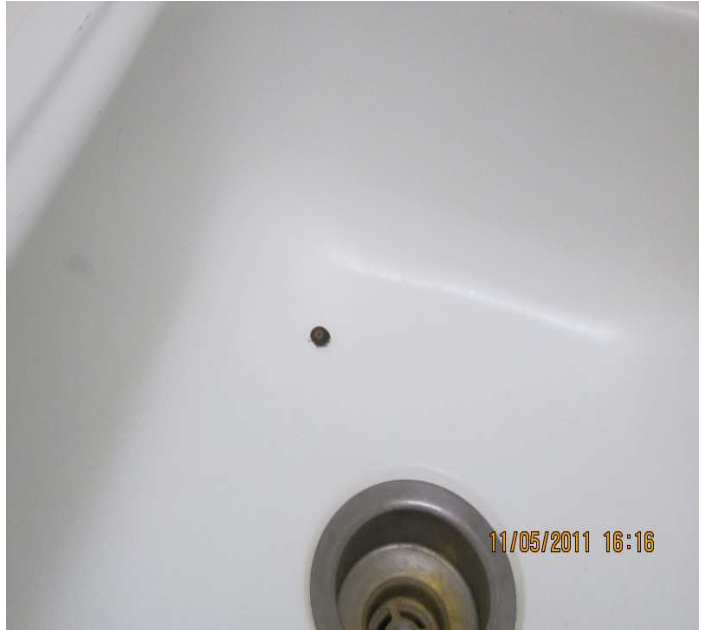
PHOTO NO. 18 DAMAGED LEFT SIDE OF  
KITCHEN SINK

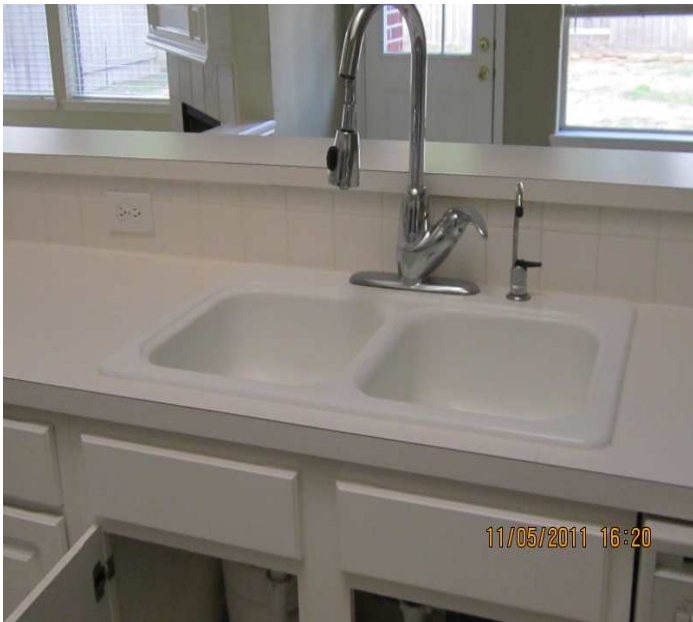
<b>NO. 15</b>	<b>SHOWER DOOR, IN MASTER BATH, WILL NOT CLOSE PROPERLY. CERAMIC TILE, IN THE SHOWER OF THE MASTER BATH, NEEDS REPAIR. KITCHEN SINK IS MISSING AN ANTI-SIPHONING DEVICE. IT IS REQUIRED DUE TO THE PRESENCE OF THE SPRAY NOZZLE. SEE APPENDIX N-2 SHOWER HEAD, IN THE MASTER BATH, NEEDS TO BE RESECURED PROPERLY. SHOWER HEADS, IN BOTH BATHS, ARE LEAKING BOTH BATHTUBS ARE MISSING PLUMBING ACCESS PANELS. SEE APPENDIX K-2 &amp; K-3. REPAIRS ARE NEEDED COMMUNE TANKS ARE MISSING AN ANTI-SIPHONING DEVICE. SEE APPENDIX JJ-2. KITCHEN SINK IS DAMAGED ON THE LEFT SIDE. REPAIRS ARE NEEDED.</b>	<b>\$800.00 TO \$1,000.00</b>
---------------	---	---------------------------------------

PHOTO NO. 19 KITCHEN SINK MISSING  
ANTI-SIPHONING DEVICE

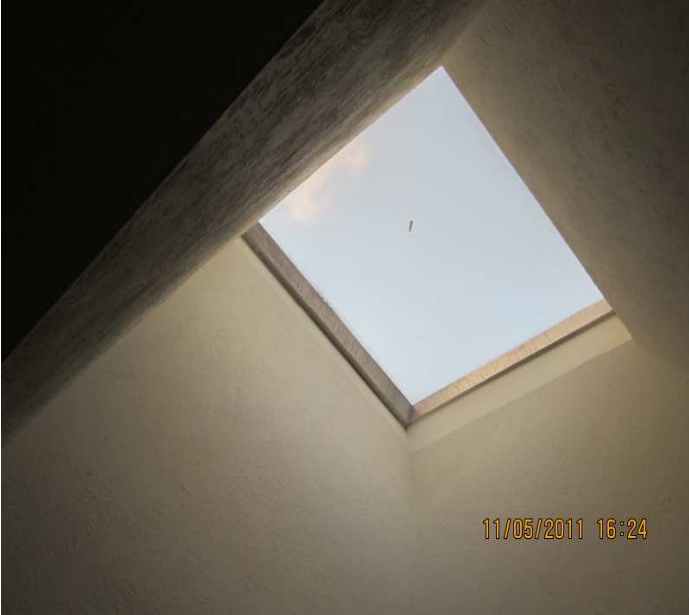
PHOTO NO. 21

<b>J. FIREPLACE / CHIMNEY</b>		
<b>NO. 8</b>	<b>FIREPLACE NEEDS TO BE CLEANED AND SERVICED</b>	<b>\$150.00 TO \$250.00</b>
<b>I. OTHER</b>		
<b>NO. 9</b>	<b>SKYLIGHT, IN THE KITCHEN, NEEDS TO BE REFLASHED PROPERLY REPAIRS ARE NEEDED</b>	<b>\$150.00 TO \$250.00</b>

SKYLIGHT IN KITCHEN

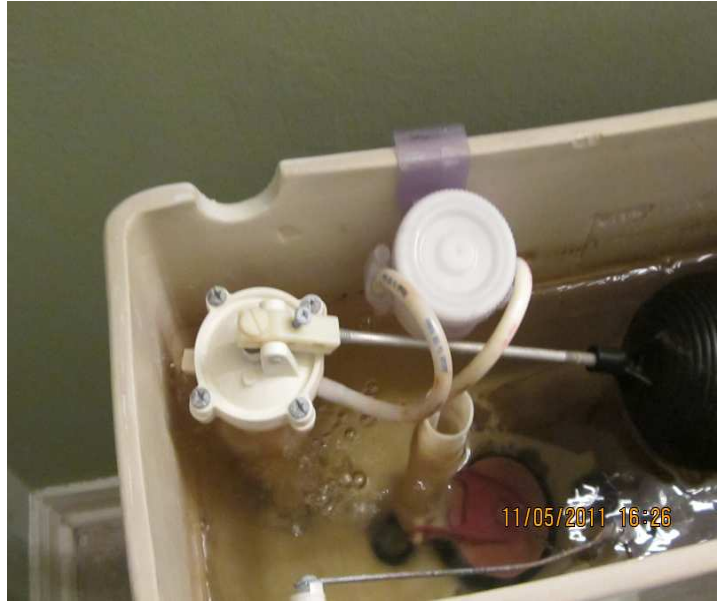
PHOTO NO. 22

COMMODOE TANKS MISSING  
ANTI-SIPHONING DEVICE

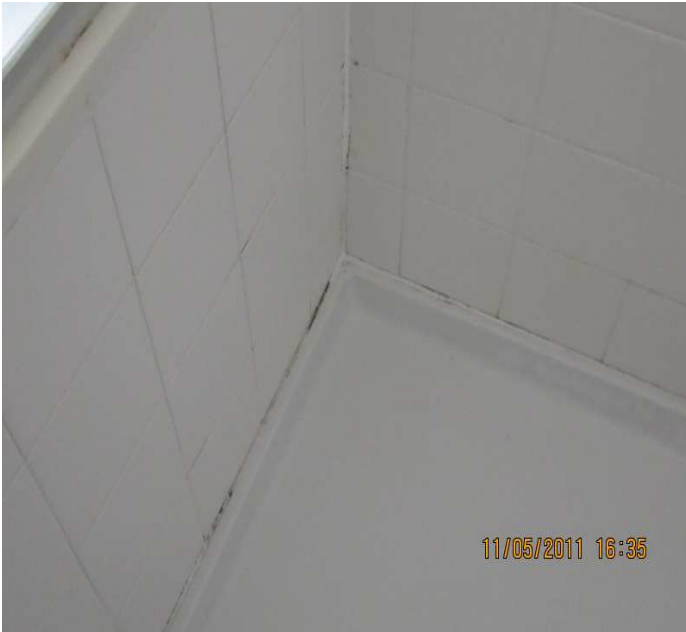
PHOTO NO. 23 CERAMIC TILE, IN SHOWER  
OF MASTER BATH, NEEDS REPAIR

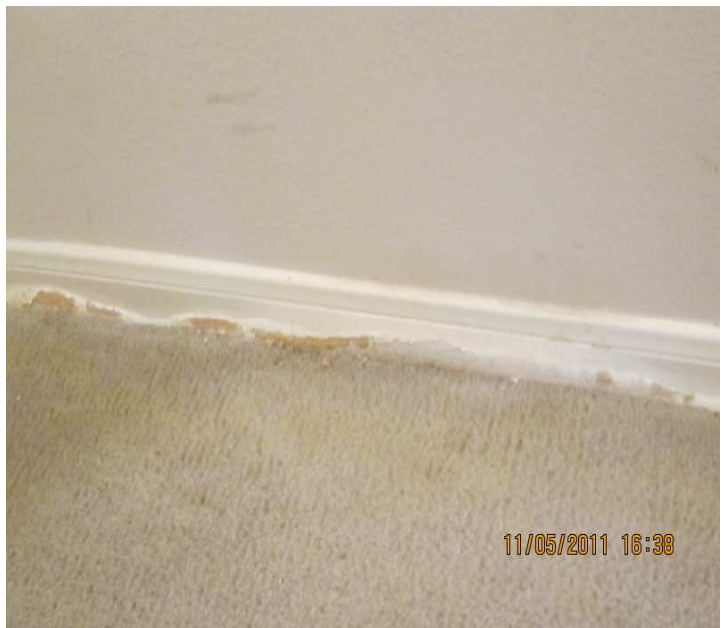
PHOTO NO. 24 DAMAGED BASEBOARD IN  
MIDDLE BEDROOM CLOSET

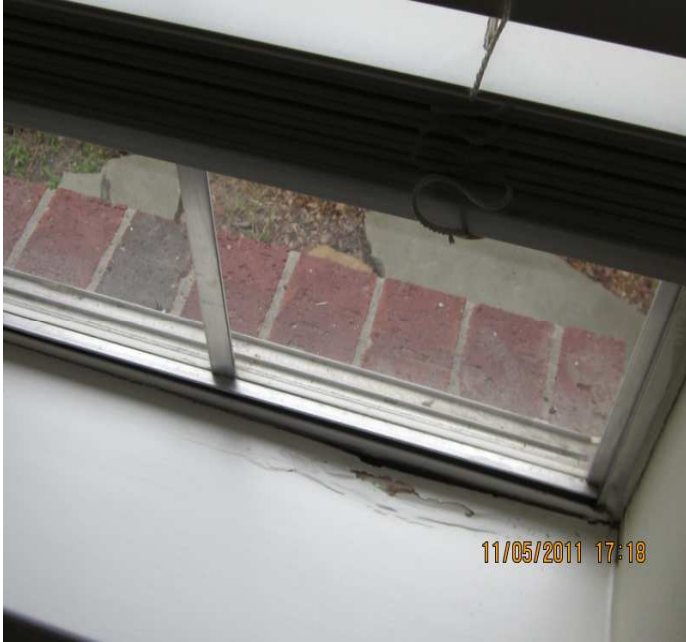
PHOTO NO. 25      WATER DAMAGED WINDOW  
SILL IN LIVING ROOM

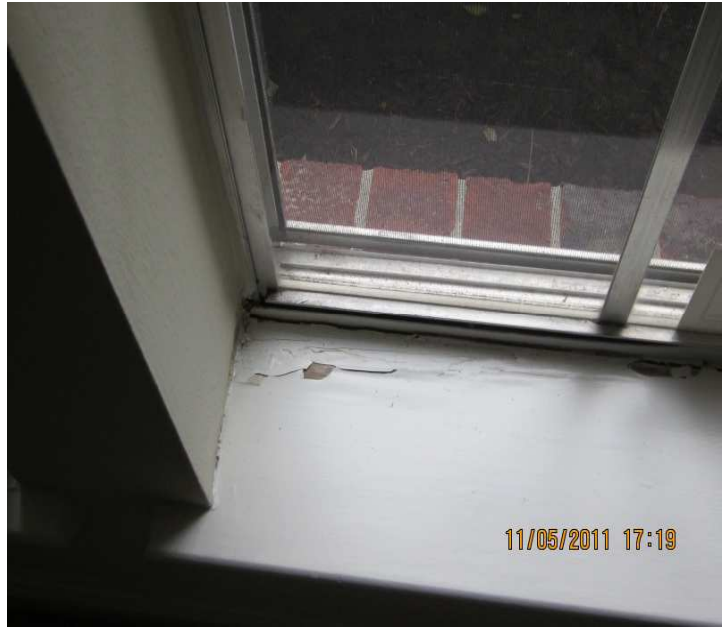
PHOTO NO. 26      WATER DAMAGED WINDOW  
SILL IN STUDY
