**ADDENDUM TO PROPERTY INSPECTION REPORT  
PROPERTY INSPECTION AGREEMENT  
(SAMPLE REPORT)**

**ALLIED HOME INSPECTION SERVICES**

**JOHN O. FRANZEN  
LICENSED BUILDING INSPECTOR  
T.R.E.C. # 1553**

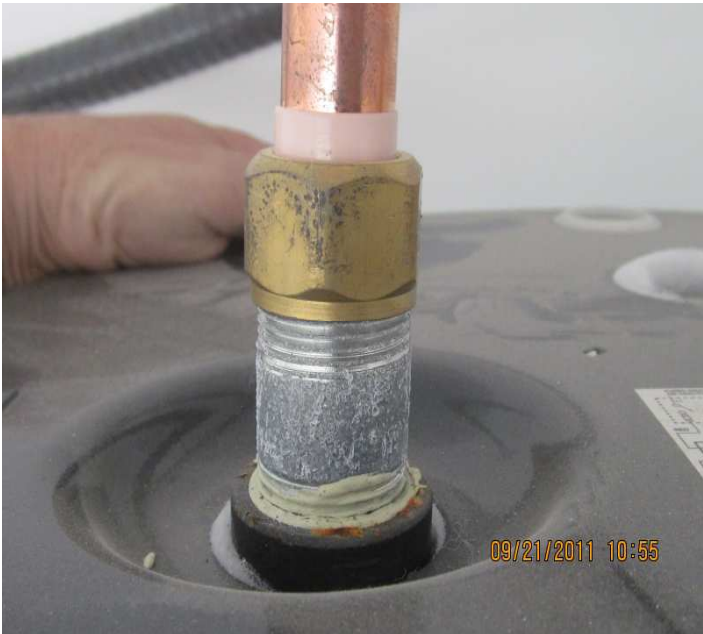
- NO. 7            GALVANIZED - COPPER PIPING CONNECTIONS, AT THE TOP OF THE WATER HEATER, ARE MISSING DIELECTRIC FITTINGS. SEE APPENDIX K-2 & K-3. REPAIRS ARE NEEDED**

PHOTO NO. 3  
WATER HEATER PIPING  
MISSING DIELECTRIC FITTINGS

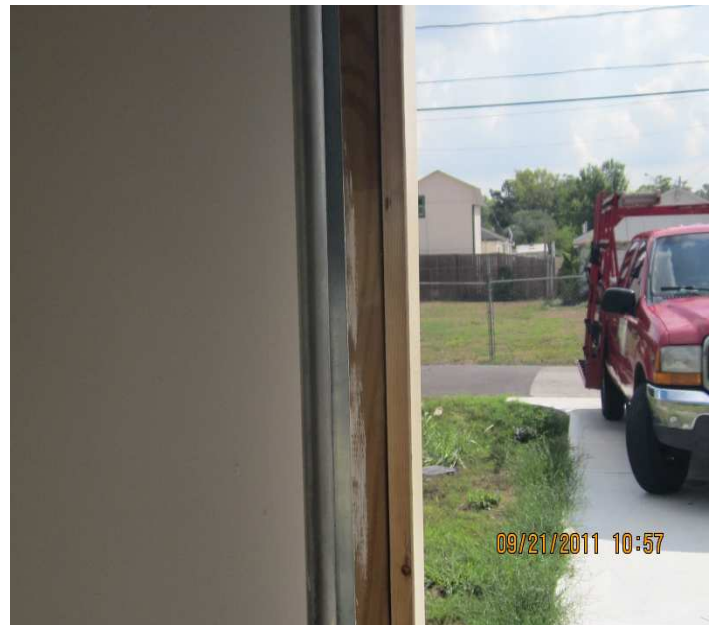
PHOTO NO. 4  
VERTICAL GARAGE DOOR  
FRAME BOARDS NEED TO BE PAINTED

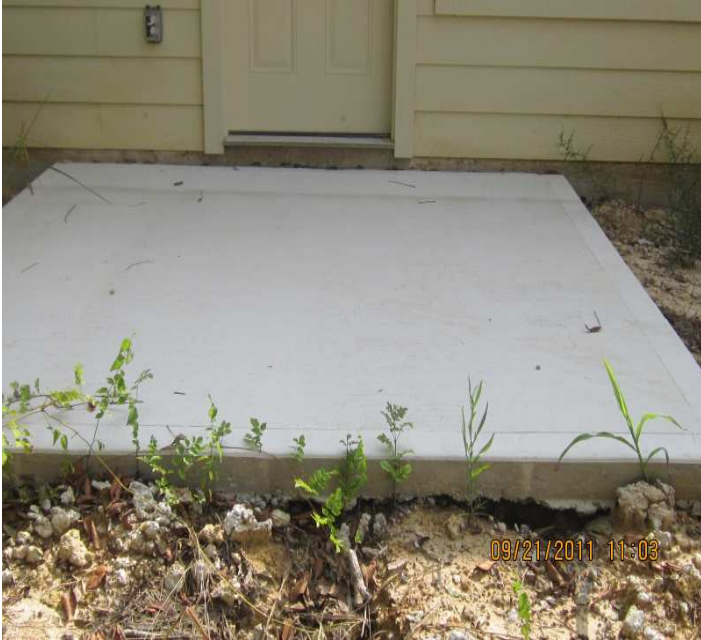
PHOTO NO. 5

GAPS UNDER THE BACK  
CONCRETE PATIO

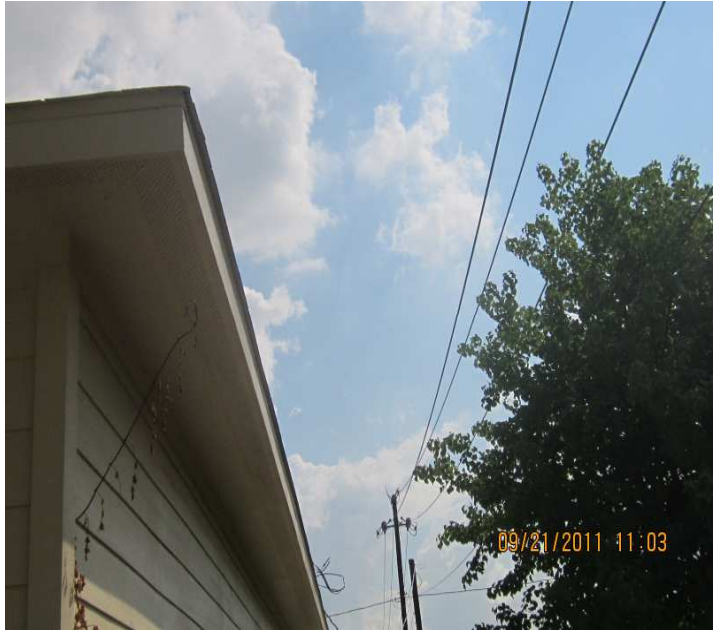
PHOTO NO. 6

- NO. 5            MISSING GUTTERS, DOWNSPOUTS, AND SPLASH BLOCKS ON ALL FOUR SIDES. SEE APPENDIX B-1 & U-3. REPAIRS ARE NEEDED.**

SOUTH EAVE MISSING  
GUTTERS

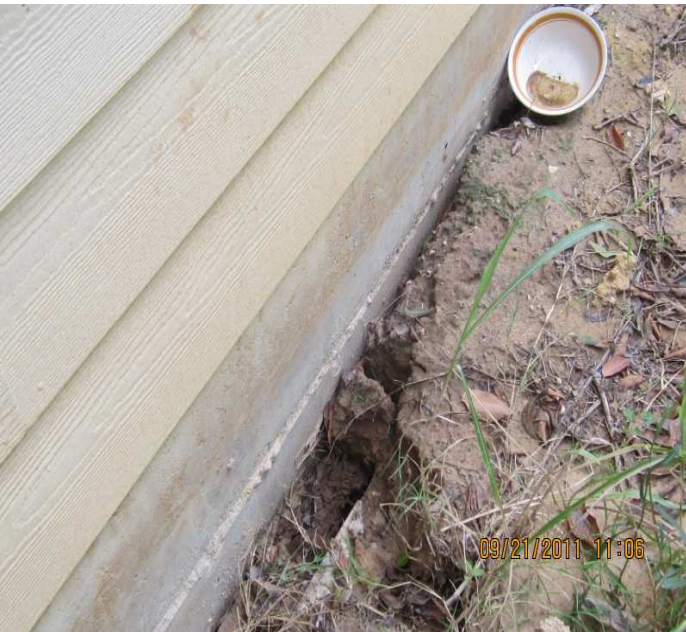
PHOTO NO. 7

- GAPS, UNDER THE FOUNDATION ON THE BACK SIDE, NEED TO BE FILLED AND COMPACTED PROPERLY.**
- NOTE:**  
**IF THIS REPAIR IS NOT DONE PROPERLY, THERE IS A STRONG POSSIBILITY OF FUTURE FOUNDATION SETTLEMENT AND NEEDED REPAIRS.**

GAPS, N GROUND, BY BACK  
SIDE SLAB

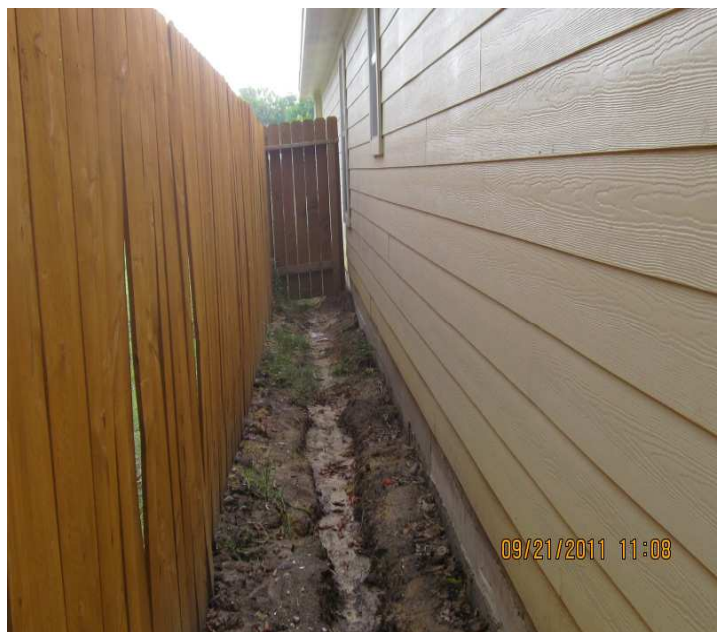
PHOTO NO. 8

- NO. 20            LARGE TRENCH, IN THE NORTH SIDE YARD, NEEDS TO BE FILLED IN AND SLOPED PROPERLY TO THE FRONT. THIS IS A BREEDING GROUND FOR MOSQUITOES. REPAIRS ARE NEEDED.**

DRAINAGE PROBLEM ON  
NORTH SIDE OF HOUSE

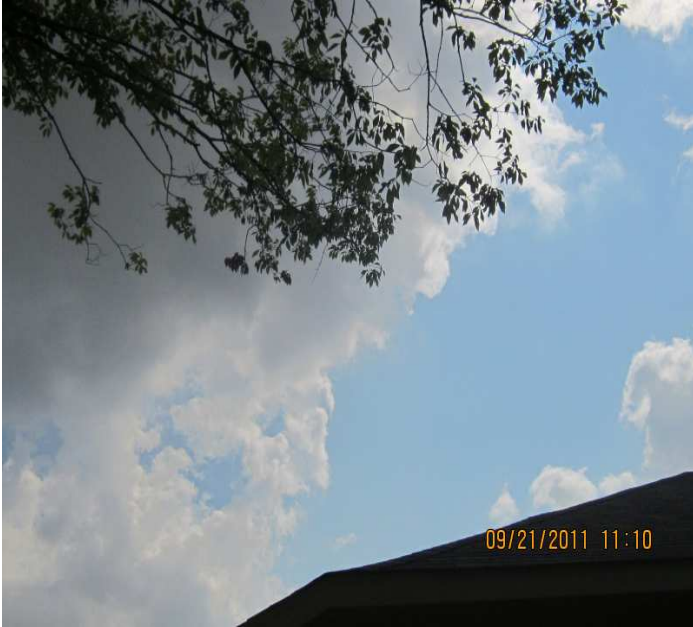
PHOTO NO. 9

TREE LIMBS OVER ROOF

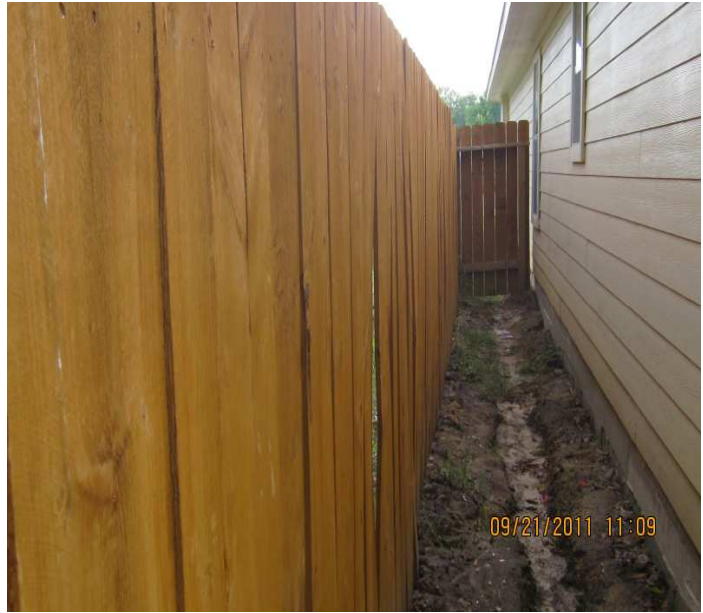
PHOTO NO. 10

- NO. 19            WOOD FENCE PICKETS, ON THE NORTH SIDE, ARE BOWED AND DAMAGED IN A NUMBER OF AREAS. REPAIRS ARE NEEDED.**

DAMAGED FENCE PICKETS  
ON NORTH SIDE

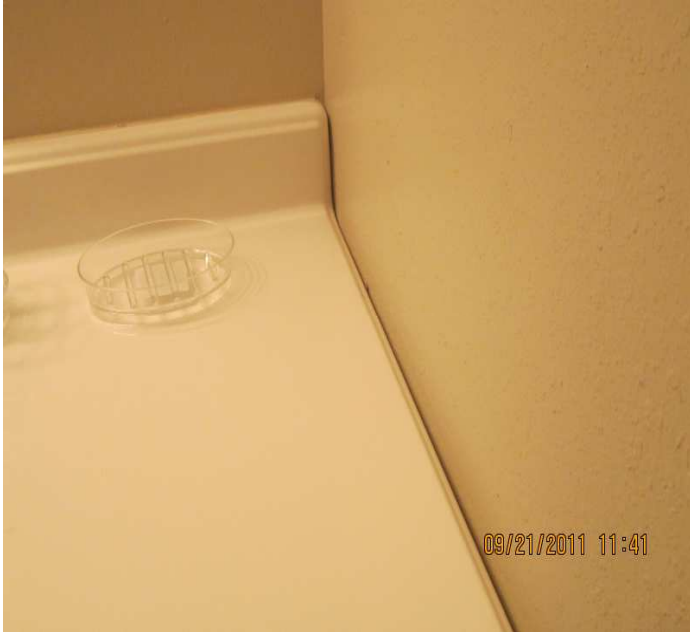
- NO. 31            GAPS, AT THE SIDES OF THE MASTER BATH SINK COUNTER TOP,  
NEED TO BE REPAIRED.**

**PHOTO NO. 13      GAPS, AT THE SIDES OF  
SINK COUNTER TOP IN M. BATH**

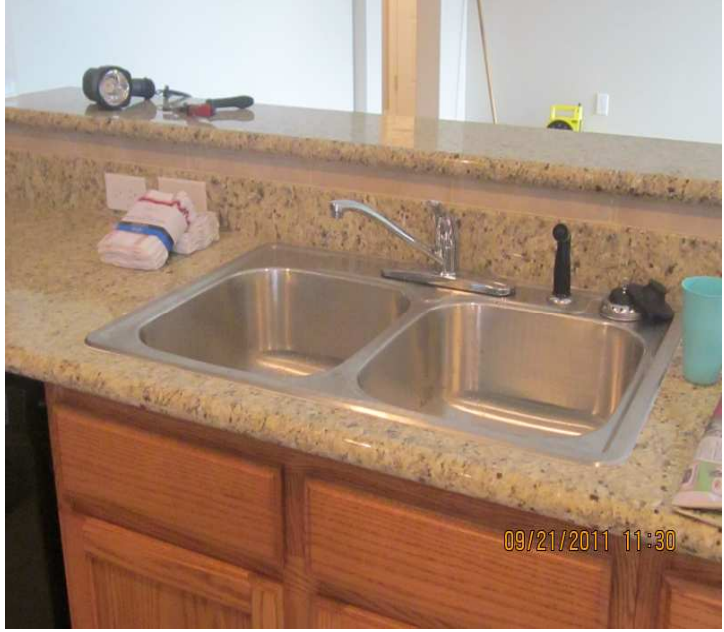
- NO. 23            KITCHEN SINK IS MISSING AN ANTI-SIPHONING DEVICE. IT IS REQUIRED DUE TO THE PRESENCE OF THE SPRAY NOZZLE. SEE APPENDIX N-2.**

**PHOTO NO. 14      KITCHEN SINK MISSING  
ANTI-SIPHONING DEVICE**

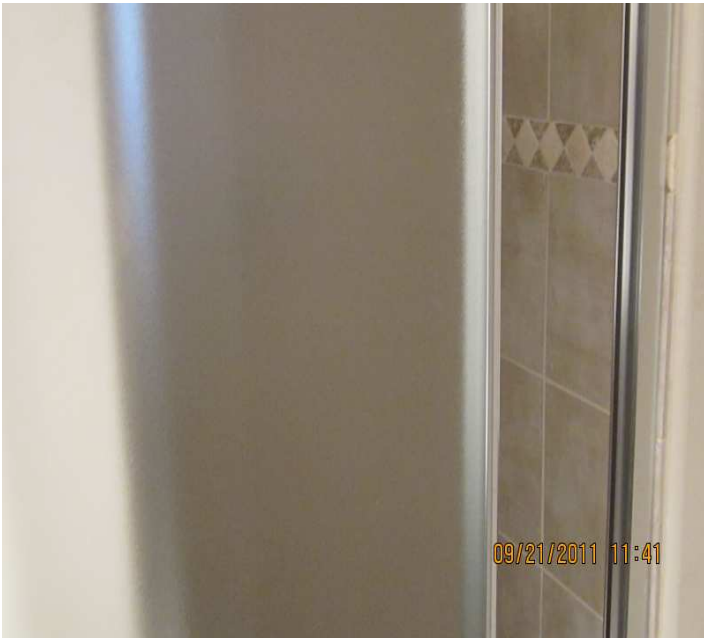
SHOWER DOOR, IN THE MASTER BATH, NEEDS TO BE INSTALLED PROPERLY. IT CAME APART IN OUR HANDS WHEN WE TRIED TO OPEN IT. REPAIRS ARE NEEDED

**PHOTO NO. 15      SHOWER DOOR, IN M. BATH,  
NEEDS TO BE INSTALLED PROPERLY**

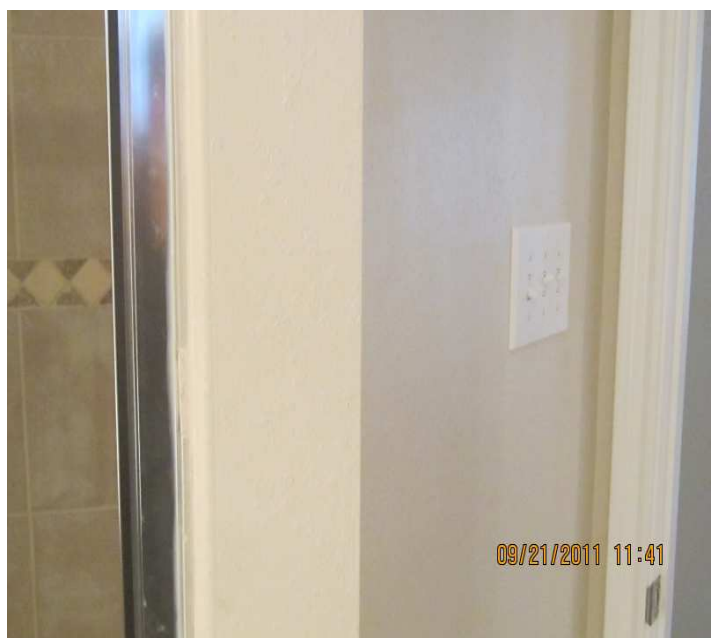
- NO 32            WALL SWITCHES, IN THE MASTER BATH, CAN BE REACHED WHILE  
STANDING IN THE TUB. THE PRESENT SETUP POSES A SEVERE  
SAFETY HAZARD. THESE WALL SWITCHES NEED TO BE  
RELOCATED AWAY FROM THE TUB.**

**PHOTO NO. 16      WALL SWITCHES TOO CLOSE  
TO SHOWER IN M. BATH.**

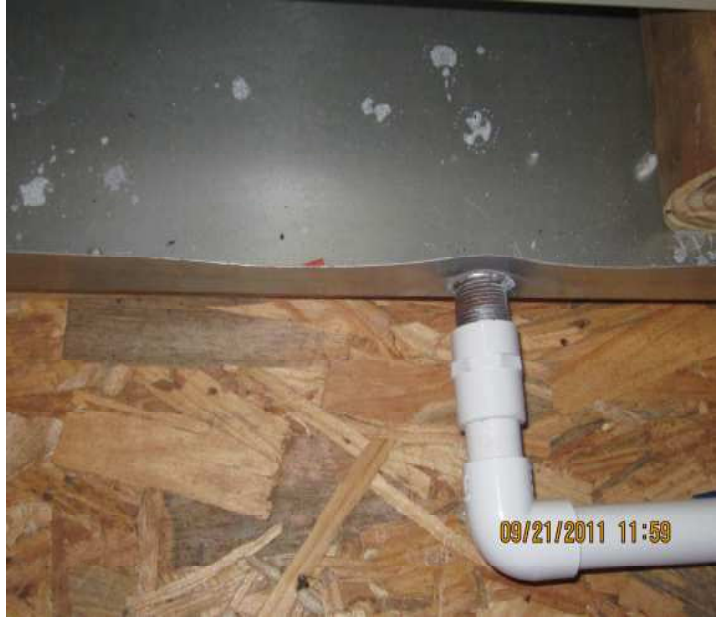
PHOTO NO. 18

- NO. 34            METAL A/C DRAIN PAN, IN THE ATTIC, IS MISSING A FLOAT SWITCH.  
SEE APPENDIX CC-2. REPAIRS ARE NEEDED.**

METAL A/C DRAIN PAN  
MISSING FLOAT SWITCH

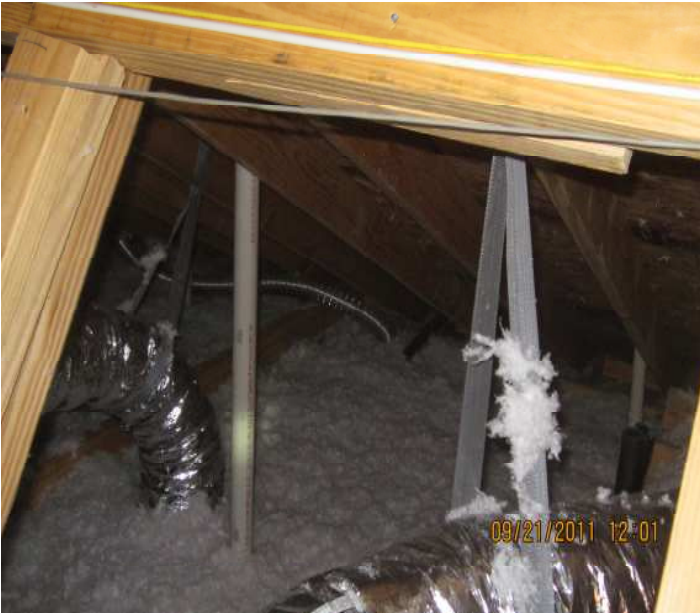
PHOTO NO. 19

- NO. 17            INSULATION IS LAYING IN THE ATTIC ON VENT FAN ASSEMBLIES. THE PRESENT SETUP POSES A FIRE HAZARD. THE INSULATION NEEDS TO BE PULLED BACK FROM THESE AREAS. SEE APPENDIX JJ-4 & S-3.**

INSULATION LAYING ON  
BATH VENT FAN ASSEMBLIES
