**ADDENDUM TO PROPERTY INSPECTION REPORT  
PROPERTY INSPECTION AGREEMENT  
SAMPLE REPORT**

**ALLIED HOME INSPECTION SERVICES**

**JOHN O. FRANZEN  
LICENSED BUILDING INSPECTOR  
T.R.E.C. # 1553**

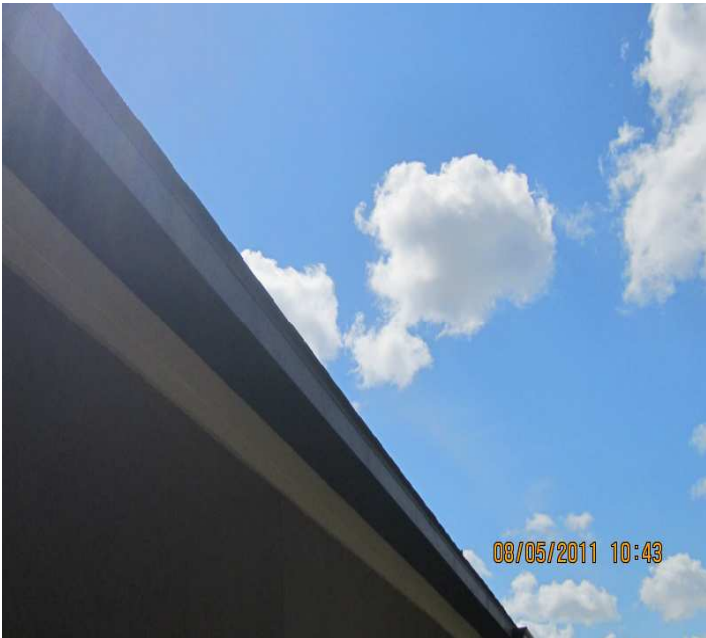
- NO. 3            MISSING GUTTERS, DOWNSPOUTS, AND SPLASH BLOCKS ON ALL FOUR SIDES. SEE APPENDIX B-1 & U-3.**

PHOTO NO. 3 MISSING GUTTERS ON WEST EAVE

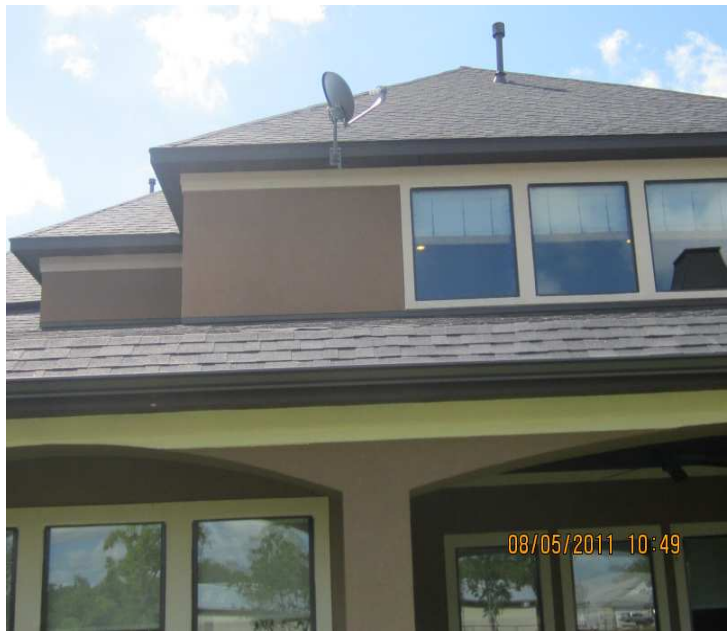
- NO. 4            THERE ARE TURNED UP ROOF SHINGLES ON THE BACK SIDE ROOF. REPAIRS ARE NEEDED.**

PHOTO NO. 4 TURNED UP ROOF SHINGLES ON BACK SIDE OF ROOF

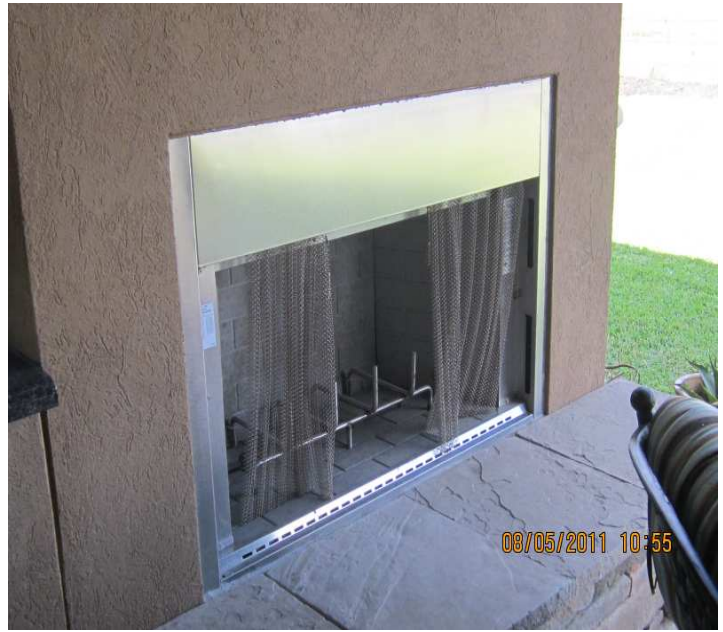
- NO. 6            LEFT SIDE WALL, OF THE OUTDOOR FIREPLACE, IS LOOSE. THIS WALL NEEDS TO BE RESECURED PROPERLY.**

PHOTO NO. 6      BACK PATIO FIREPLACE

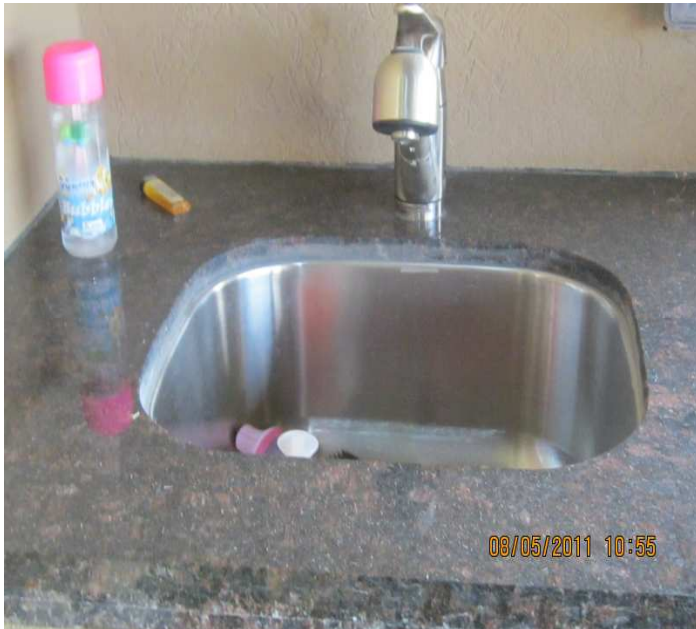
- NO. 11**          **VERTICAL WOOD TRIM, AT THE OVERHEAD GARAGE DOORS, NEEDS TO BE PAINTED.**
- NO. 12**          **SINK, IN THE BACK PATIO, IS MISSING AN ANTI-SIPHONING DEVICE. IT IS REQUIRED DUE TO THE PRESENCE OF THE SPRAY NOZZLE. SEE APPENDIX N-2**

PHOTO NO. 7      BACK PATIO SINK MISSING  
ANTI-SIPHONING DEVICE

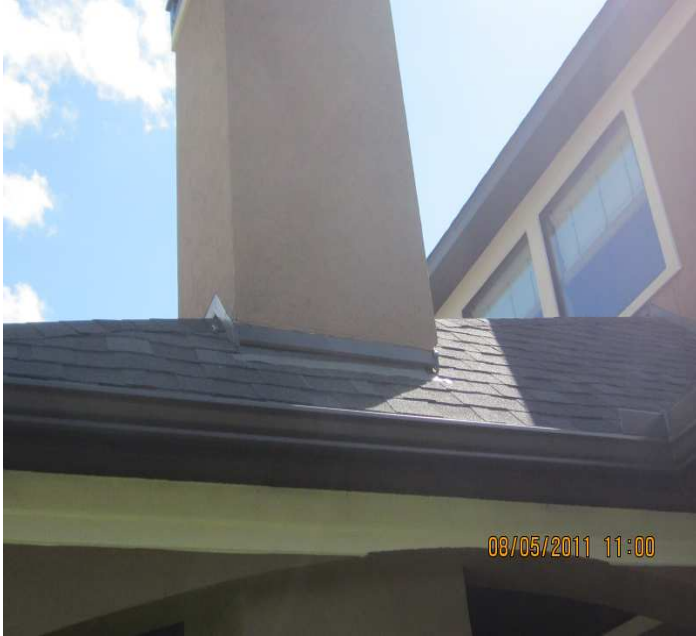
- NO. 13**          **GAPS, AT THE METAL PATIO CHIMNEY FLASHING, NEED REPAIR.**
- NO. 14**          **GAPS, AT THE LOWER BACK ROOF SHINGLES NEAR THE TOP OF THE VALLEY, NEED REPAIR.**

PHOTO NO. 9 METAL PATIO CHIMNEY  
FLASHING NEEDS REPAIR

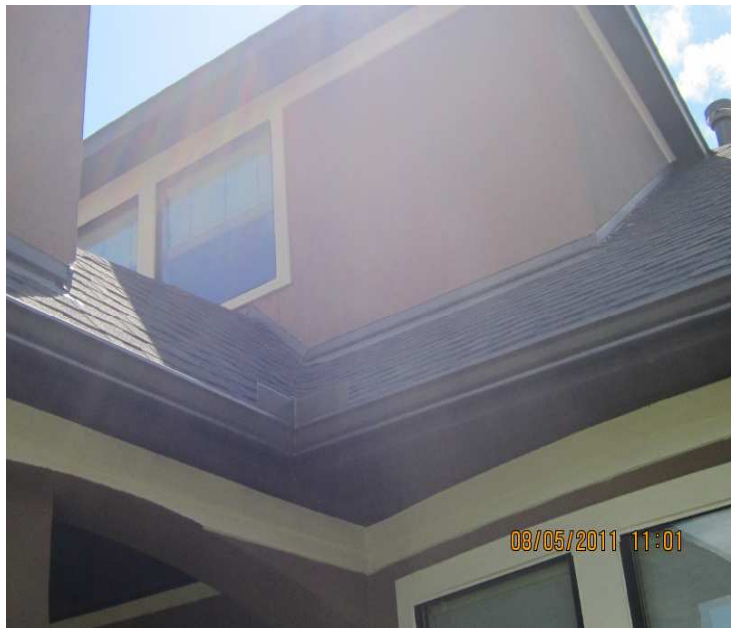
PHOTO NO. 10 TURNED UP ROOF SHINGLES  
AT TOP OF BACK VALLEY

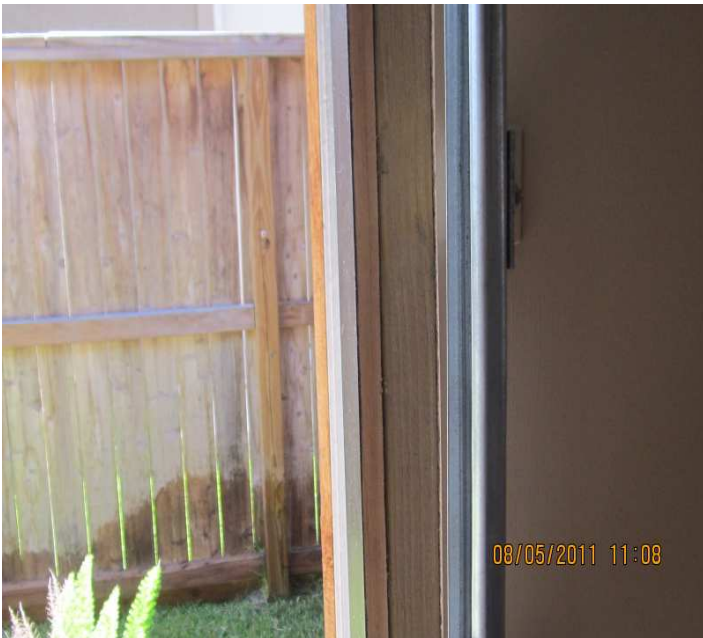
PHOTO NO. 11 VERTICAL GARAGE DOOR  
FRAME BOARDS NEED TO BE PAINTED

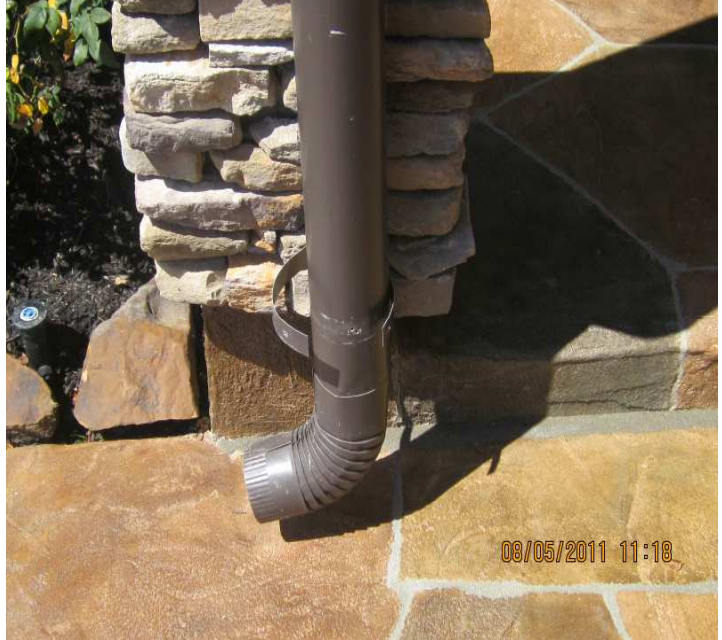
- NO. 15**          **DOWNSPOUT BRACKET, IN FRONT BY THE GARAGE DOOR, IS DAMAGED. SEE PHOTO PAGES**
- NO. 16**          **KITCHEN SINK IS MISSING AN ANTI-SIPHONING DEVICE. IT IS REQUIRED DUE TO THE PRESENCE OF THE SPRAY NOZZLE. SEE APPENDIX N-2.**

PHOTO NO. 14 BROKEN DOWNSPOUT  
BRACKET BY GARAGE

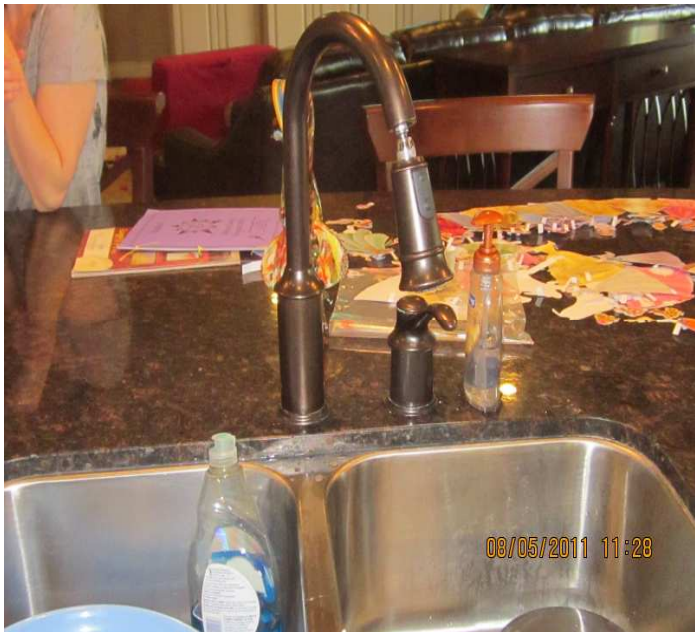
- NO. 19            SPRAY NOZZLE, AT THE KITCHEN SINK, WILL NOT RETRACT PROPERLY. REPAIRS ARE NEEDED.**

PHOTO NO. 15 SPRAY NOZZLE, AT  
KITCHEN SINK, WILL NOT RETRACT PROPERLY

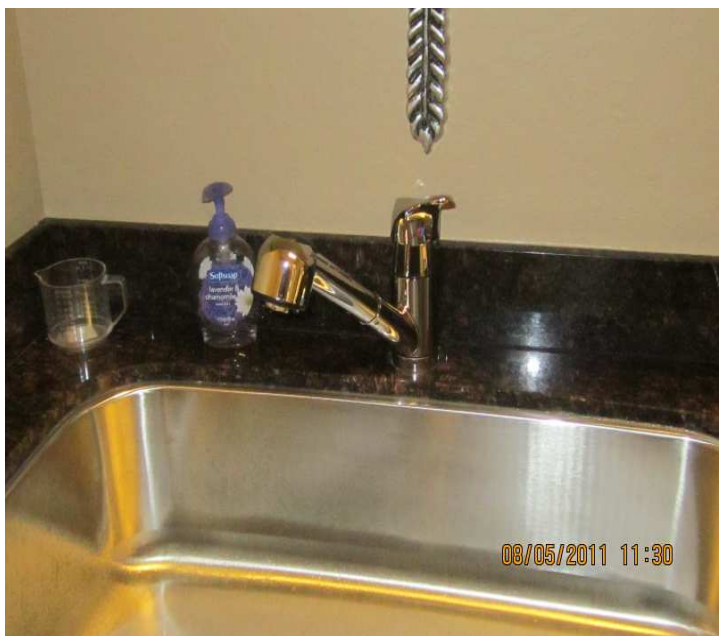
- NO. 21            UTILITY ROOM SINK IS MISSING AN ANTI-SIPHONING DEVICE. IT IS REQUIRED DUE TO THE PRESENCE OF THE SPRAY NOZZLE. SEE APPENDIX N-2**

PHOTO NO. 16 UTILITY ROOM SINK MISSING  
ANTI-SIPHONING DEVICE

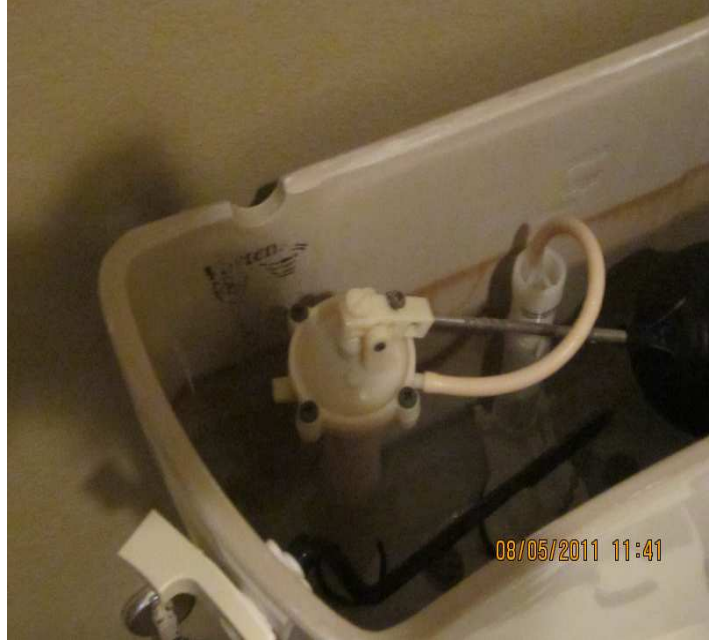
- NO. 20            COMMODE TANKS ARE MISSING AN ANTI-SIPHONING DEVICE. SEE APPENDIX JJ-2**

PHOTO NO. 18 COMMODE TANKS MISSING ANTI-SIPHONING DEVICE

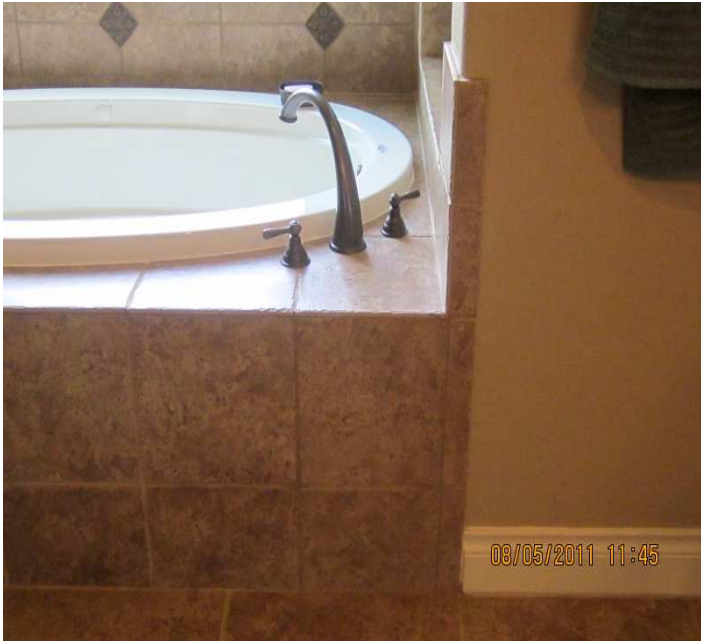
| <b>NO. 31</b> | <b>ALL, OF THE BATHTUBS, ARE MISSING A PLUMBING ACCESS PANEL. SEE APPENDIX K-2 &amp; K-3.</b> |

PHOTO NO. 19 TUB MISSING PLUMBING ACCESS PANEL

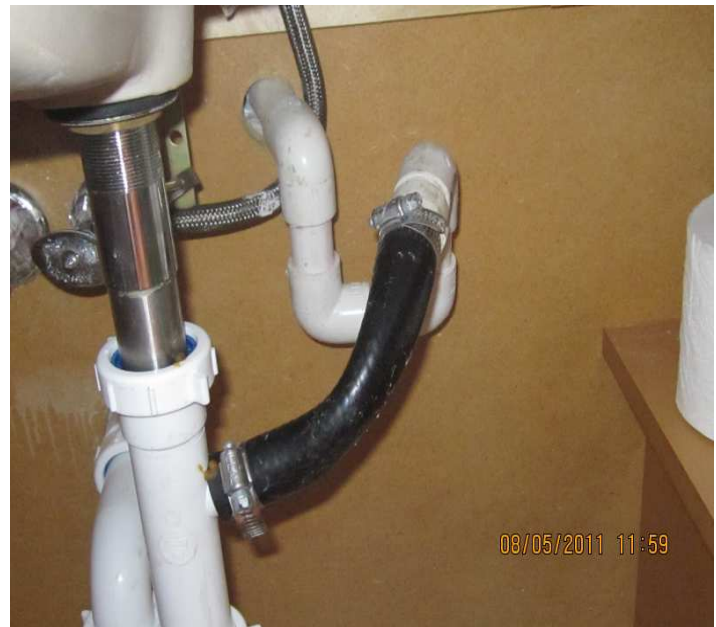
| <b>NO. 30</b> | <b>A/C PRIMARY DRAIN LINE, UNDER THE SINK IN THE UPSTAIRS EAST SIDE BATH, IS BADLY CRIMPED. REPAIRS ARE NEEDED</b> |

PHOTO NO. 20 BADLY CRIMPED A/C PRIMARY DRAIN LINE UNDER UPSTAIRS BATH SINK

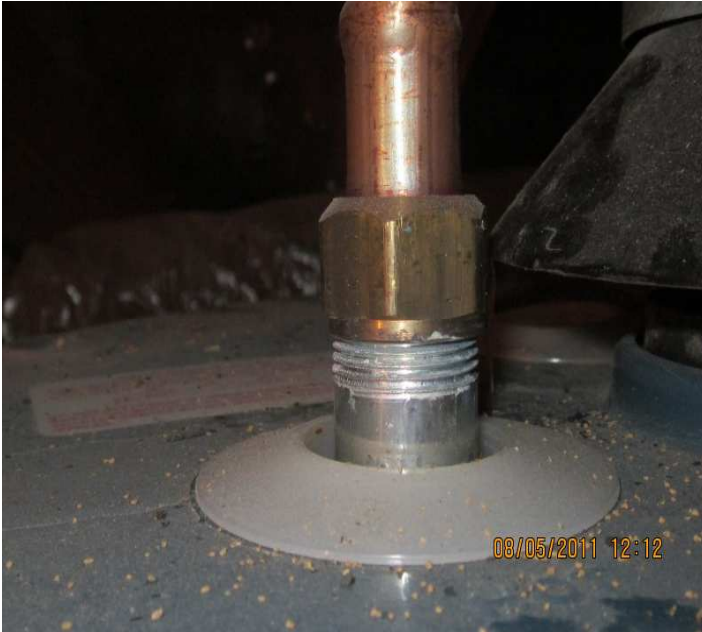
| <b>NO. 32</b> | <b>GALVANIZED - COPPER PIPING CONNECTIONS, AT THE TOPS OF BOTH WATER HEATERS, ARE MISSING DIELECTRIC FITTINGS. SEE APPENDIX K-2 &amp; K-3</b> |

PHOTO NO. 23 WATER HEATER PIPING MISSING DIELECTRIC FITTINGS

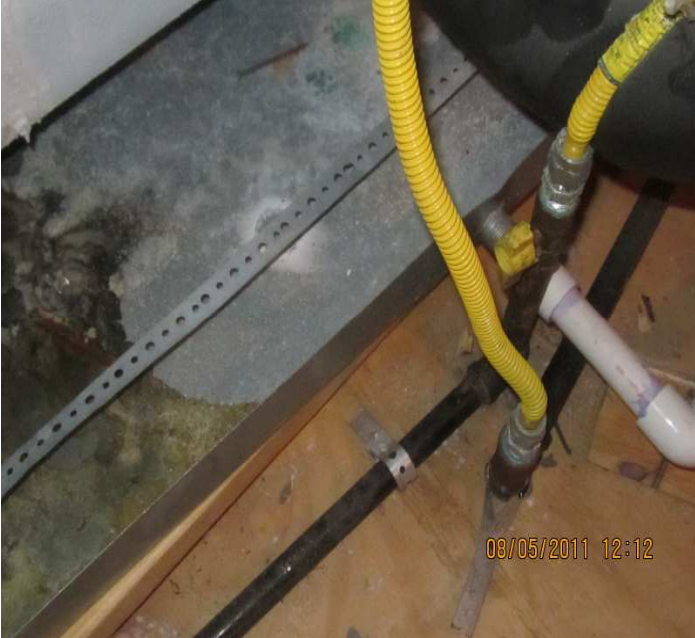
| <b>NO. 33</b> | <b>BOTH, OF THE TWO METAL A/C DRAIN PANS, IN THE ATTIC, ARE MISSING FLOAT SWITCHES. SEE APPENDIX CC-2.</b> |

PHOTO NO. 25 A/C DRAIN PAN, IN ATTIC,  
MISSING FLOAT SWITCH

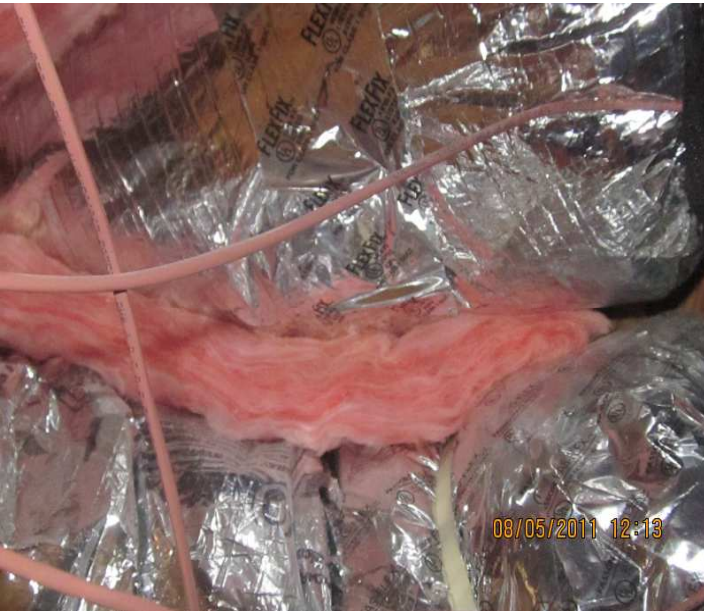
**NO. 35            COLD SIDE DUCTWORK, IN THE ATTIC, IS LAYING AGAINST EACH  
OTHER AND HAS ONLY WHITE INSULATION PLACED BETWEEN THEM.  
EITHER THE PINK INSULATION NEEDS TO BE REPLACED WITH A  
RUBBER SHIELD OR THE DUCTWORK SEPARATED FROM EACH  
OTHER. SEE APPENDIX W.**

PHOTO NO. 27 PINK INSULATION BETWEEN  
DUCTWORK IN ATTIC

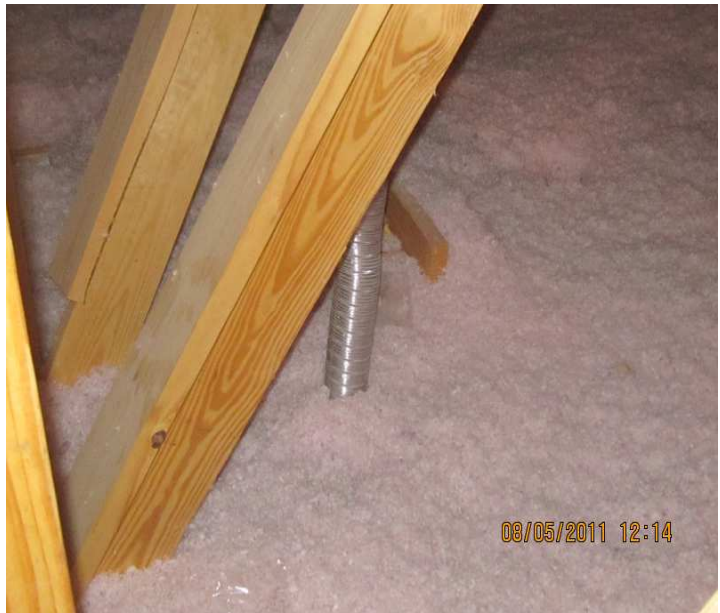
- NO. 17            INSULATION IS LAYING IN THE ATTIC ON VENT FAN ASSEMBLIES. THE PRESENT SETUP POSES A FIRE HAZARD. THE INSULATION NEEDS TO BE PULLED BACK FROM THESE AREAS. SEE APPENDIX JJ-4 & S-3.**

PHOTO NO. 28 INSULATION, IN ATTIC, LAYING  
ON VENT FAN ASSEMBLY
