**ADDENDUM TO PROPERTY INSPECTION REPORT  
PROPERTY INSPECTION AGREEMENT  
SAMPLE REPORT**

**ALLIED HOME INSPECTION SERVICES**

**JOHN O. FRANZEN  
LICENSED BUILDING INSPECTOR  
T.R.E.C. # 1553**

TYPE OF STRUCTURE:        SFH

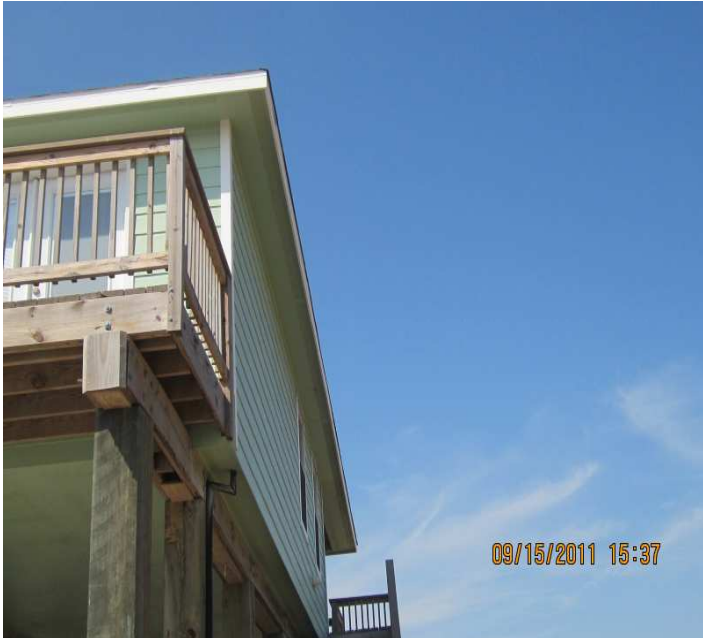
PHOTO NO. 3

FRONT DECK GUARD RAIL  
DOES NOT MEET "4-INCH" RULE

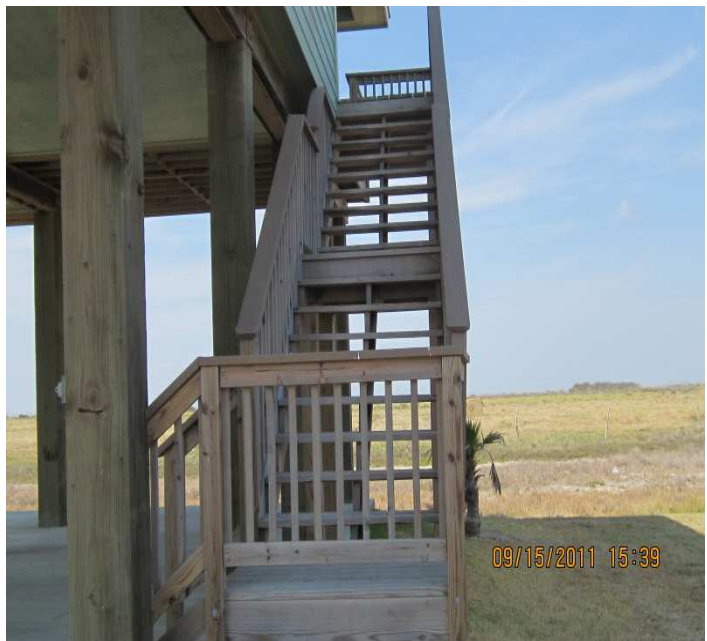
PHOTO NO. 4

EAST STAIRWAY DOES NOT  
MEET "4-INCH" RULE

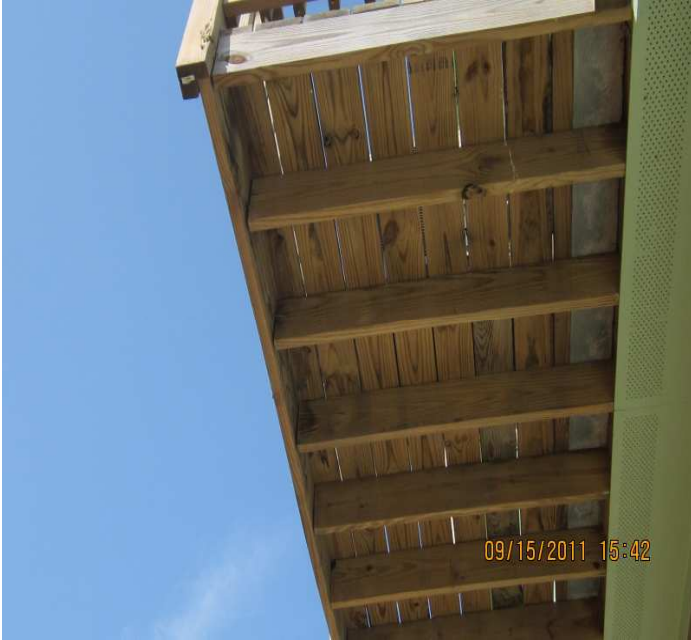
- NO. 5            FLOOR JOISTS, ON THE A/C DECK ON THE WEST SIDE, ARE MISSING JOIST HANGERS.**

PHOTO NO. 5 A/C PLATFORM MISSING  
JOIST HANGERS

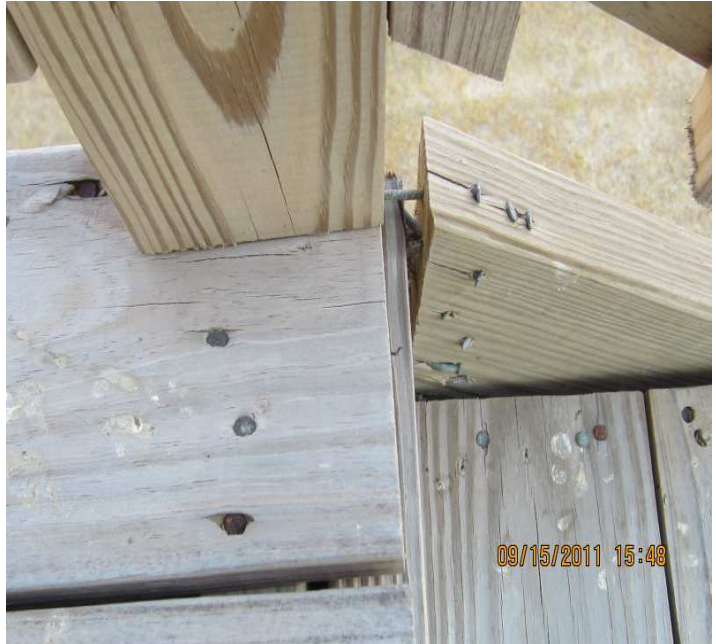
- NO. 3            WOOD EXTERIOR STAIRWAY IS PULLING APART IN SEVERAL AREAS. MAJOR REPAIRS ARE NEEDED. THE PRESENT SETUP POSES A SAFETY HAZARD. ADDITIONAL VERTICAL SUPPORTS ARE NEEDED**

PHOTO NO. 6 STAIRWAY PULLING AWAY  
AT TOP

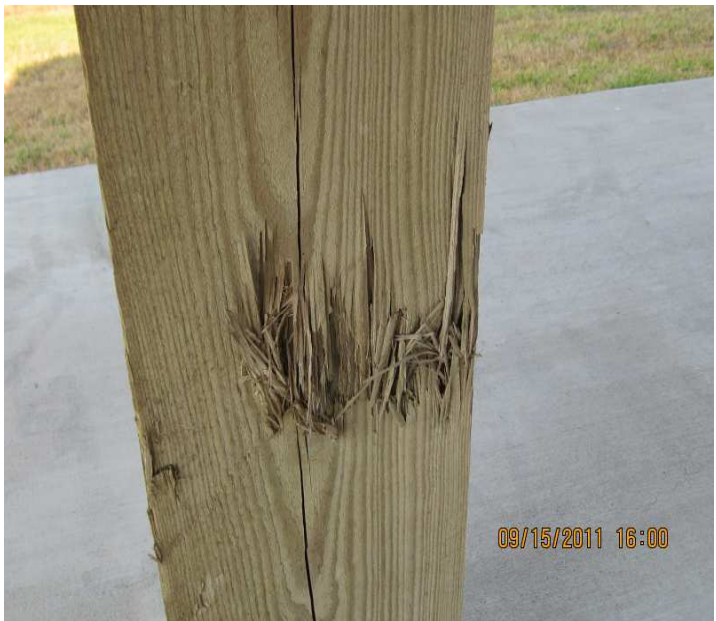
- NO. 13**           **THERE ARE AT LEAST TWO PIERS (ONE IN FRONT AND ONE IN BACK) THAT ARE DAMAGED. REPAIRS ARE NEEDED**
- NO. 14**           **BOTH BATH TUBS ARE MISSING PLUMBING ACCESS PANELS. SEE APPENDIX K-2 & K-3.**

PHOTO NO. 8 DAMAGED WOOD PIER IN  
BACK

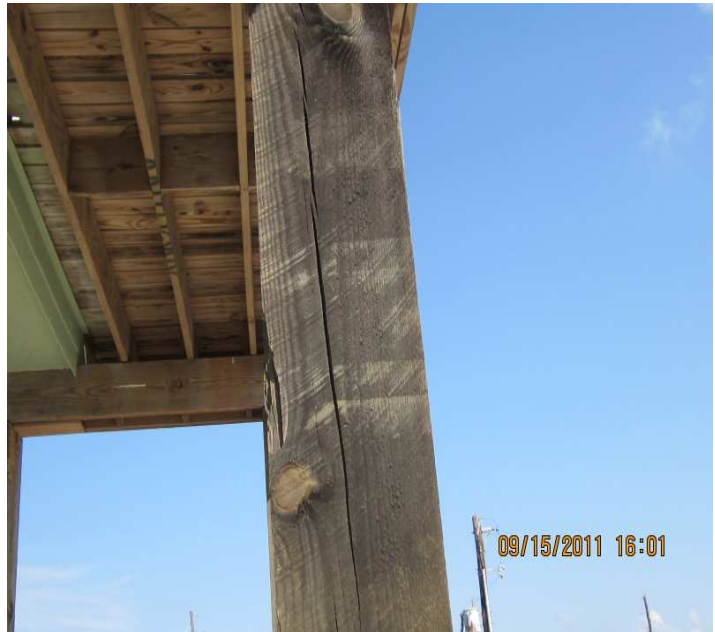
PHOTO NO. 10 DAMAGED WOOD PIER IN  
FRONT BY GARAGE

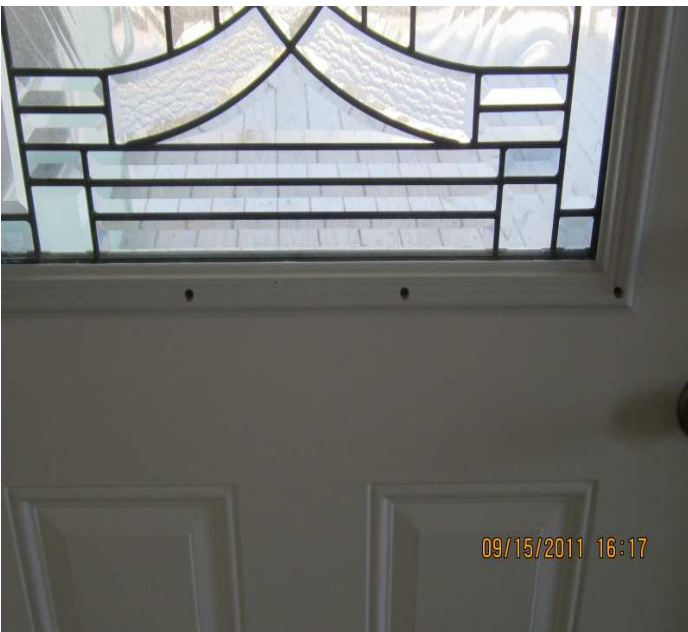
- NO. 21**      **EXIT DOORS, TO THE SECOND LEVEL FRONT DECK, ARE BINDING. REPAIRS ARE NEEDED**
- NO. 22**      **SCREW HOLES, ON THE FRONT ENTRY DOOR AND BEDROOM EXIT DOORS TO THE DECKS, NEED TO BE PLUGGED AND PAINTED.**

PHOTO NO. 11 SCREW HOLES NEED TO BE  
PLUGGED ON FRONT ENTRY DOOR

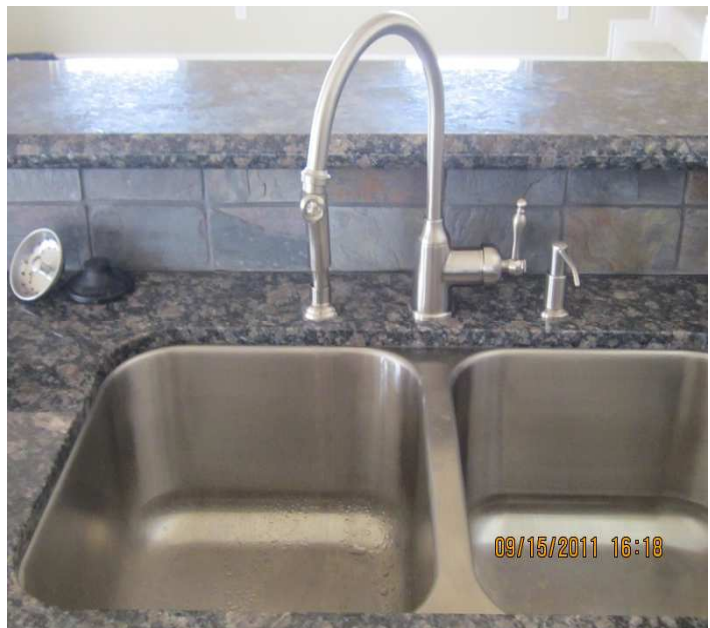
PHOTO NO. 12 KITCHEN SINK MISSING  
ANTI-SIPHONING DEVICE

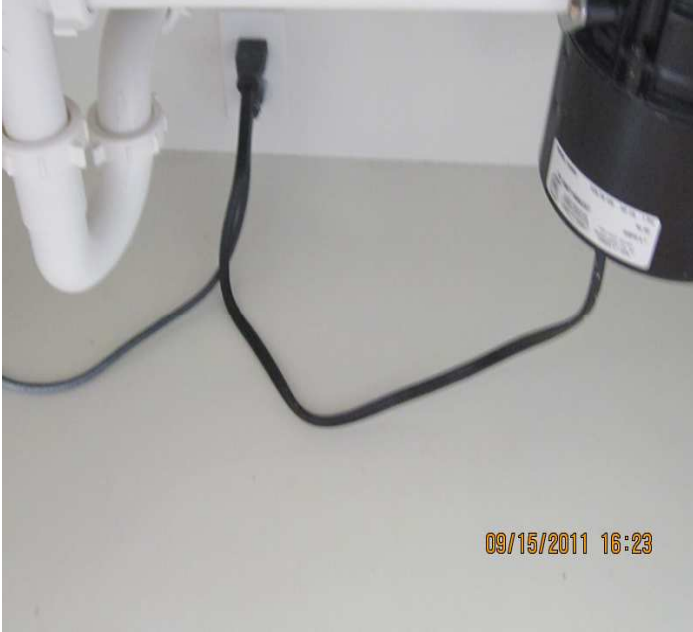
- NO. 28**      **POWER CORD, TO THE DISPOSAL UNDER THE KITCHEN SINK, NEEDS TO BE ENCLOSED IN A SHIELDED FLEX CONDUIT.**
- NO. 29**      **KITCHEN SINK IS MISSING AN ANTI-SIPHONING DEVICE. IT IS REQUIRED DUE TO THE PRESENCE OF THE SPRAY NOZZLE. SEE APPENDIX N-2**
- NO. 30**      **THERE IS LOW WATER PRESSURE AT THE KITCHEN SINK. REPAIRS ARE NEEDED**
- NO. 31**      **TURN TABLE, IN THE MICROWAVE, IS NOT OPERABLE. REPAIRS ARE NEEDED.**
- NO. 32**      **OVEN THERMOSTAT IS OFF APPROX. 45 DEGREES ON THE HIGH SIDE IN "BAKE" SETTING. THE THERMOSTAT NEEDS TO BE ADJUSTED.**
- NO. 33**      **WEST SIDE KITCHEN OUTLET, ABOVE THE COUNTER TOP, HAS A GAP BY IT. REPAIRS ARE NEEDED.**
- NO. 34**      **LEFT SIDE BACK KITCHEN SPLASH BLOCK HAS A HOLE IN IT. A COVER IS NEEDED**
- NO. 35**      **CEILING, IN THE BREAKFAST AREA, IS WATER DAMAGED. IT WAS NOT DETERMINED THE SOURCE OF THE WATER PENETRATION**

PHOTO NO. 13 POWER CORD, TO DISPOSAL,  
NOT ENCLOSED IN CONDUIT

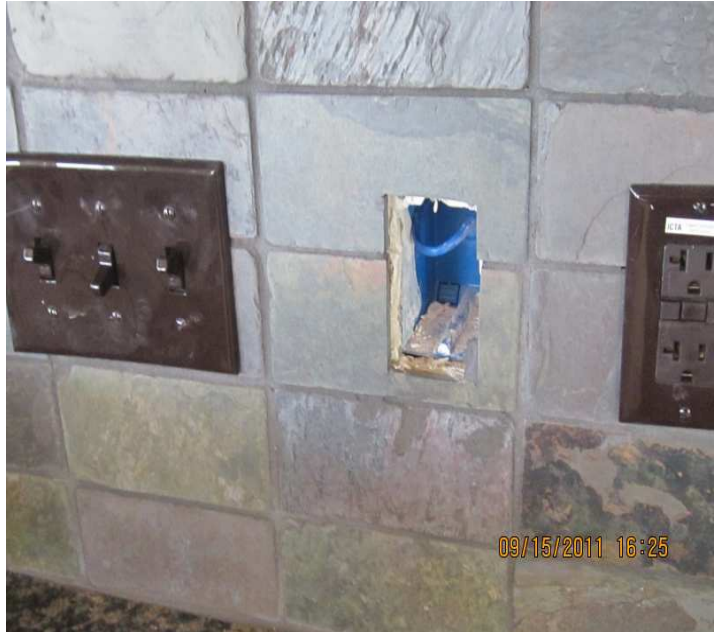
PHOTO NO. 14 HOLE IN KITCHEN BACK  
SPLASH ON FRONT SIDE

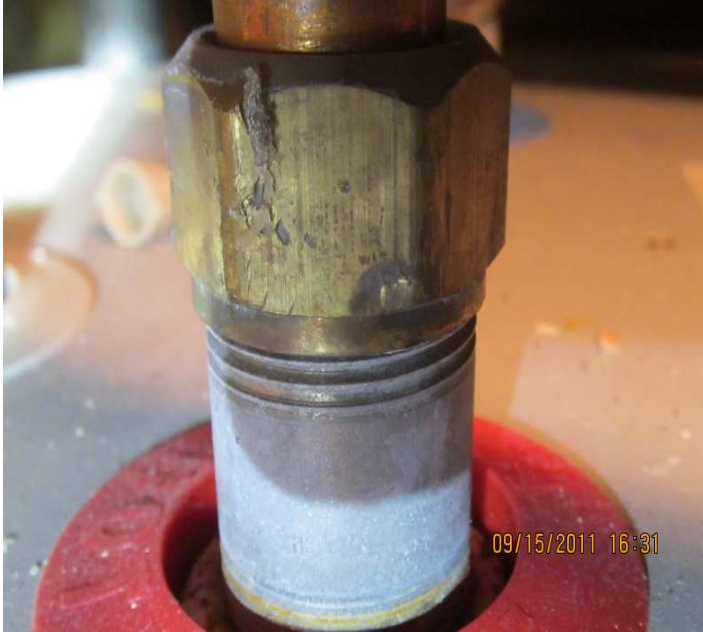
- NO. 27**      **GALVANIZED - COPPER PIPING CONNECTIONS, AT THE TOP OF THE WATER HEATER, ARE MISSING DIELECTRIC FITTINGS. SEE APPENDIX K-2 & K-3**

PHOTO NO. 17 WATER HEATER PIPING  
MISSING DIELECTRIC FITTINGS

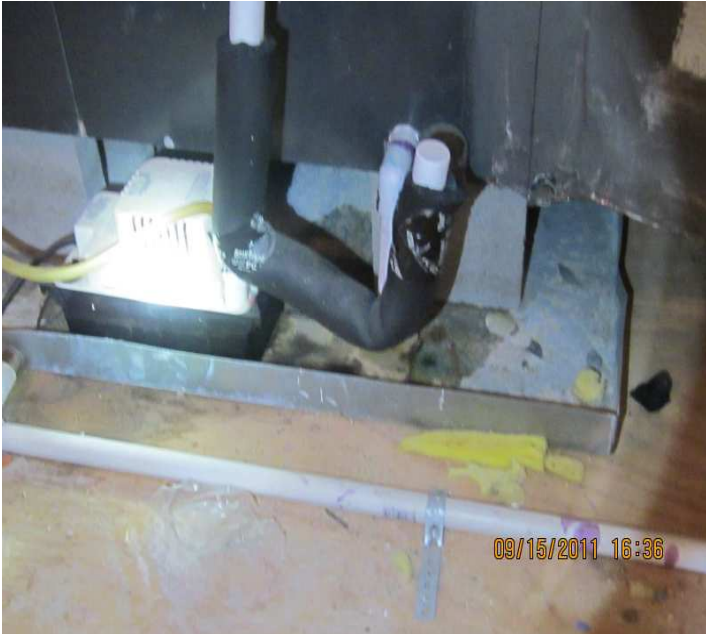
- NO. 19**      **THERE IS STANDING WATER IN THE A/C METAL DRAIN PAN IN THE ATTIC. REPAIRS ARE NEEDED.**
- NO. 20**      **THE METAL A/C DRAIN PAN, IN THE ATTIC, IS MISSING A FLOAT SWITCH. SEE APPENDIX CC-2.**

PHOTO NO. 19 A/C DRAIN PAN MISSING  
FLOAT SWITCH & HAS WATER IN IT.

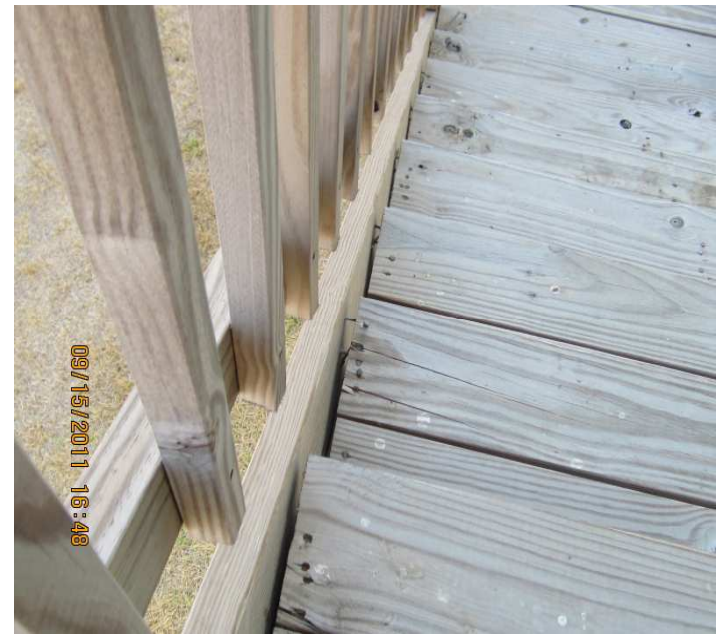
PHOTO NO. 20 STEPS, ON EXTERIOR  
STAIRWAY, PULLING APART

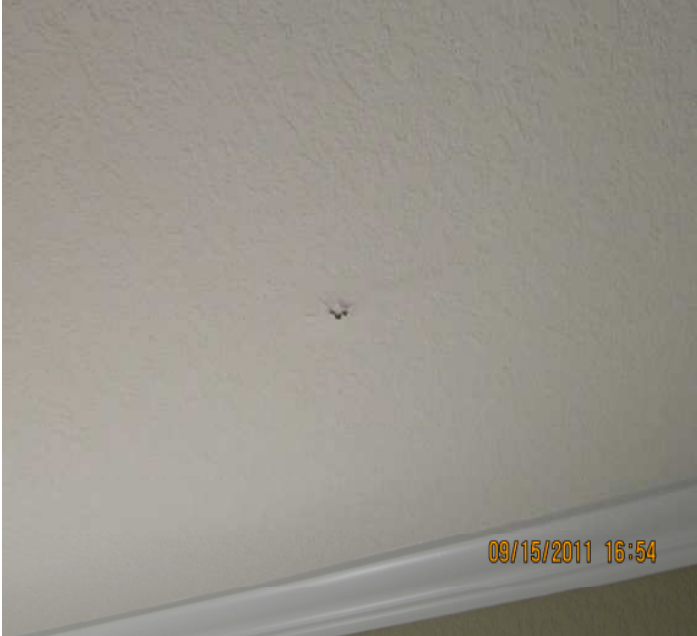
PHOTO NO. 21

DAMAGED CEILING IN  
BREAKFAST AREA

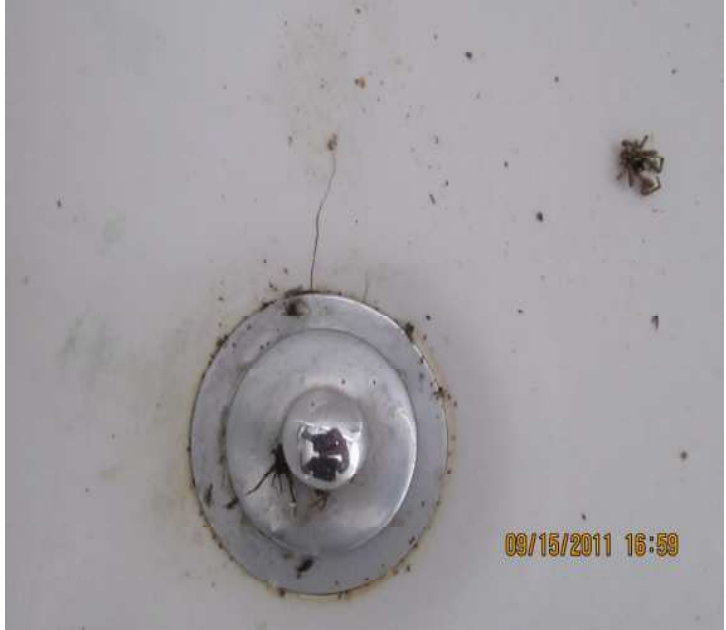
PHOTO NO. 22

- NO. 15**           **JACUZZI TUB IS MISSING AN ACCESS PANEL FOR THE MOTOR AND PUMP. SEE APPENDIX N-3.**
- NO. 16**           **TUB, IN THE NO. 2 BATH, IS DAMAGED BY THE DRAIN. REPAIR OR REPLACEMENT OF THE TUB IS NEEDED.**

TUB, IN NO. 2 BATH, IS  
DAMAGED AT DRAIN

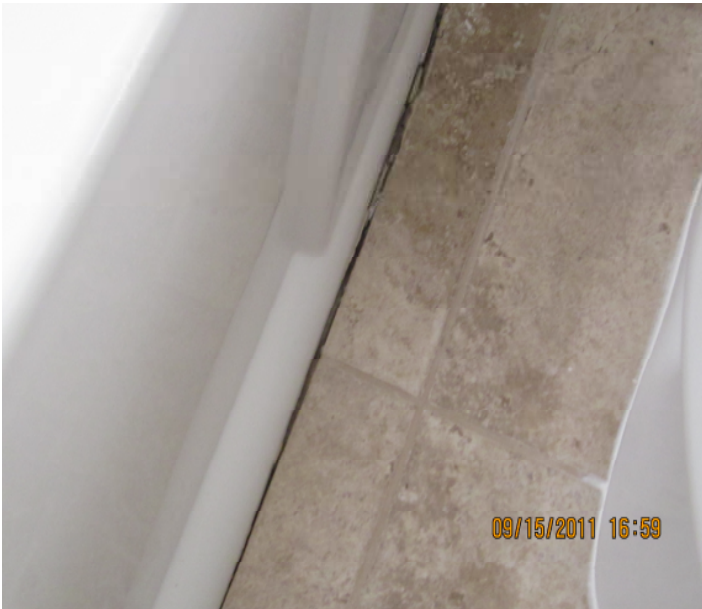
PHOTO NO. 23

- NO. 17**           **LARGE GAP, BETWEEN THE TILE FLOORING AND THE TUB IN THE NO. 2 BATH, NEEDS REPAIR.**

GAPS BETWEEN TUB AND  
FLOOR TILE IN # 2 BATH

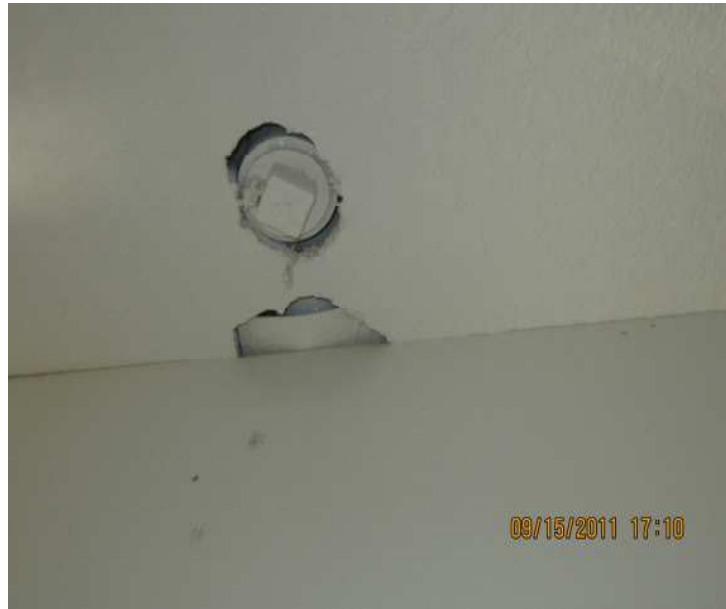
PHOTO NO. 24

GAPS AT SEWER LINES UNDER  
BATH SINK

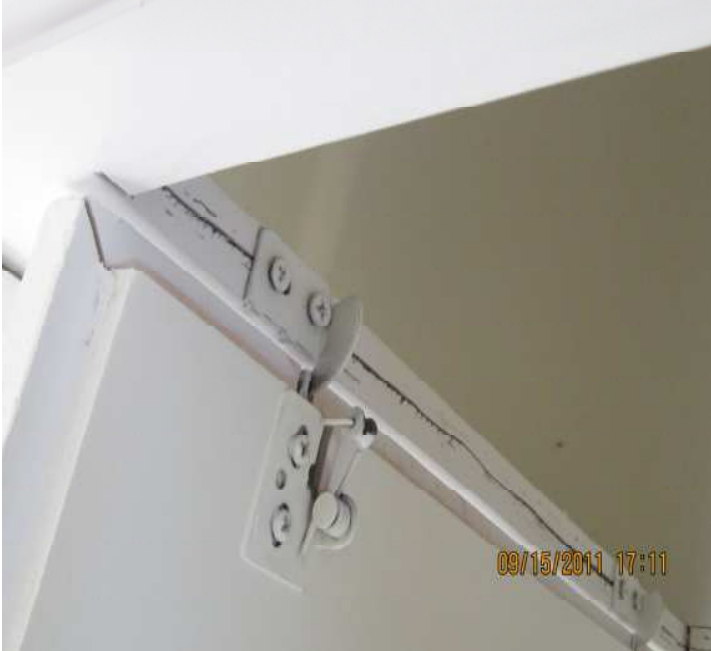
PHOTO NO. 25

- NO. 40            BATH SINK CABINET DOOR FRAME, IN THE MASTER BATH, IS SPLIT. REPAIRS ARE NEEDED**

DAMAGED BATH SINK  
CABINET DOOR FRAME

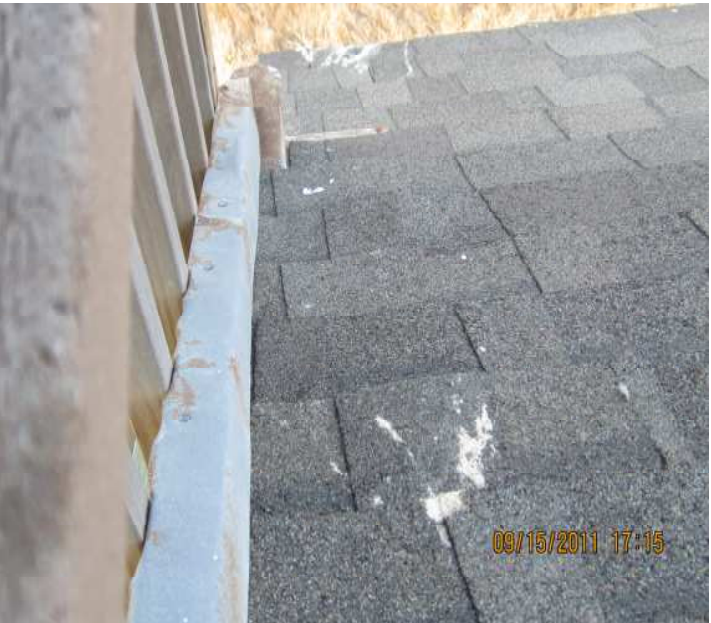
PHOTO NO. 27

- NO. 23**      **ROOF, AT THE BACK BY THE BACK DECK, HAS PAINT ON THE SHINGLES. PAINT NEEDS TO BE REMOVED OR SHINGLES REPLACED.**
- NOTE:**  
**AS DISCUSSED DURING THE INSPECTION, ONE 3 TON A/C SYSTEM MAY BE UNDERSIZED FOR A TWO STORY HOME WITH HIGH CEILINGS AND LOTS OF GLASS.**

PAINT NEEDS TO BE  
REMOVED FROM SHINGLES

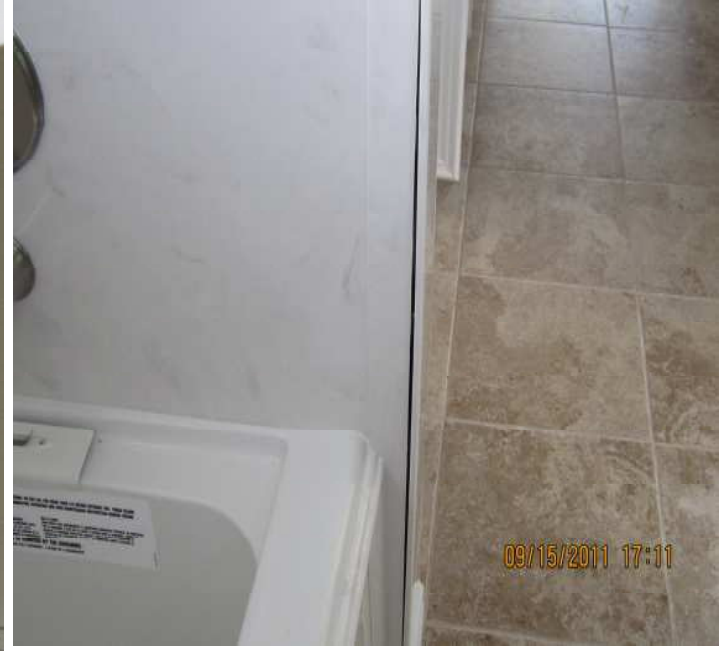
PHOTO NO. 26

- NO. 39            VERTICAL TILE, BY THE JACUZZI IN THE MASTER BATH, IS PULLING AWAY FROM THE WALL. REPAIRS ARE NEEDED**

VERTICAL TILE TRIM, IN M. BATH,  
PULLING AWAY FROM WALL

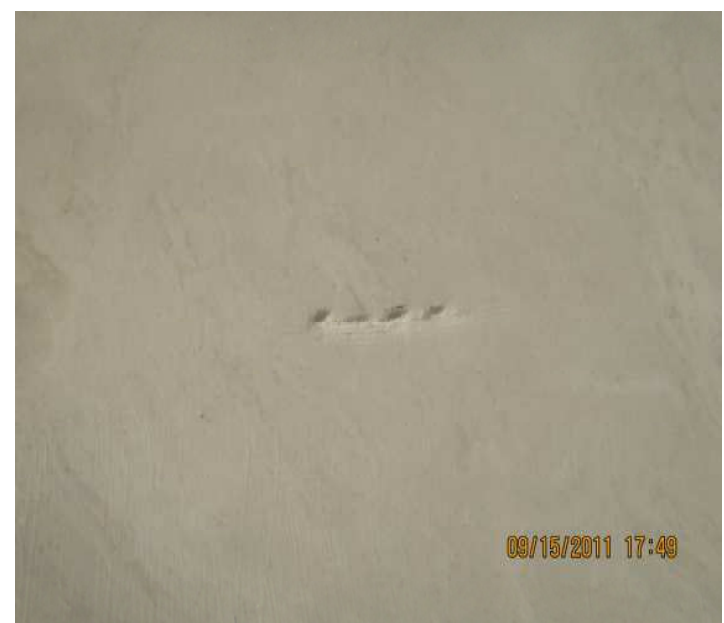
PHOTO NO. 28

- NO. 7            MARBLE BATH SINK COUNTER, IN THE SECOND LEVEL BATH, IS DAMAGED ON THE RIGHT SIDE. REPAIR OR REPLACEMENT IS NEEDED.**

DAMAGED MARBLE BATH  
COUNTER TOP

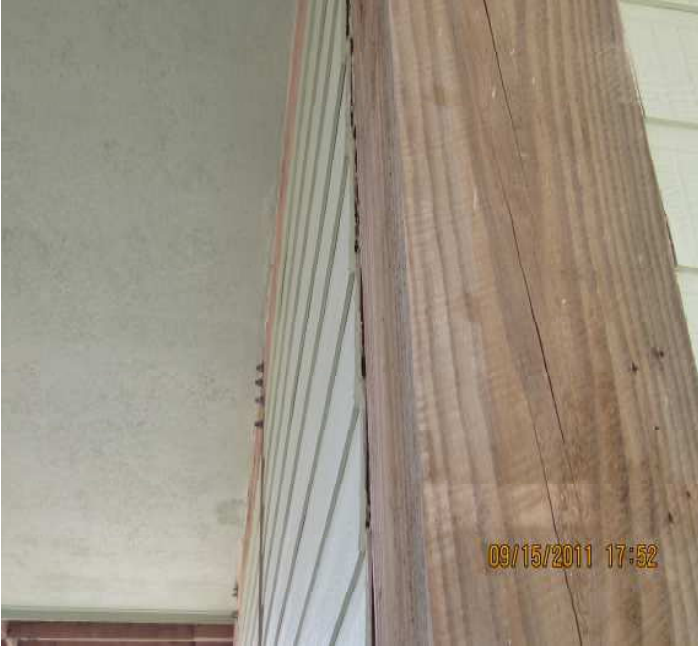
**PHOTO NO. 29      SIDING, ON EAST SIDE OF  
GARAGE, IS PULLING AWAY**

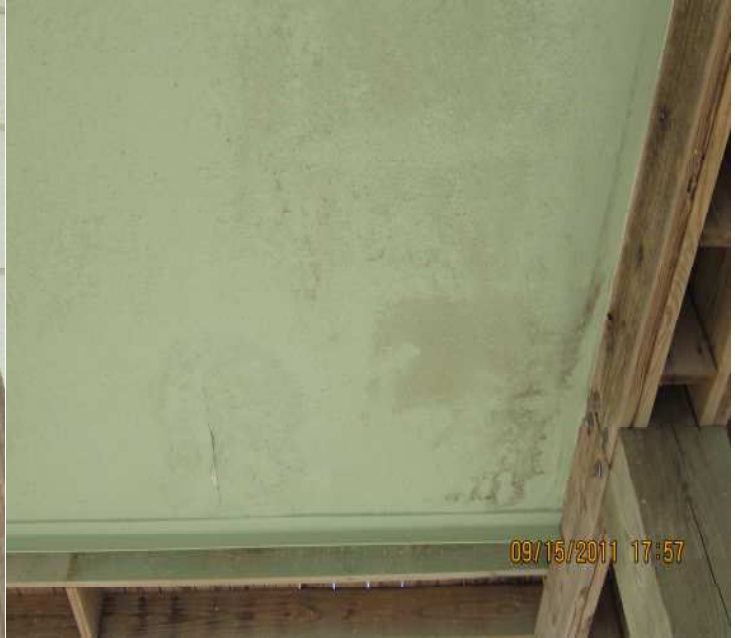
- NO. 12**           **CEILING, AT THE BOTTOM OF THE HOUSE AT THE BACK, IS DAMAGED AND WATER STAINED. THE SOURCE, OF THE WATER, WAS NOT DETERMINED. REPAIRS ARE NEEDED.**

**PHOTO NO. 30      WATER DAMAGED CEILING  
AT BACK SIDE OF CARPORT**
