**ADDENDUM TO PROPERTY INSPECTION REPORT
PROPERTY INSPECTION AGREEMENT
SAMPLE REPORT**

ALLIED HOME INSPECTION SERVICES

**JOHN O. FRANZEN
LICENSED BUILDING INSPECTOR
T.R.E.C. # 1553**

TYPE OF STRUCTURE: LOFT

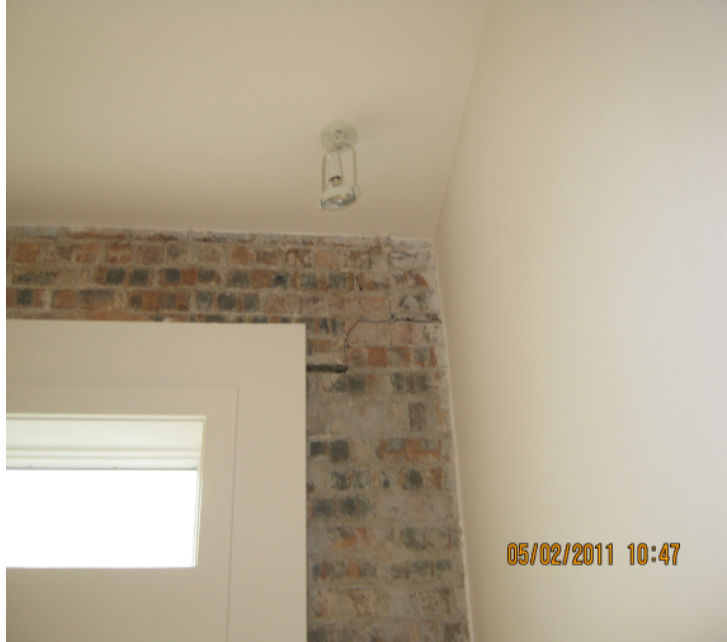
- NO. 1 BRICK, ON WALL OF THE LIVING ROOM, HAS A NUMBER OF MORTAR CRACKS. SEE PHOTO PAGES. REPAIRS ARE NEEDED**

PHOTO NO. 2 DAMAGED BRICK MORTAR ON WEST LIVING ROOM WALL

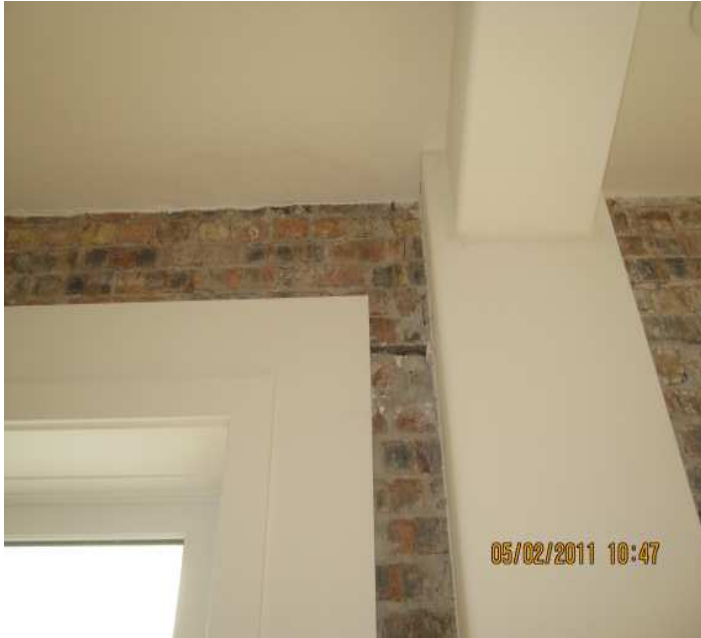
PHOTO NO. 3 DAMAGED BRICK MORTAR ON EAST LIVING ROOM WALL

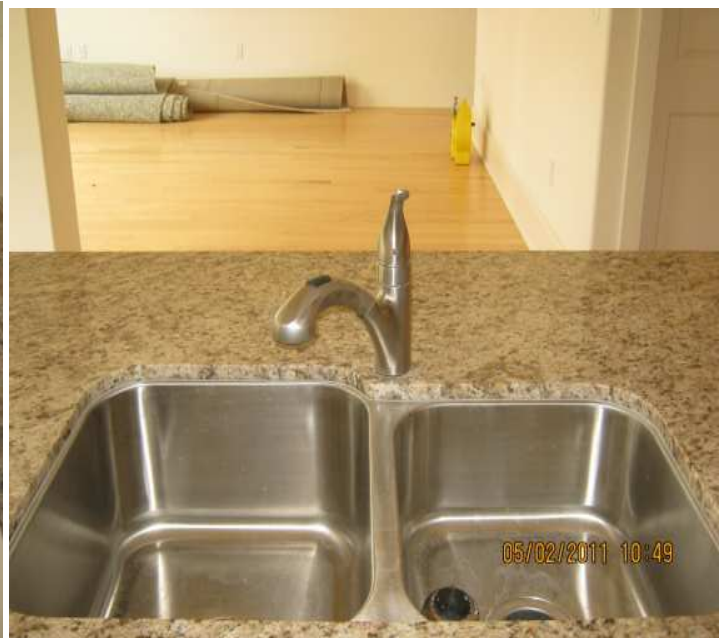
- NO. 3 KITCHEN SINK IS MISSING AN ANTI-SIPHONING DEVICE. IT IS REQUIRED DUE TO THE PRESENCE OF THE SPRAY NOZZLE. LOOPING, UNDER THE SINK, IS NOT ALLOWED. SEE APPENDIX N-2 SEE PHOTO PAGES**

PHOTO NO. 4 KITCHEN SINK MISSING ANTI-SIPHONING DEVICE

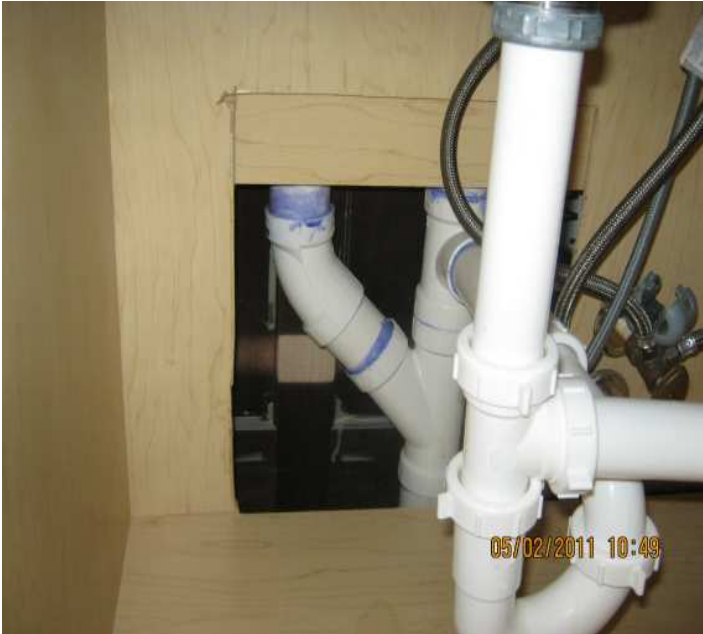
- NO. 4 BACK WALL, UNDER THE KITCHEN SINK, IS DAMAGED. SEE PHOTO PAGES. REPAIRS ARE NEEDED.**

PHOTO NO. 5 DAMAGED BACK WALL UNDER KITCHEN SINK

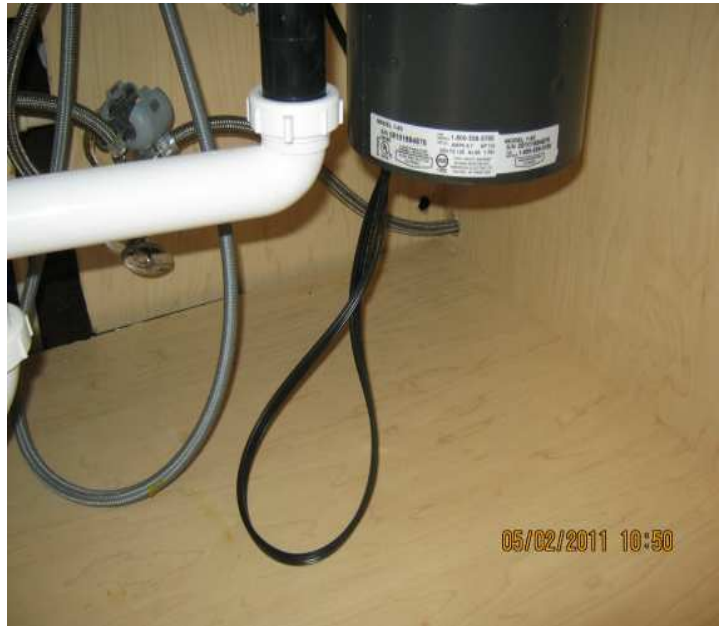
- NO. 5 POWER CORD, TO THE DISPOSAL UNDER THE KITCHEN SINK, NEEDS TO BE ENCLOSED IN A SHIELDED FLEX CONDUIT.**

PHOTO NO. 6 POWER CORD, TO DISPOSAL, NOT ENCLOSED IN CONDUIT

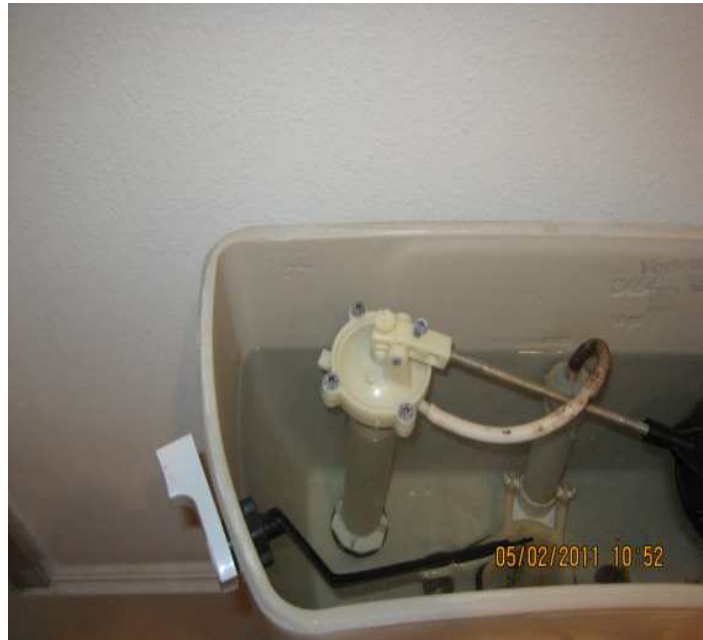
- NO. 2 COMMODE TANKS ARE MISSING AN ANTI-SIPHONING DEVICE. SEE PHOTO PAGES. SEE APPENDIX JJ-2**

PHOTO NO. 7 COMMODE TANKS MISSING ANTI-SIPHONING DEVICE

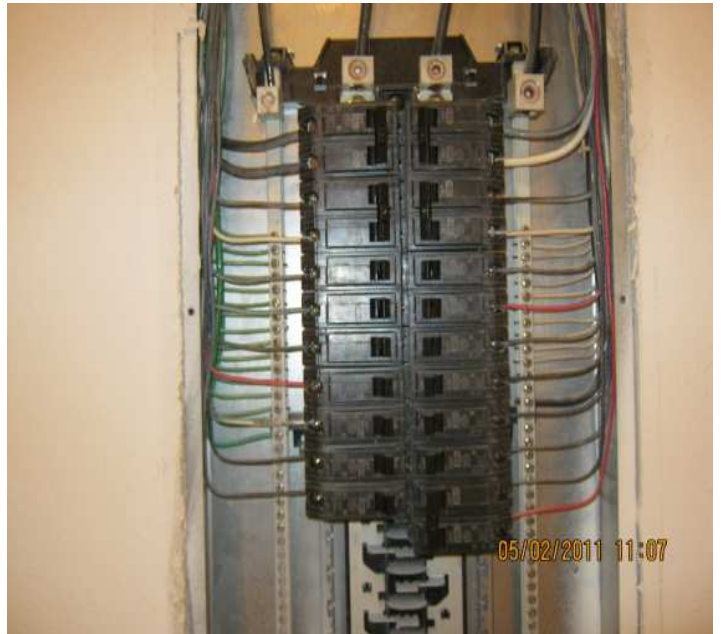
NO. 10 THERE ARE APPROXIMATELY THREE WHITE NEUTRAL WIRES COMING OUT OF BREAKERS. THESE WHITE WIRES NEED TO BE TRACED BY LICENSED ELECTRICIAN TO DETERMINE IF THEY ARE REALLY HOT WIRES THAT HAVE NOT BEEN TAGGED AS HOTS, IF THEY ARE REALLY NEUTRAL WIRES, THEN THE BREAKER BOX NEEDS TO BE REWIRED. SEE PHOTO PAGES

UNABLE TO LOCATE THE MAIN BREAKER BOX. THE SUB-PANEL BREAKER BOX IS LOCATED IN THE NO. 2 BEDROOM. IT IS REQUIRED THAT EACH UNIT, IN THE BUILDING, HAVE A SEPARATE MAIN BREAKER BOX. THIS SEPARATE MAIN BREAKER BOX, NEEDS TO BE IDENTIFIED AS BELONGING TO UNIT 206. BUYER NEEDS TO DETERMINE THE LOCATION OF THE MAIN BREAKER BOX.

PHOTO NO. 8 SUB-PANEL BREAKER BOX IN NO. 2 BEDROOM

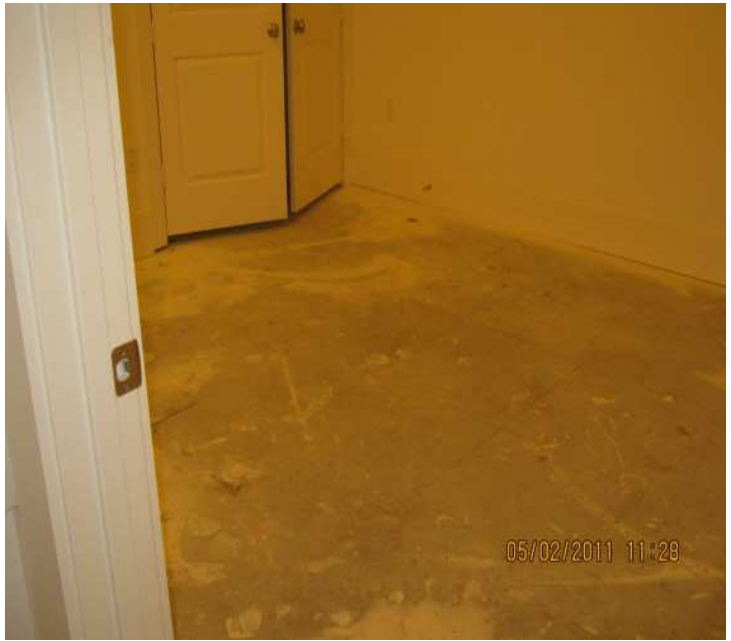
NO. 13 FLOORING NEEDS TO BE INSTALLED IN THE TWO BEDROOMS. SEE PHOTO PAGES

PHOTO NO. 10 MISSING FLOORING IN
BEDROOMS

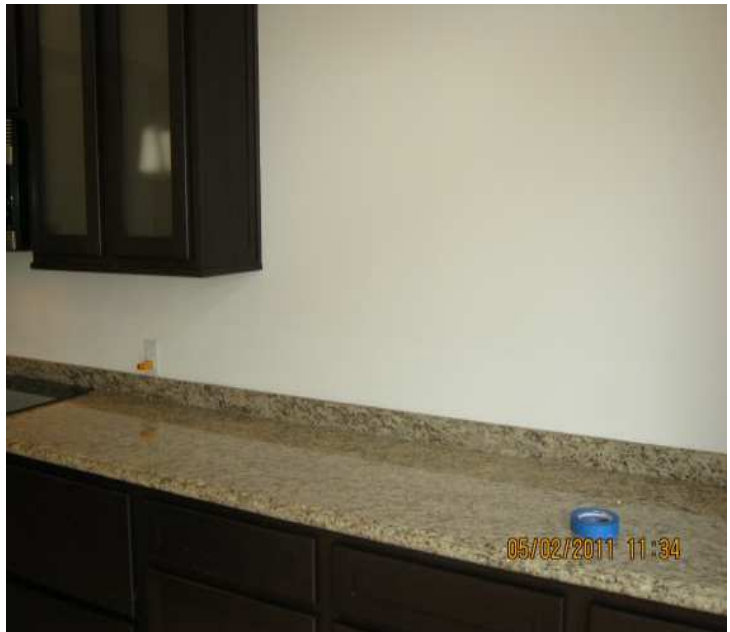
- NO. 17 ADDITIONAL KITCHEN OUTLETS ARE NEEDED TO SERVE THE EAST SIDE COUNTER TOP AND THE PENINSULA. SEE APPENDIX M, P-1, P-2, E3801.2.1, & E3801.4.**

PHOTO NO. 12 EAST SIDE KITCHEN COUNTER
TOP, NEEDS ADDITIONAL OUTLET S

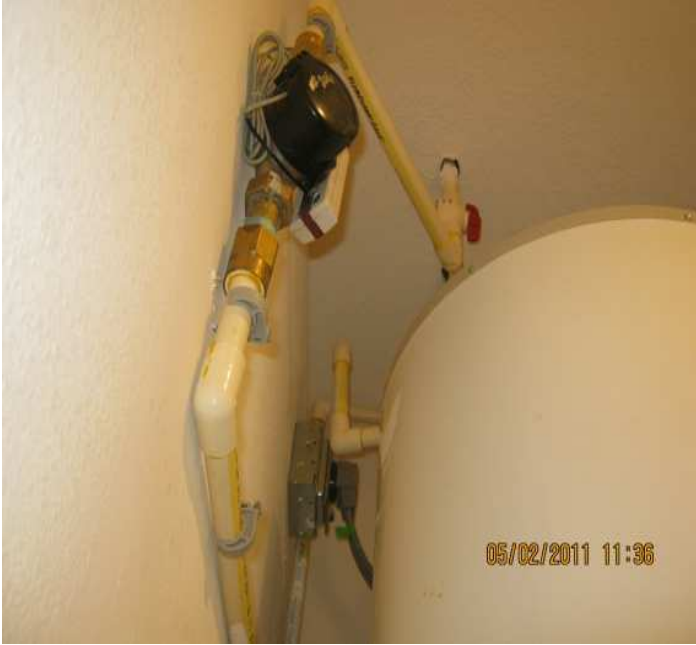
- NO. 18 PVC DRAIN LINE, OFF THE T&P VALVE OF THE WATER HEATER, IS NOT GRAVITY FLOW. SEE APPENDIX DD-1-A, DD-1-B, & DD-1-C. SEE PHOTO PAGES**

PHOTO NO. 13 T & P DRAIN LINE, AT THE
WATER HEATER, IS NOT GRAVITY FLOW

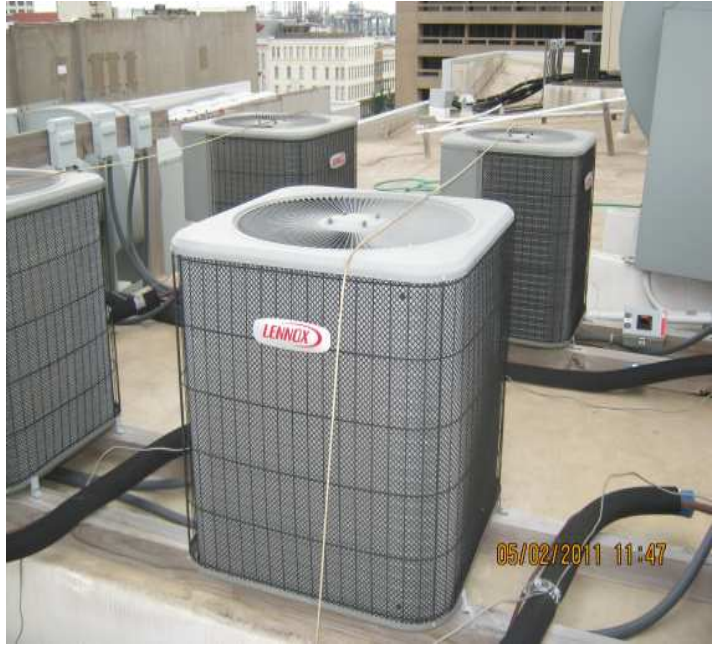
NO. 24 THE A/C CONDENSER UNIT, ON THE ROOF, NEEDS TO BE IDENTIFIED AS BELONGING TO UNIT 206. SEE PHOTO PAGES

PHOTO NO. 14 A/C UNIT ON ROOF

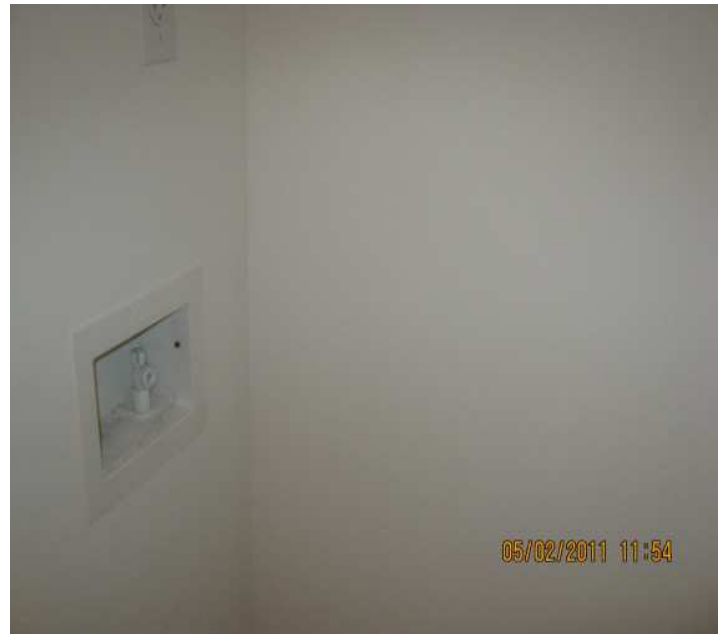
- NO. 21 UNABLE TO LOCATE A DRYER VENT IN THE UTILITY ROOM. SEE APPENDIX E & EE-1-A. REPAIRS ARE NEEDED.**

PHOTO NO. 16 UNABLE TO LOCATE
DRYER VENT IN UTILITY AREA

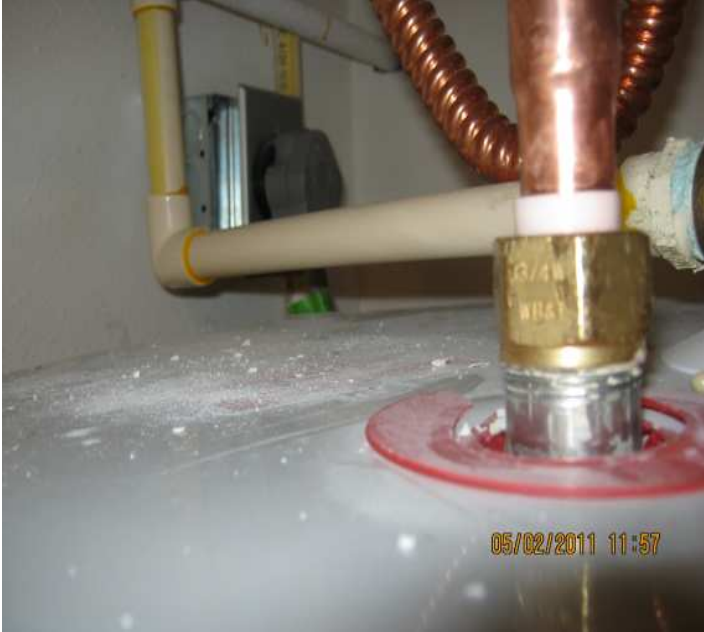
- NO. 20 THE SHELF, IN THE UTILITY ROOM WHERE THE WATER HEATER, IS LOCATED. LOOKS VERY ROUGH. SEE PHOTO PAGES. REPAIRS ARE NEEDED.**

PHOTO NO. 18 DAMAGED WATER HEATER
 SHELF.
