**ADDENDUM TO PROPERTY INSPECTION REPORT
PROPERTY INSPECTION AGREEMENT
(SAMPLE REPORT)**

**ALLIED HOME INSPECTION SERVICES
P. O. BOX 980354
HOUSTON, TEXAS 77098 - 0354
713 / 522 - 0856**

**JOHN O. FRANZEN
LICENSED BUILDING INSPECTOR
T.R.E.C. # 1553**

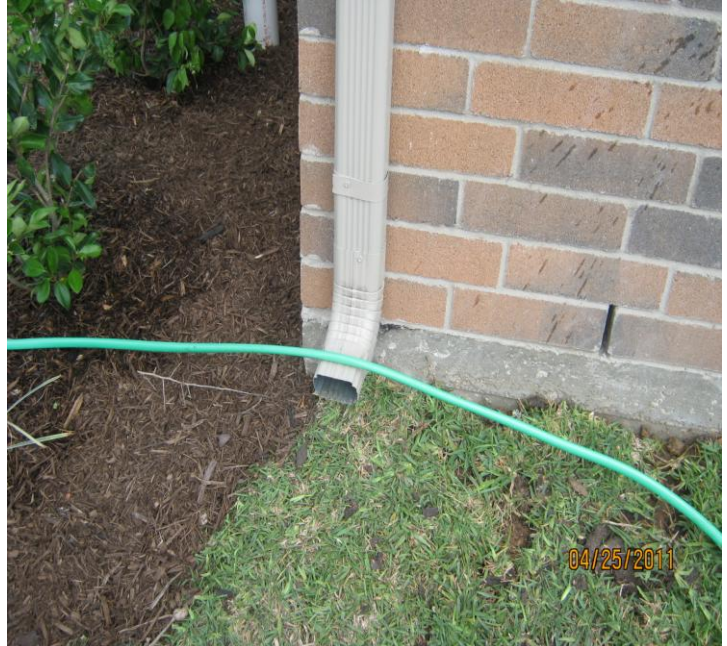
- NO. 22 MISSING SPLASH BLOCKS UNDER DOWNSPOUTS. SEE APPENDIX B-1 & U-3.**

PHOTO NO. 2 MISSING SPLASH BLOCKS UNDER DOWNSPOUTS

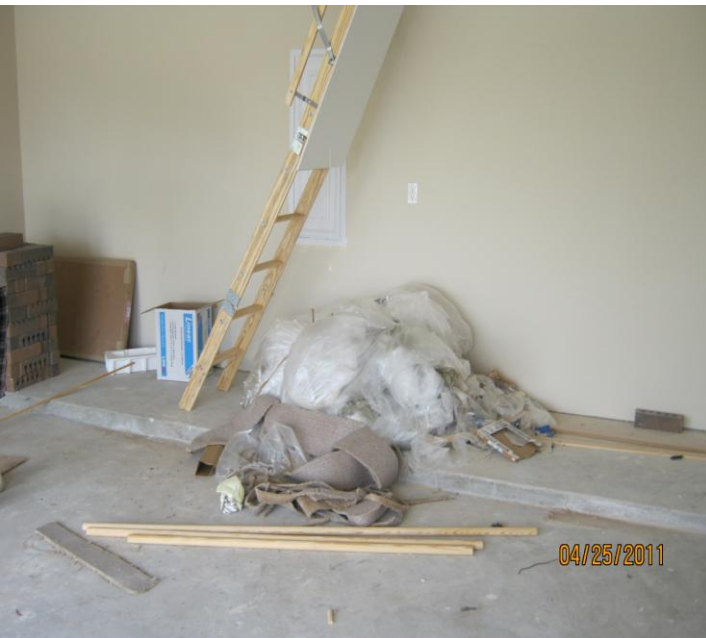
PHOTO NO. 3 TRASH INSIDE THE GARAGE

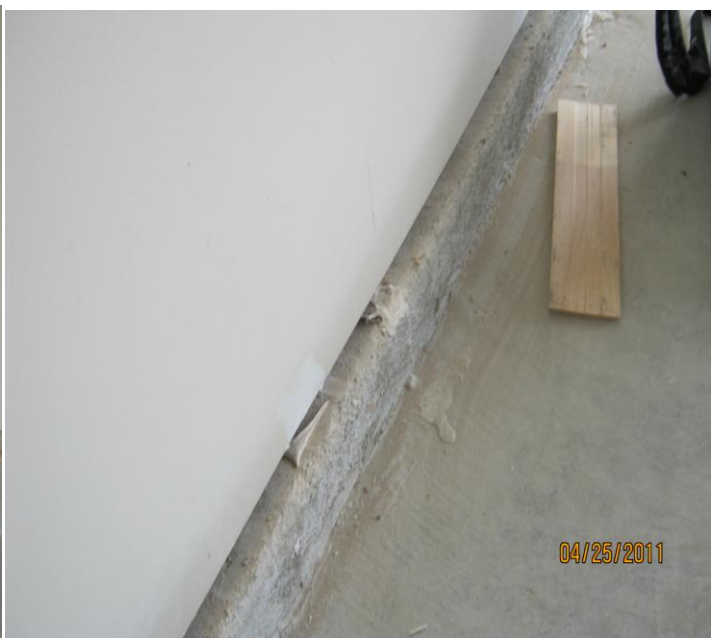
- NO. 7 THE INTERIOR GARAGE WALLS ARE DAMAGED AT THE BOTTOM IN SEVERAL AREAS. REPAIRS ARE NEEDED.**

PHOTO NO. 4 DAMAGED INTERIOR GARAGE WALLS & GAPS

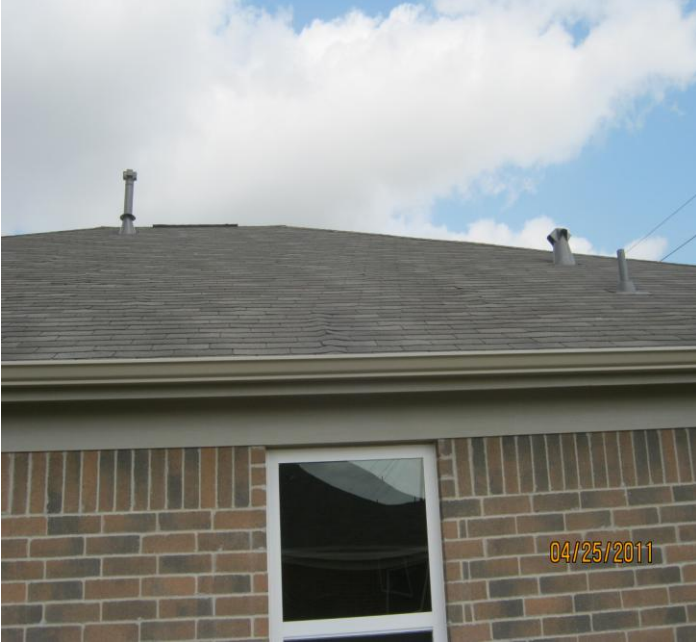
PHOTO NO. 5

**MAJOR HUMPS IN THE
EAST SIDE ROOF**

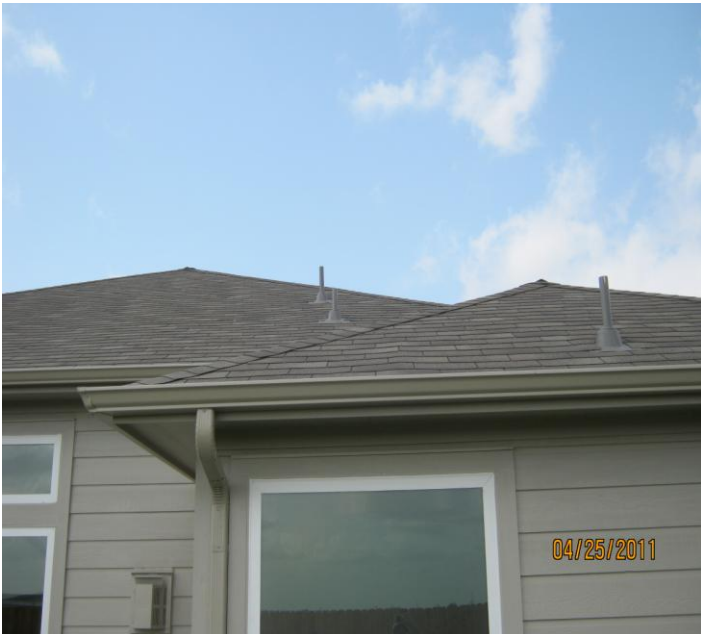
PHOTO NO. 7

HUMPS IN BACK SIDE ROOF

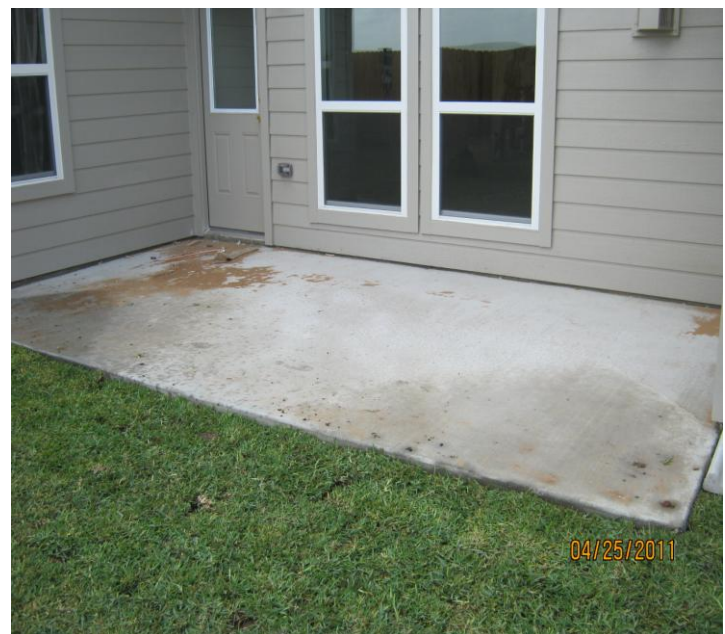
PHOTO NO. 8

**BACK PATIO NEEDS TO BE
SCRAPED & WASHED DOWN**

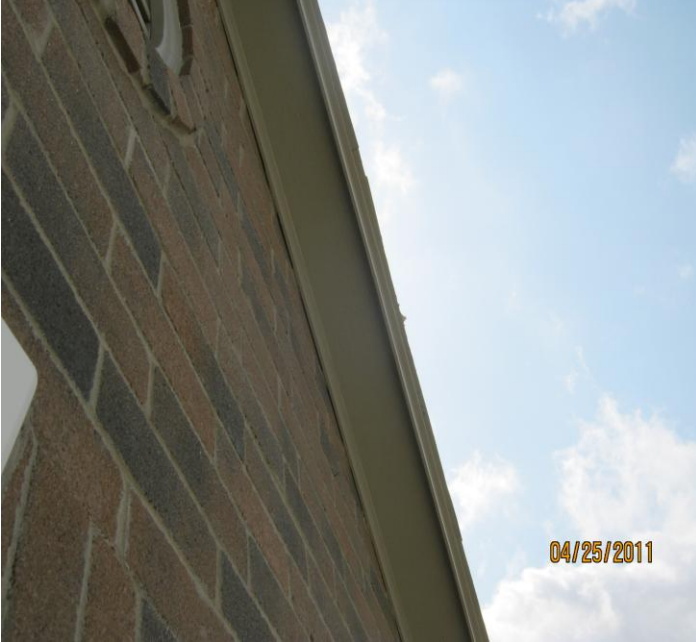
PHOTO NO. 9 GAPS BETWEEN FRIEZE
BOARDS AND BRICK

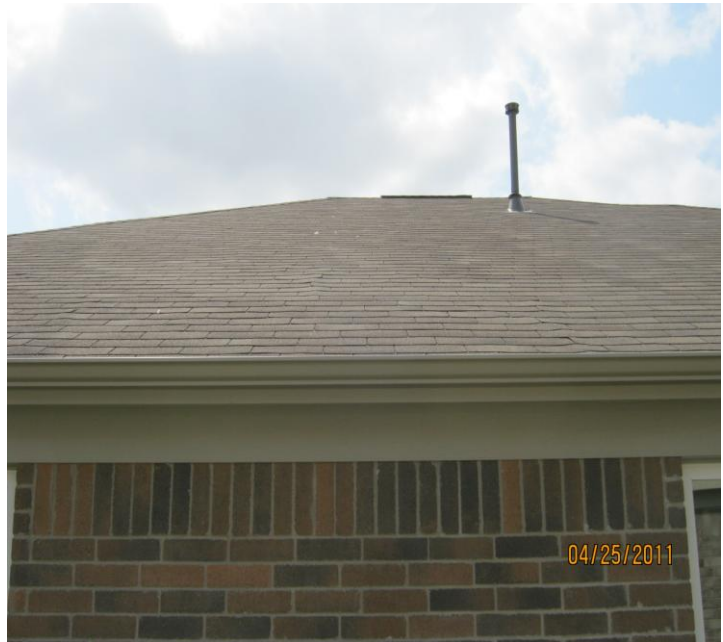
- NO. 11 WEST SIDE ROOF HAS MAJOR HUMPS IN IT. THE ROOF HAS NOT BEEN INSTALLED PROPERLY AND NEEDS TO BE REPLACED**

PHOTO NO. 10 ROOF, ON WEST SIDE, HAS
HUMPS

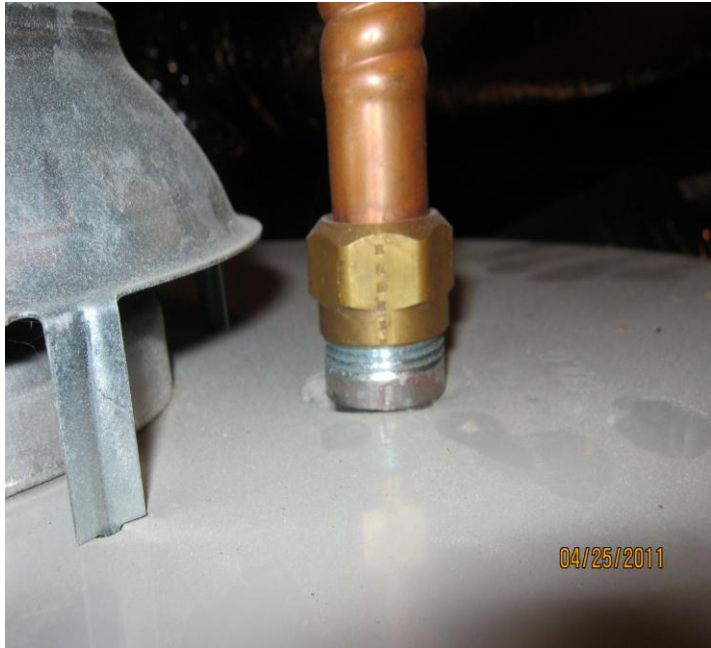
- NO. 19 GALVANIZED - COPPER PIPING CONNECTIONS, AT THE WATER HEATER IN THE ATTIC, ARE MISSING DIELECTRIC FITTINGS. SEE APPENDIX K-2 & K-3**

PHOTO NO. 14 PIPING, AT WATER HEATER,
MISSING DIELECTRIC FITTINGS

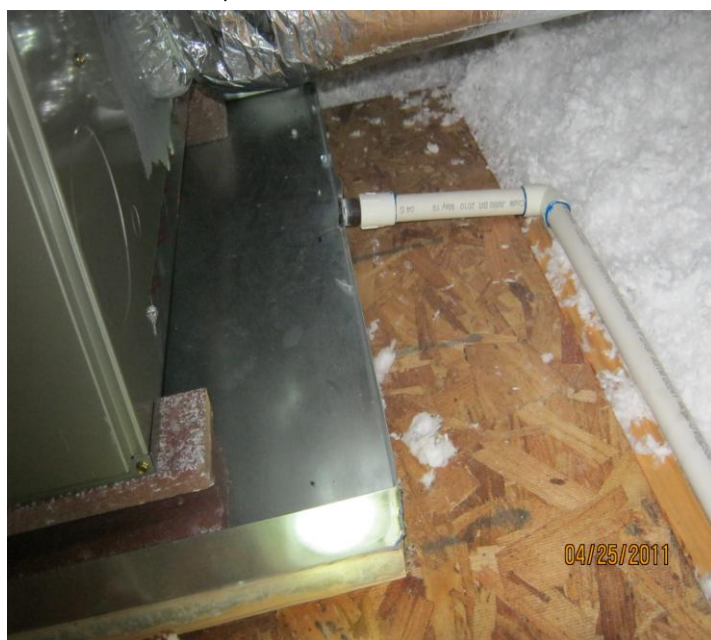
- NO. 16 METAL A/C DRAIN PAN, IN THE ATTIC, IS MISSING A FLOAT SWITCH. SEE APPENDIX CC-2. REPAIRS ARE NEEDED.**

PHOTO NO. 16 METAL A/C DRAIN PAN, IN
ATTIC, MISSING FLOAT SWITCH

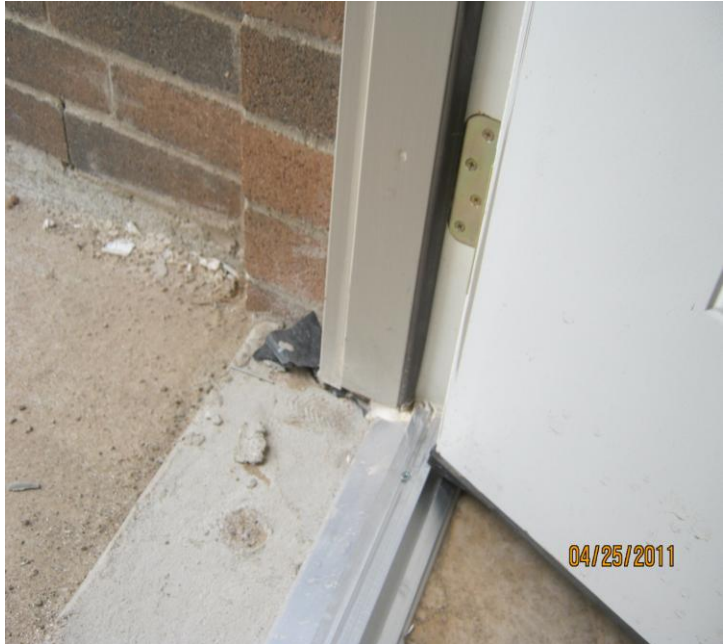
- NO. 15 GAPS, ON BOTH SIDES OF THE THRESHOLD OF THE FRONT ENTRY DOOR, NEED REPAIR**

PHOTO NO. 18 GAPS AT FRONT ENTRY
DOOR THRESHOLD

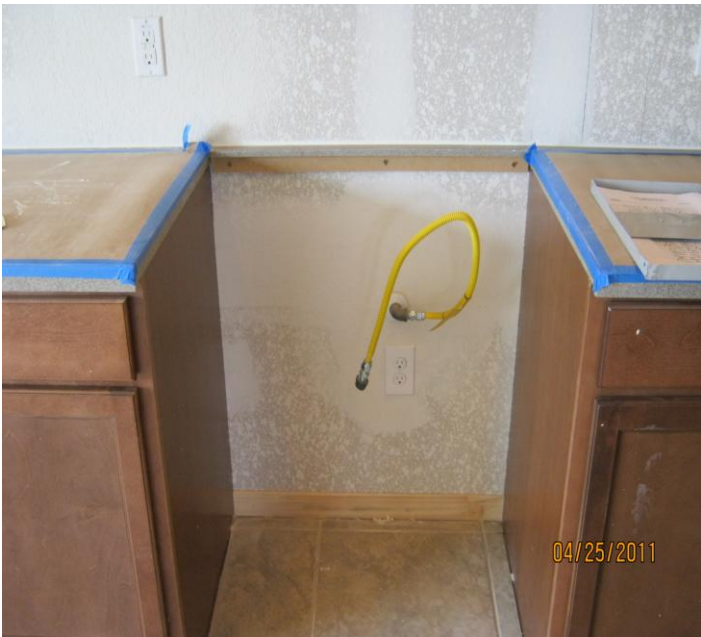
- NO. 26 GAS LINE SHUTOFF VALVE, TO THE RANGE / OVEN NEEDS TO
BE RELOCATED TO THE SIDE OF THE APPLIANCE UNDER THE
ADJACENT CABINET. SEE APPENDIX H, R-4, R-5, & Z. REPAIRS
ARE NEEDED.**

PHOTO NO. 19 GAS LINE, TO RANGE, IS
NOT EASILY ACCESSIBLE

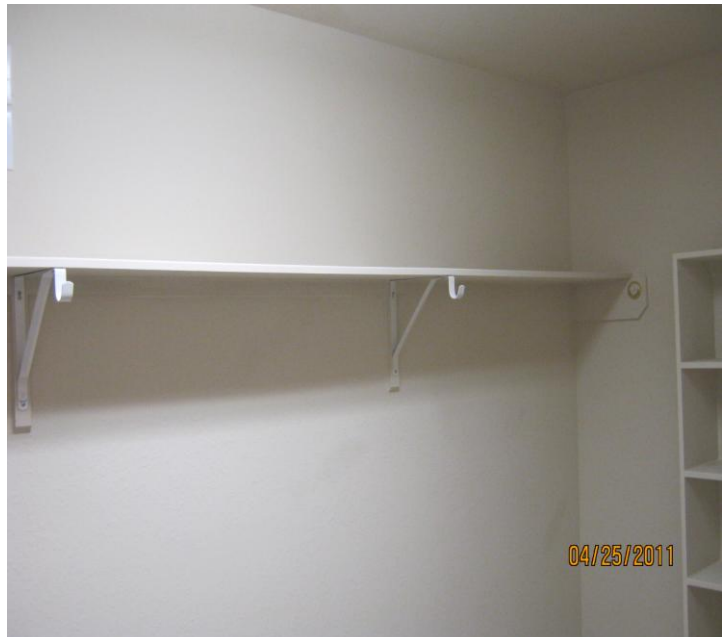
PHOTO NO. 20 CLOSET POLES NOT
INSTALLED

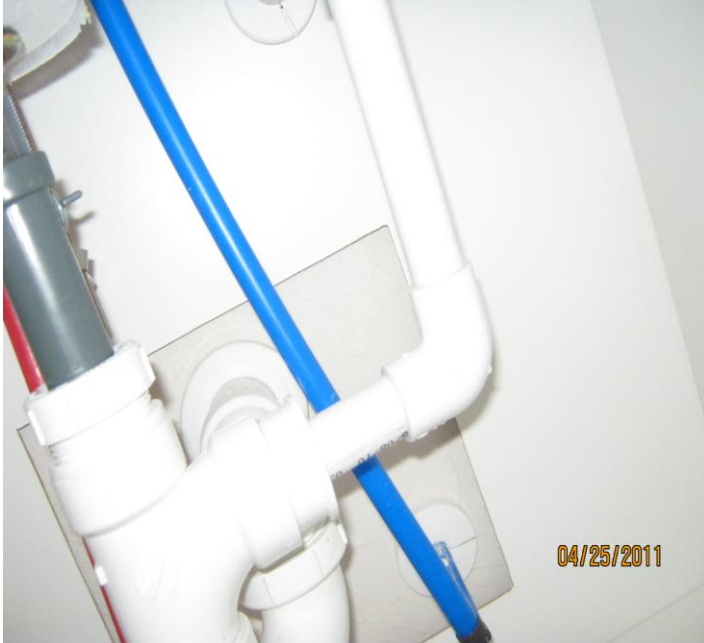
PHOTO NO. 21 A/C PRIMARY DRAIN LINE
NEEDS TO BE INSULATED

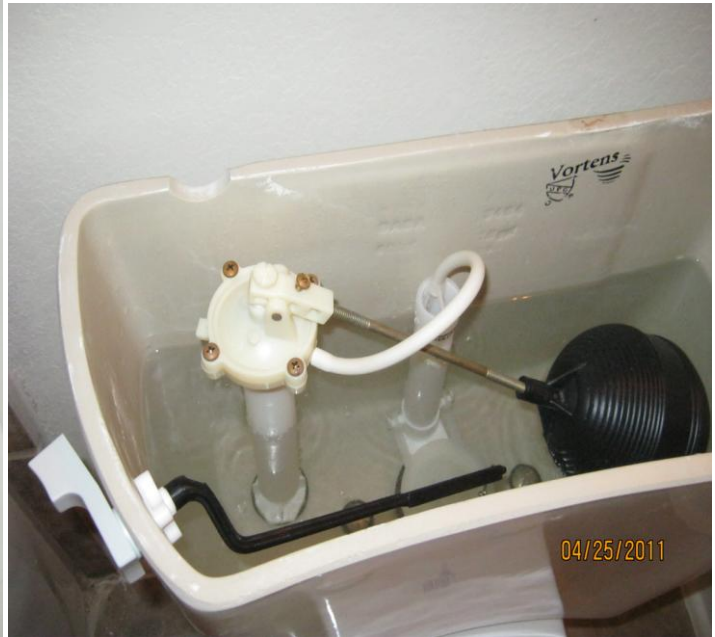
- NO. 30 COMMODE TANKS ARE MISSING AN ANTI-SIPHONING DEVICE.
SEE APPENDIX JJ-2. REPAIRS ARE NEEDED.**

PHOTO NO. 22 COMMODE TANKS ARE
MISSING ANTI-SIPHONING DEVICE

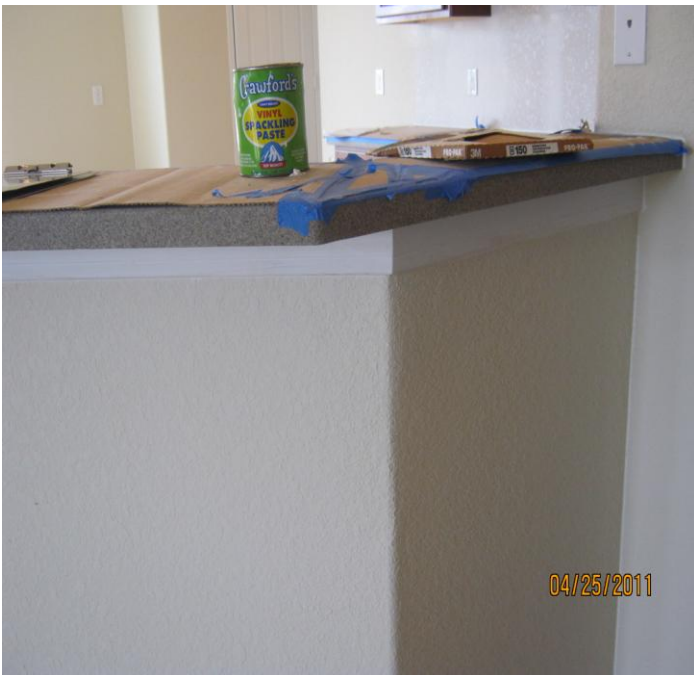
- NO. 17 WALL, UNDER THE KITCHEN COUNTER TOP AT THE BEND, IS NOT ALIGNED PROPERLY. REPAIRS ARE NEEDED.**

PHOTO NO. 23 WALL, UNDER KITCHEN
COUNTER TOP, NOT ALIGNED PROPERLY
