**ADDENDUM TO PROPERTY INSPECTION REPORT
PROPERTY INSPECTION AGREEMENT
(SAMPLE REPORT)**

**ALLIED HOME INSPECTION SERVICES
P. O. BOX 980354
HOUSTON, TEXAS 77098-0354
713 / 522 - 0856**

**JOHN O. FRANZEN
LICENSED BUILDING INSPECTOR
T.R.E.C. # 1553**

ADDRESS:
COUNTY HARRIS
KEY MAP NO.
TYPE OF STRUCTURE: SFH
APPROX. AGE OF STRUCTURE: 5 YEARS

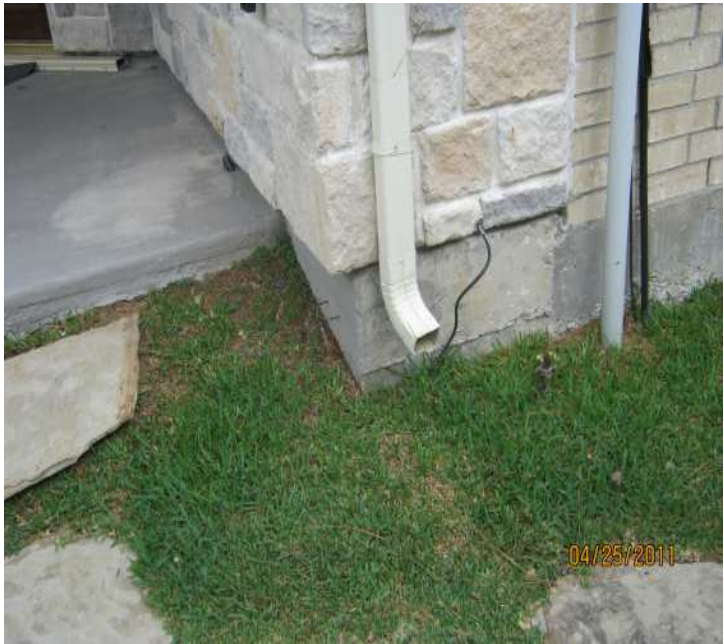
PHOTO NO. 2

**MISSING SPLASH BLOCKS
UNDER DOWNSPOUTS**

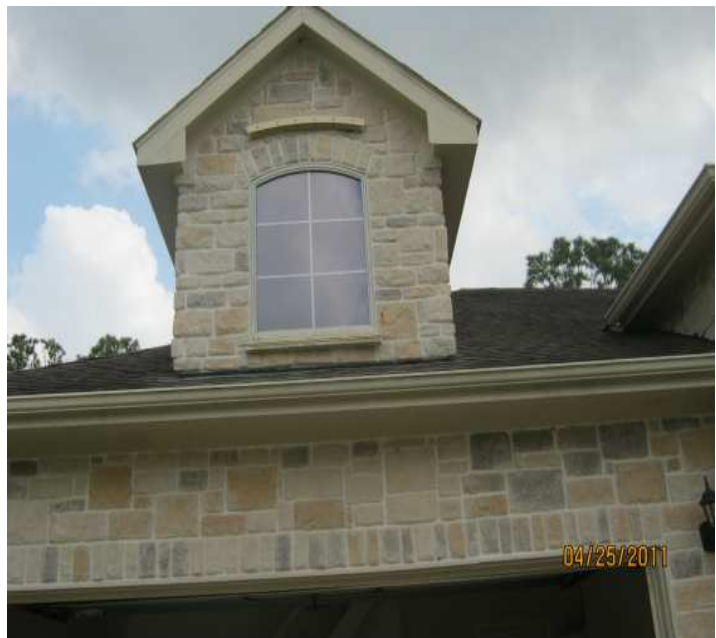
PHOTO NO. 4

**DAMAGED METAL ROOF
FLASHING LOWER FRONT ROOF**

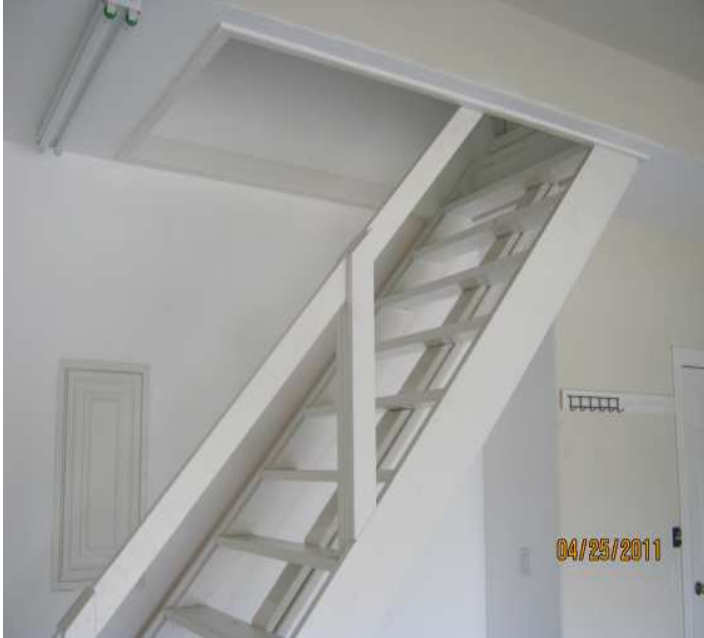
PHOTO NO. 5

NO. 8	WOODEN STAIRS IN THE GARAGE DOES NOT HAVE A MINIMUM 6 FEET 8 INCH CLEARANCE. THE LADDER NEEDS AN ADDITIONAL HAND RAIL DUE TO ITS WIDTH. THE RISER HEIGHT, OF THIS STAIRWAY, IS NOT CONSISTENT. THE GAPS, BETWEEN THE STEPS AND THE GUARD RAIL, DO NOT MEET THE "4-INCH RULE. THE STAIRWAY IS EXTREMELY STEEP AND POSES A SAFETY HAZARD. REPAIRS ARE NEEDED. SEE PHOTO PAGES. SEE APPENDIX F, F-2, & G.	\$300.00 TO \$400.00
--------------	---	-------------------------------------

ATTIC STAIRWAY IN
GARAGE

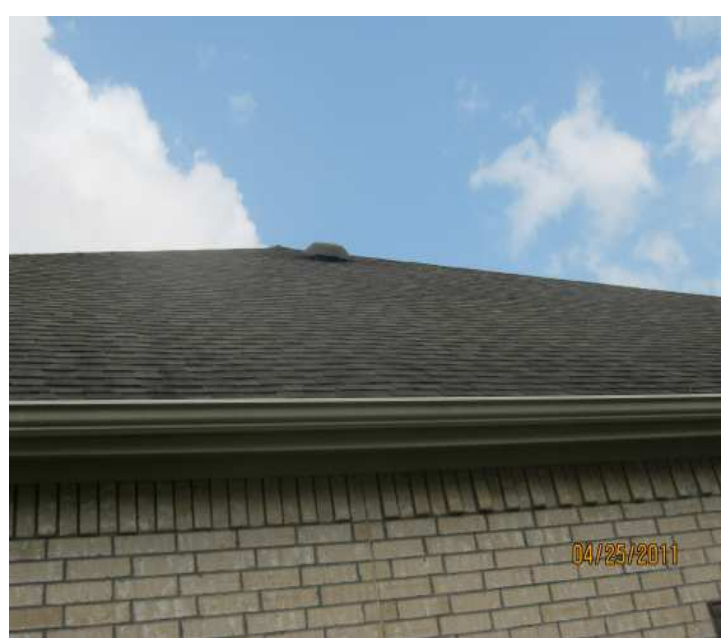
PHOTO NO. 8

DAMAGED ROOF SHINGLES
ON SOUTH SIDE

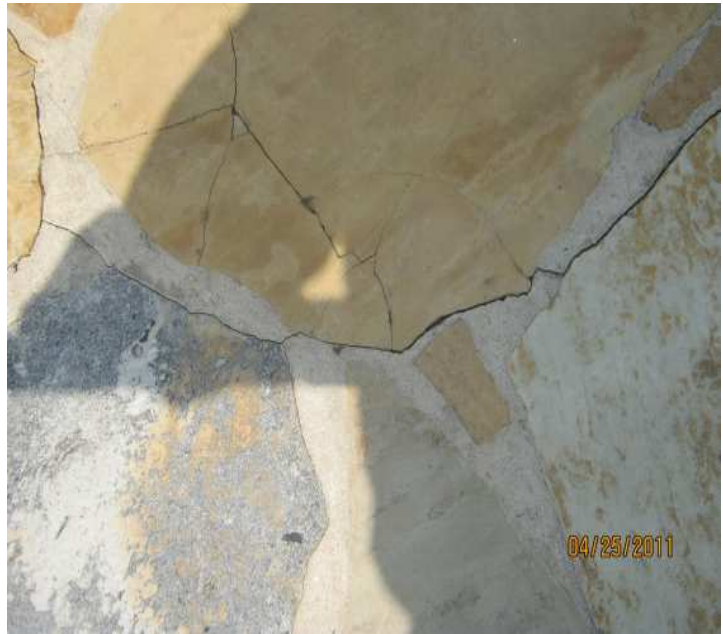
NO. 10	STONE BACK PATIO HAS A LOT OF MORTAR CRACKS. SEE PHOTO PAGES. REPAIRS ARE NEEDED.	\$100.00 TO \$150.00
NO. 11	SECTION, OF THE KITCHEN CABINET UNDER THE DISHWASHER, IS DAMAGED. REPAIRS ARE NEEDED. SEE PHOTO PAGES	\$100.00

PHOTO NO. 10 DAMAGED STONE PATIO

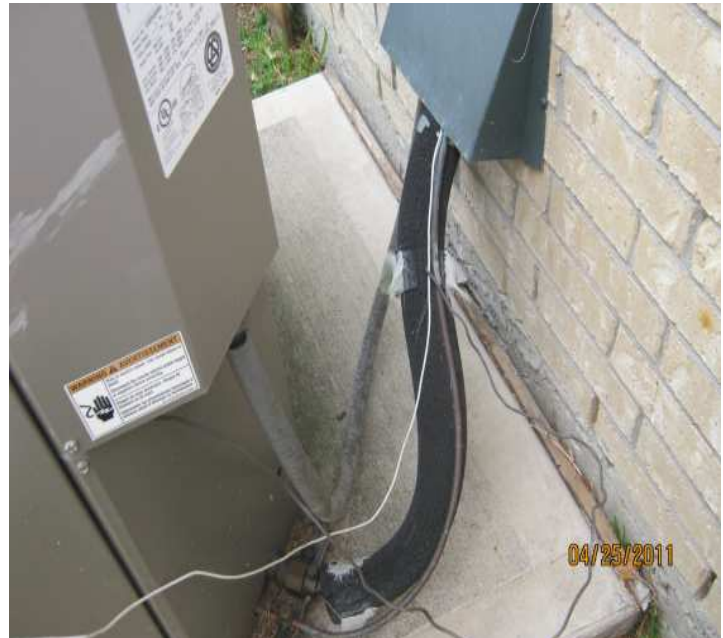
NO. 14	<p>ELECTRICAL DISCONNECT, AT THE CONDENSER UNIT, NEEDS TO BE RELOCATED A MINIMUM OF 15 INCHES TO THE SIDE OF THE CONDENSER. SEE APPENDIX E3305.2</p> <p>GAPS, AT THE A/C HOSES WHERE THEY ENTER THE HOUSE, NEED TO BE SEALED PROPERLY. LIQUID LINE, AT THE CONDENSER UNIT, IS MISSING A DRYER. METAL A/C DRAIN PAN, IN THE ATTIC, IS TOO SHALLOW. SEE APPENDIX CC-1</p> <p>TEMPERATURE READINGS ON PAGE 38 OF THIS REPORT, INDICATE THAT THE A/C SYSTEM NEEDS SERVICING.</p> <p>UNABLE TO LOCATE WHERE THE A/C SECONDARY DRAIN LINE COMES OUT ON AN EAVE OVER A WINDOW. REPAIRS ARE NEEDED.</p>	<p>\$350.00</p> <p>TO</p> <p>\$450.00</p>
---------------	---	--

PHOTO NO. 12 GAPS, AT A/C HOSES BY
CONDENSER UNIT

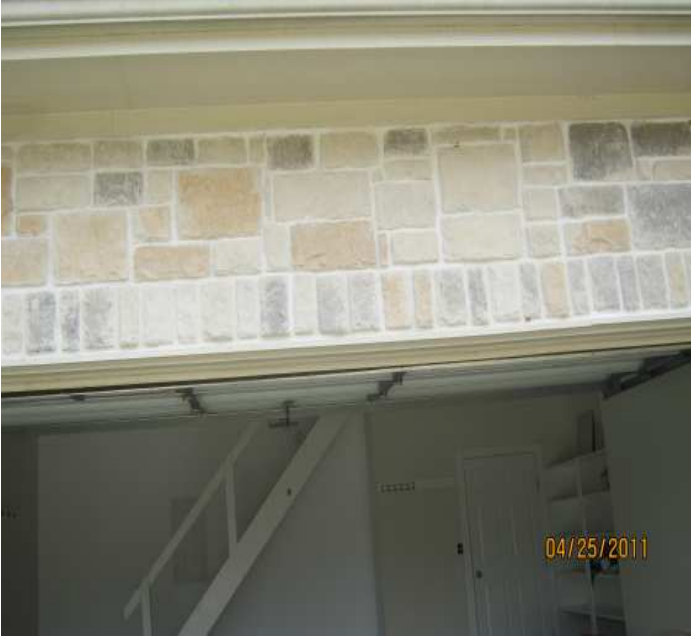
NO. 4	INTERIOR WALLS, OF THE GARAGE, ARE DAMAGED AT THE BOTTOM AND HAVE GAPS UNDER THEM. REPAIRS ARE NEEDED. MISSING WEEP HOLES, ON BRICK VENEER, OVER WINDOWS AND DOORS. SEE APPENDIX T-3	\$150.00 TO \$250.00
--------------	---	-------------------------------------

PHOTO NO. 13 MISSING WEEP HOLES ON
BRICK OVER GARAGE DOOR

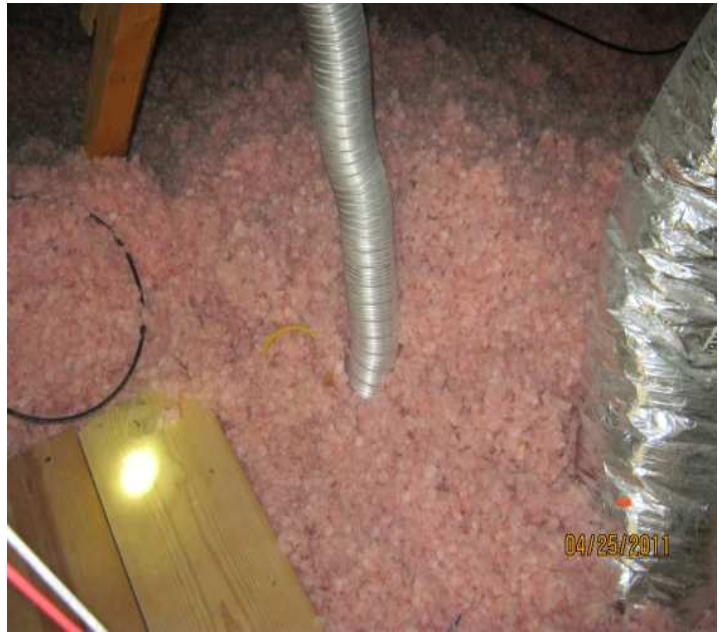
NO. 3	INSULATION IS LAYING IN THE ATTIC ON VENT FAN ASSEMBLIES. THE PRESENT SETUP POSES A FIRE HAZARD. THE INSULATION NEEDS TO BE PULLED BACK FROM THESE AREAS. SEE APPENDIX JJ-4 & S-3.	\$100.00 TO \$150.00
--------------	---	-------------------------------------

PHOTO NO. 14 INSULATION, IN ATTIC, LAYING
ON VENT FAN ASSEMBLIES

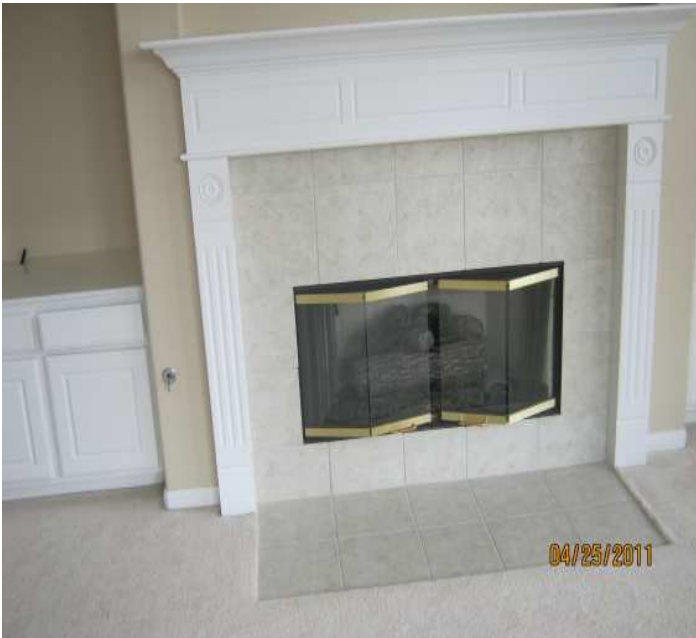
NO. OF FIREPLACES?	ONE	
LOCATION OF FIREPLACES?	LIVING ROOM	
IS THE FIREBOX (S) METAL OR MASONRY?		METAL
ARE CHIMNEY CAPS AND SPARK ARRESTORS PRESENT?		YES
NO. 9	RIGHT SIDE METAL WALL, OF THE FIREBOX, IS LOOSE. THIS WALL NEEDS TO BE RESECURED PROPERLY. SEE PHOTO PAGES	\$100.00 TO \$150.00

PHOTO NO. 15 FIREPLACE IN LIVING ROOM

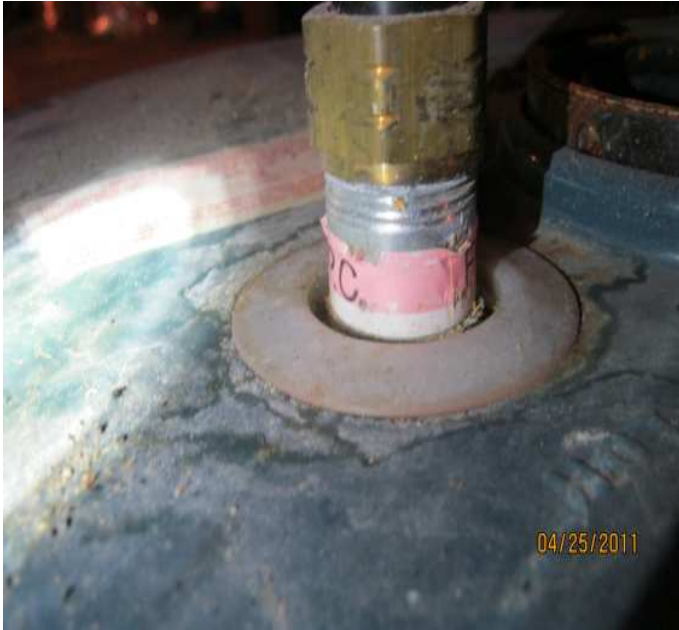
NO. 17	GALVANIZED - COPPER PIPING CONNECTIONS, AT THE TOP OF THE WATER HEATER IN THE ATTIC, ARE MISSING DIELECTRIC FITTINGS. SEE PHOTO PAGES. SEE APPENDIX K-2 & K-3. REPAIRS ARE NEEDED.	\$150.00 TO \$250.00
---------------	---	-------------------------------------

PHOTO NO. 17 WATER HEATER PIPING
MISSING DIELECTRIC FITTINGS

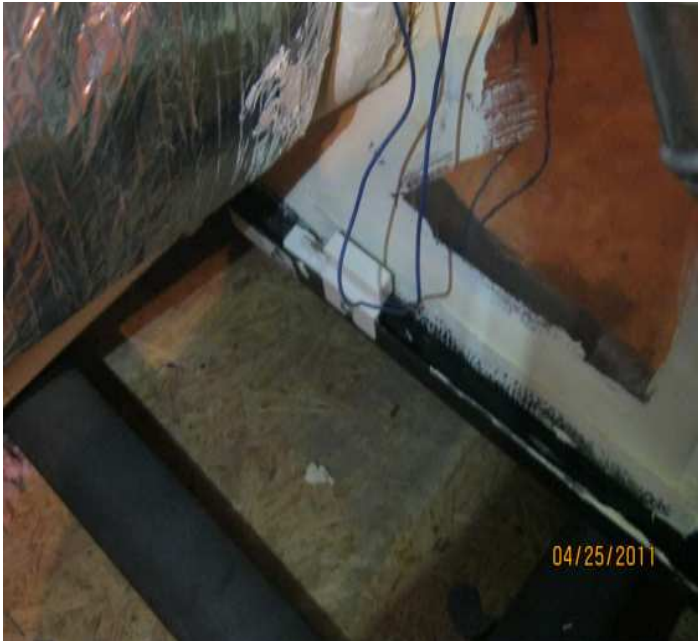
PHOTO NO. 19 A/C DRAIN PAN, IN ATTIC, IS
TOO SHALLOW

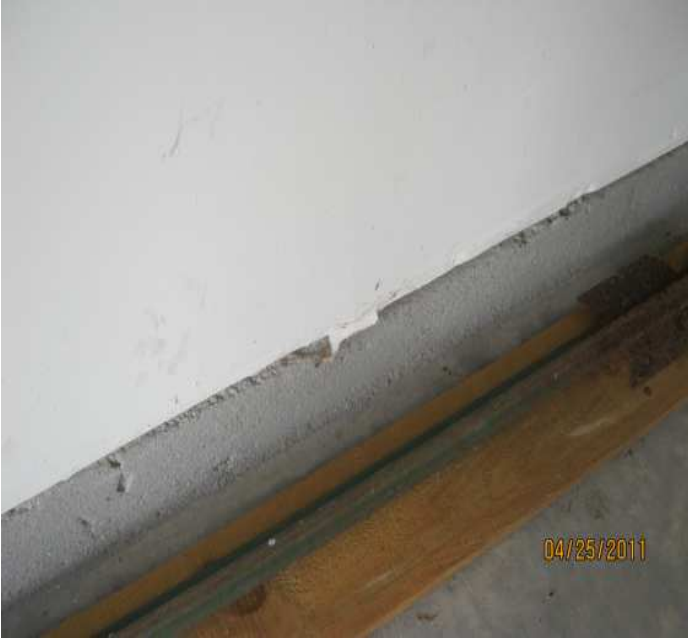
**PHOTO NO. 21 DAMAGED INTERIOR WALLS
 OF GARAGE**

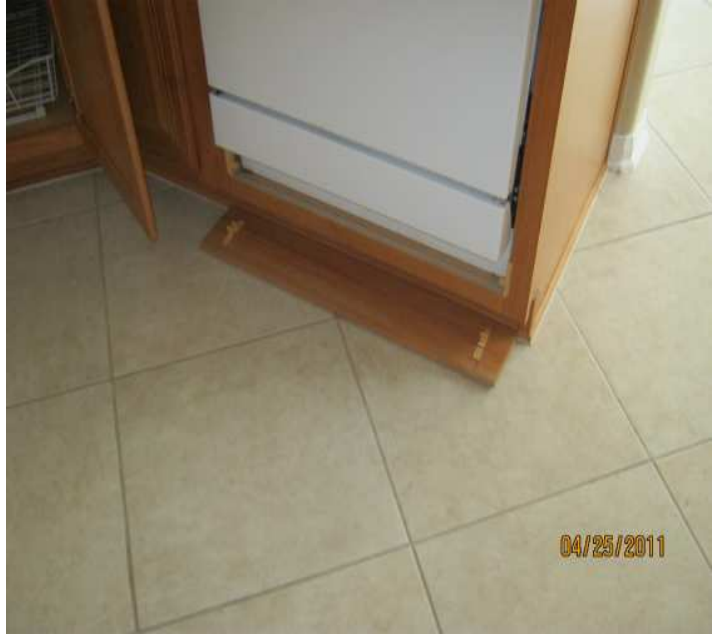
**PHOTO NO. 22 DAMAGED KITCHEN CABINET
 UNDER DISHWASHER**

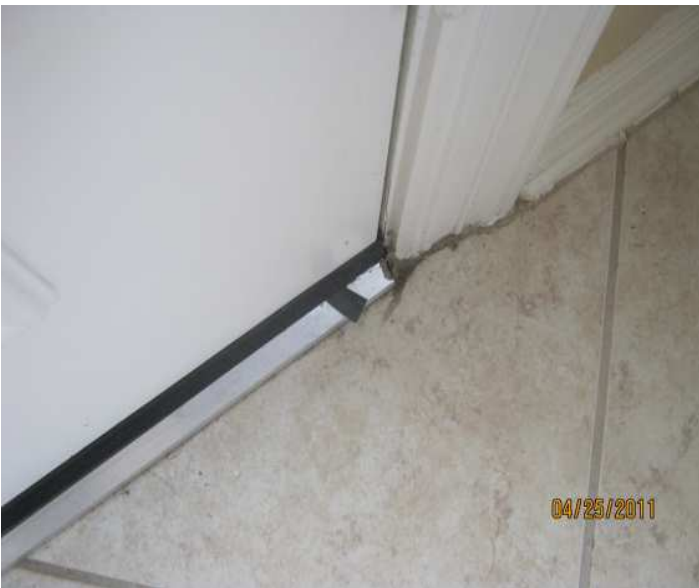
NO. 6	GARAGE ENTRY DOOR IS MISSING A DEAD BOLT LOCK. MISSING OR DAMAGED DOOR STOPS IN SEVERAL AREAS. WEATHER STRIPPING, AT THE BOTTOM OF THE BACK EXIT DOOR, IS DAMAGED. SEE PHOTO PAGES. REPAIRS ARE NEEDED.	\$100.00 TO \$150.00
--------------	--	-------------------------------------

**PHOTO NO. 23 DAMAGED WEATHER
 STRIPPING AT BOTTOM OF BACK EXIT DOOR**
